**Final Report
2006 Biota Monitoring
Moab, Utah**

Final Report
2006 Biota Monitoring
Moab, Utah, UMTRA Project Site

January 2007

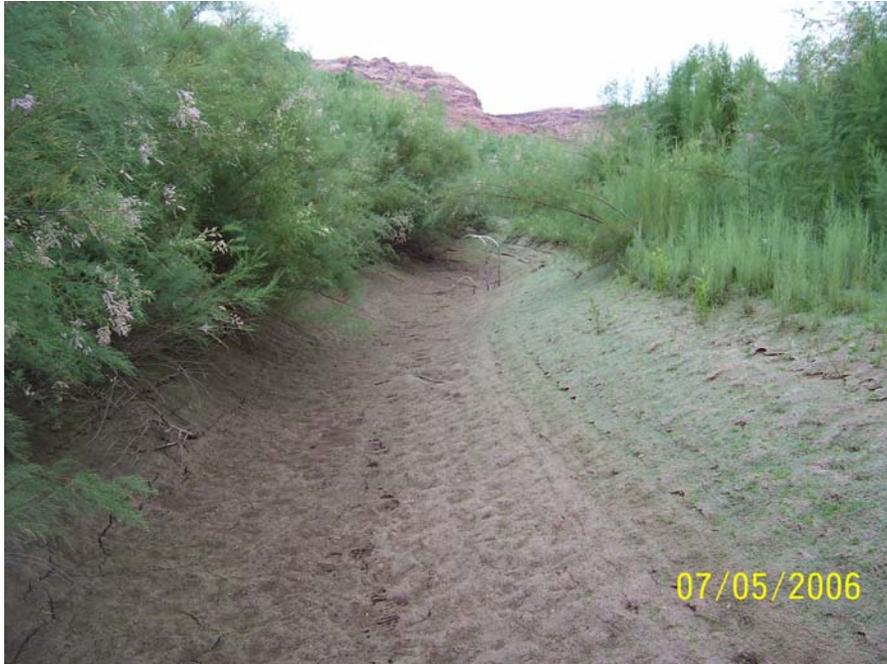
Photo 1. This former/potential backwater channel adjacent to the Baseline Area was dry throughout the biota monitoring event. View is to the north.

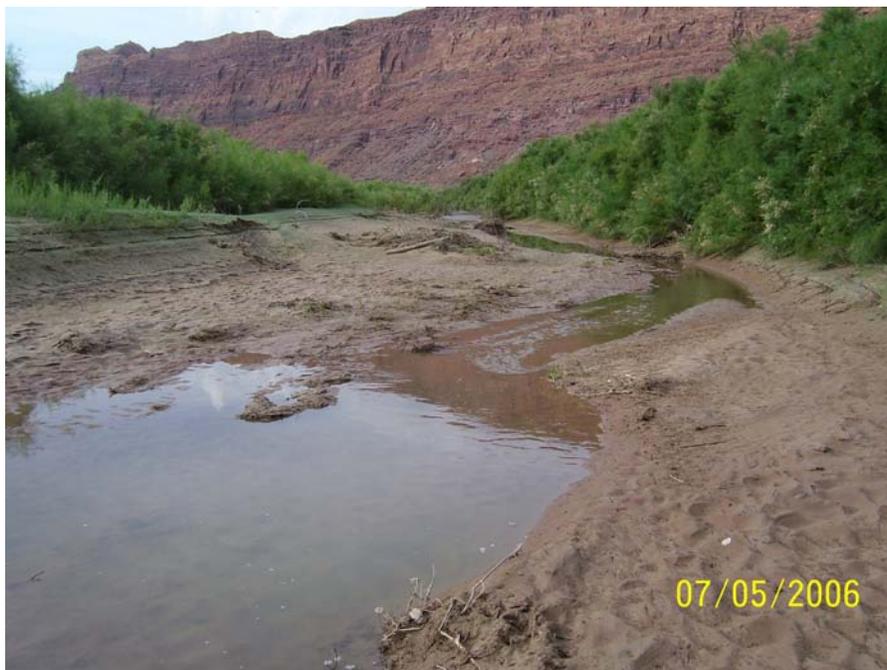
Photo 2. Configurations 3 and 2 backwater areas part of the "main backwater area" on July 5, 2006. The main backwater channel flowed freely near all of the well field configuration areas. View is to the south.

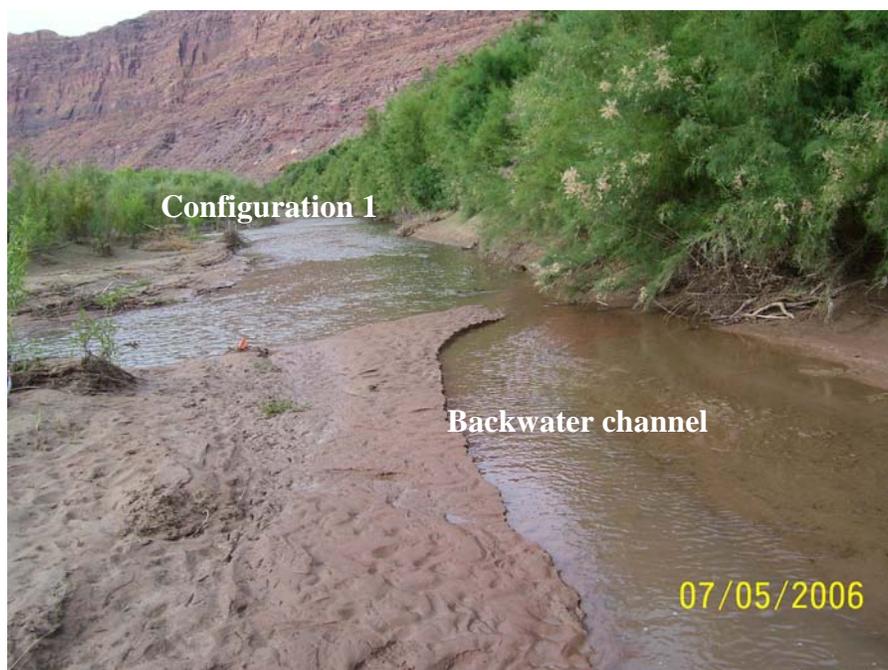
*Photo 3. The confluence of main backwater channel near the Configuration 1 area.
View is to the south.*

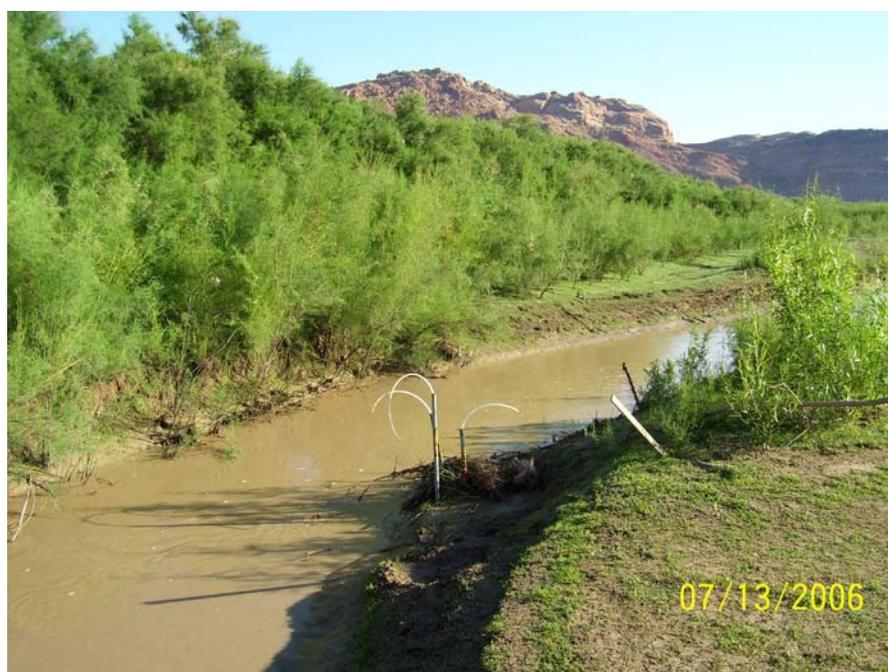
*Photo 4. The main backwater channel through the Configuration 3 area.
View is to the north.*

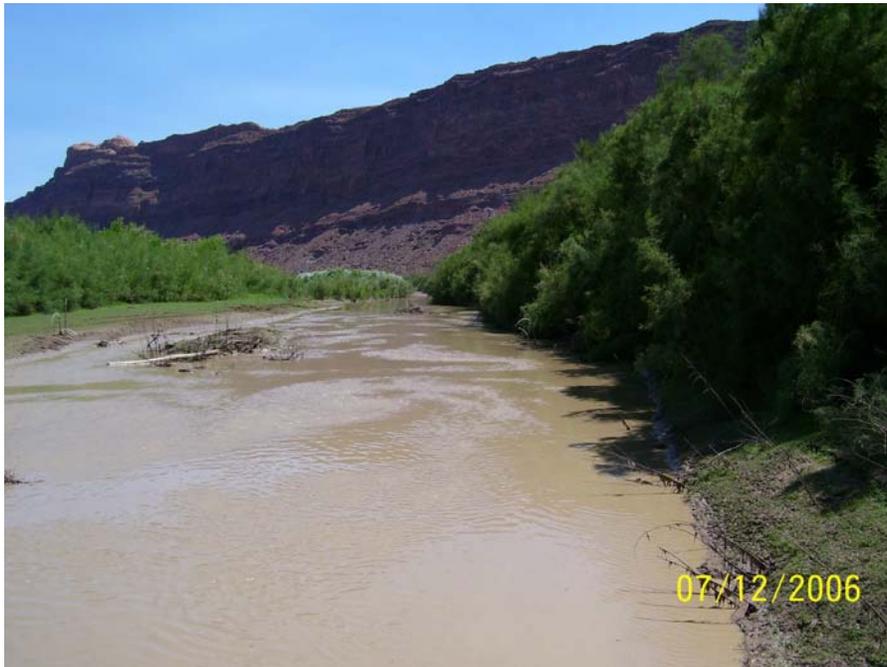
*Photo 5. The main backwater channel as it flows through the Configuration 2 area.
View is to the south.*

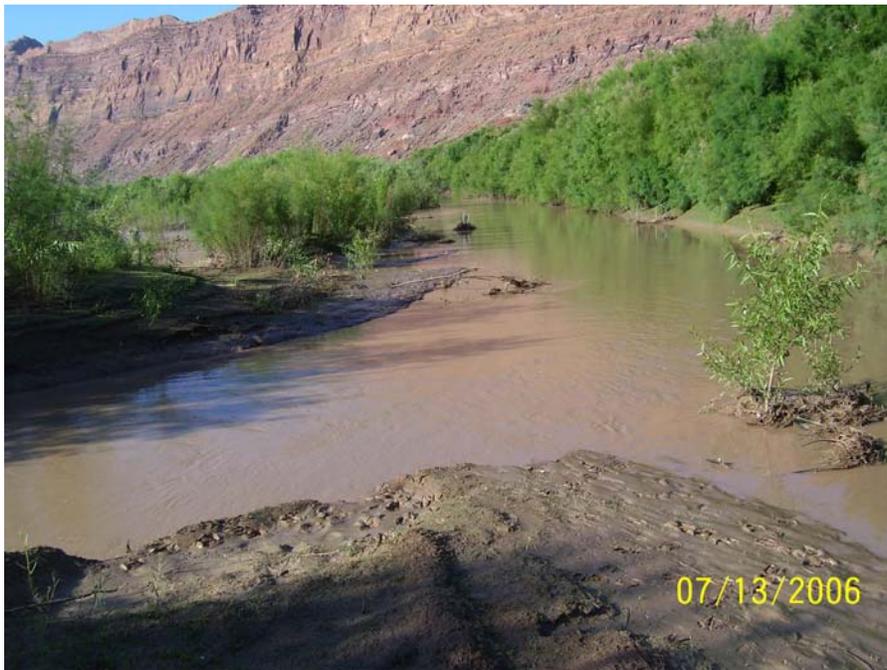
*Photo 6. The confluence of backwater channels near Configurations 1 and 2.
Compare with Photo 3 dated July, 5, 2006. View is to the south.*

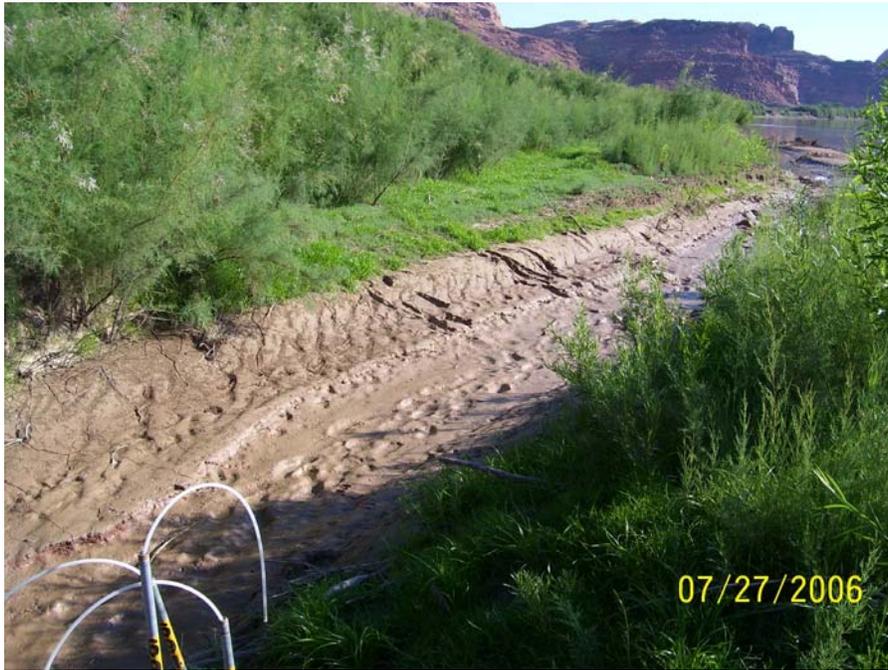
Photo 7. The backwater channel near Configuration 3 is dry at this lower river flow. Compare with Photo 4. View is to the north.

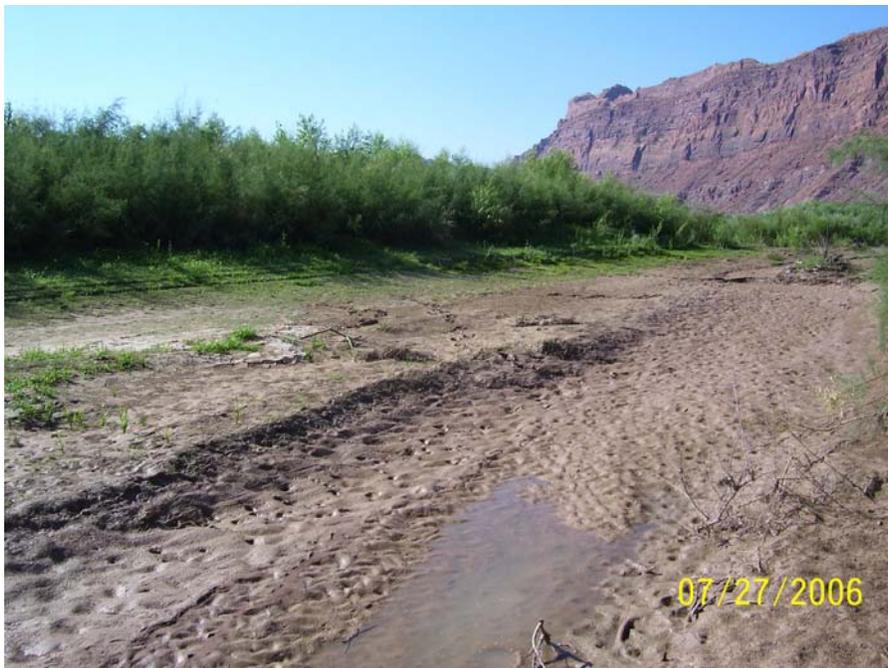
Photo 8. Configuration 2 "backwater" consisted of isolated pockets of water. The water in the foreground is surface water sample Location 0240. Compare with Photo 5. View is to the south.

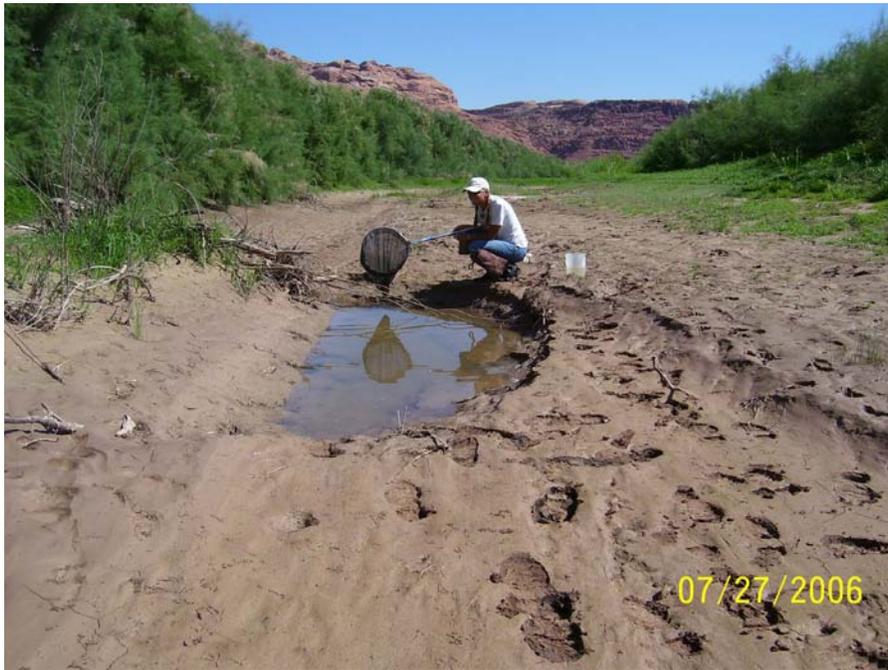
Photo 9. Surface Water Location 0236. Fish were frequently observed in this pocket of water. View is to the north.

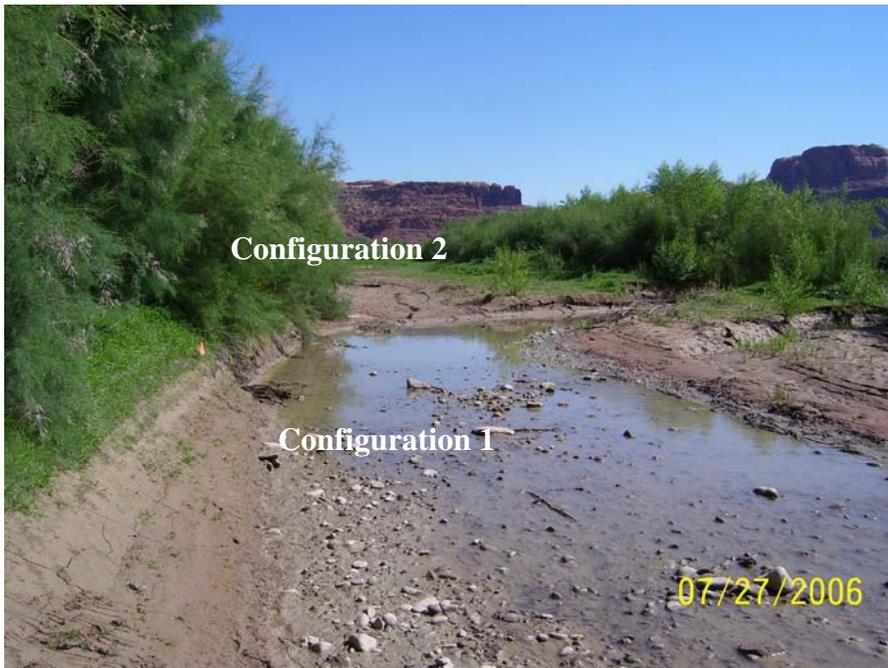
Photo 10. Backwater area near Configurations 1 and 2. View is to the north.

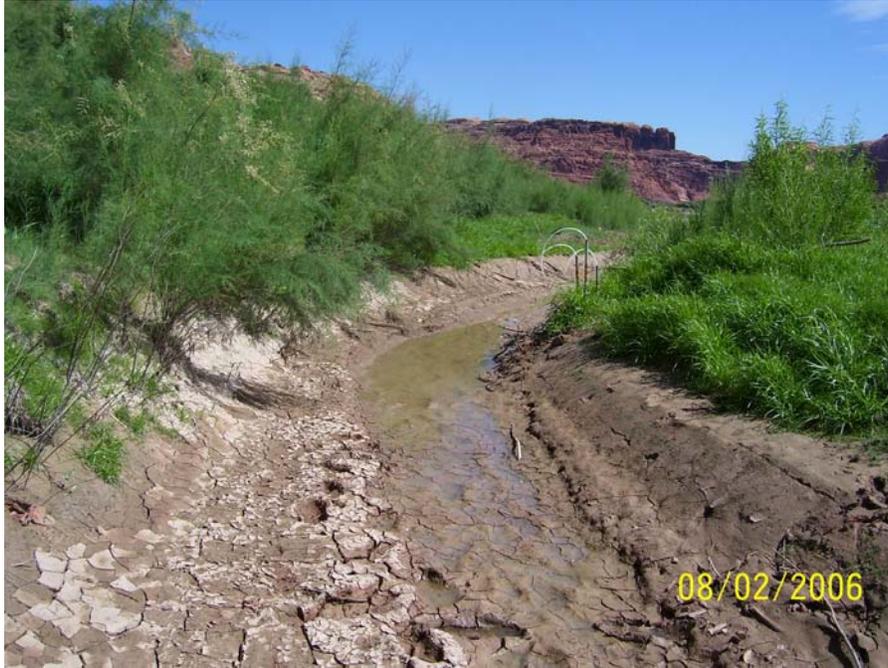
Photo 11. The main backwater channel near Configuration 3, note the desiccation cracks. Compare with Photos 4 and 7. View is to the north.

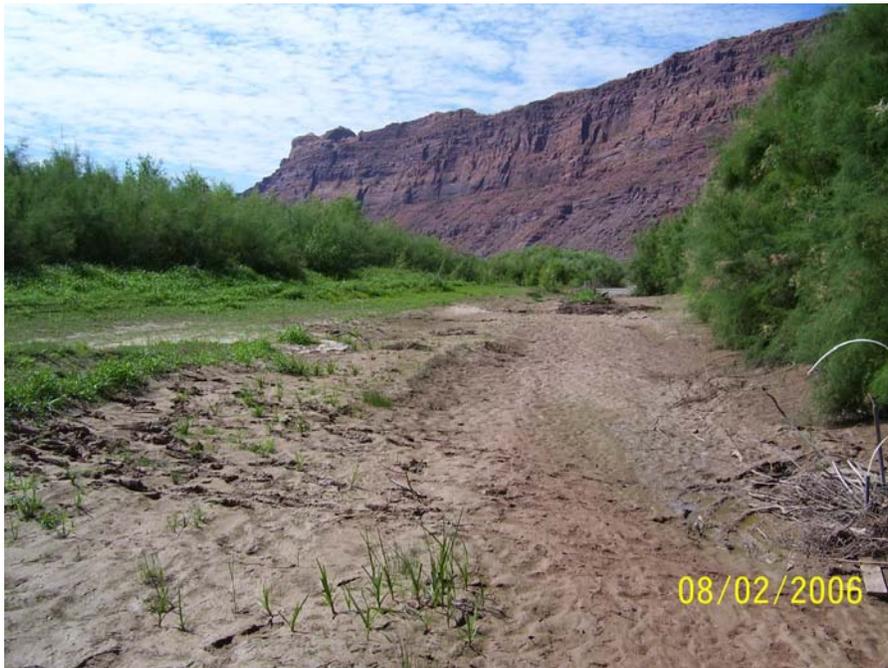
Photo 12. Backwater channel near Configuration 2 is dry, with the exception of isolated pocket at Surface Water Location 0236. View is to the south.

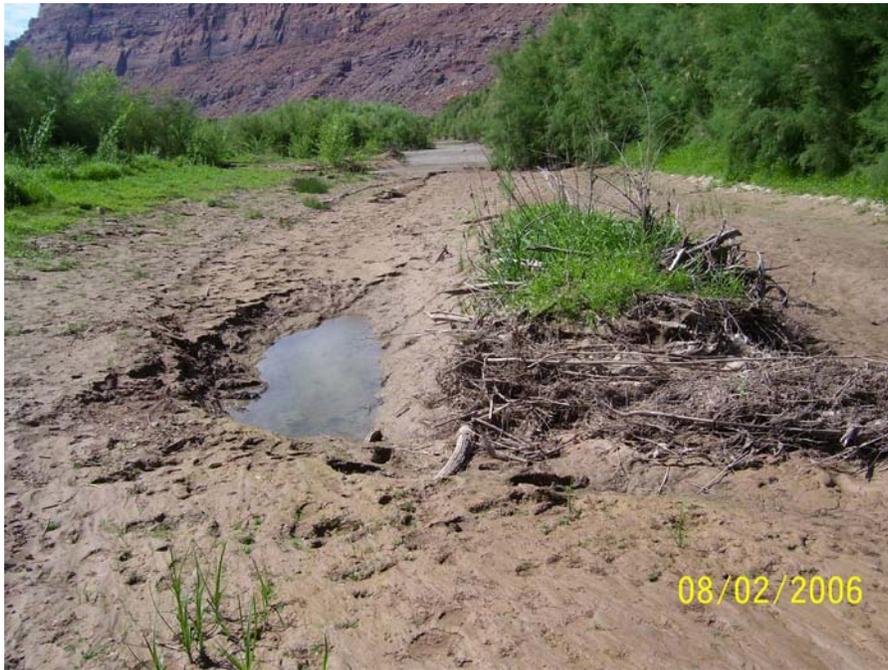
On July 31, 2006 the isolated backwater pocket near Configuration 2 (Location 0236) had a conductivity of 3,153 micromhos per centimeter ($\mu\text{mhos/cm}$) when the river flow was 3,630 cfs. Two days later, on August 2, 2006, the conductivity of Location 0236 increased to 3,820 $\mu\text{mhos/cm}$ when the river flow was 5,170 cfs (see Photo 13 in Appendix A). On August 8, 2006, the river flow was at 5,460 cfs, and the main backwater channel flowed through

Photo 13. Surface Water Location 0236 on August 2, 2006. The conductivity of this location was abnormally high on this day (3,820 $\mu\text{mhos/cm}$).

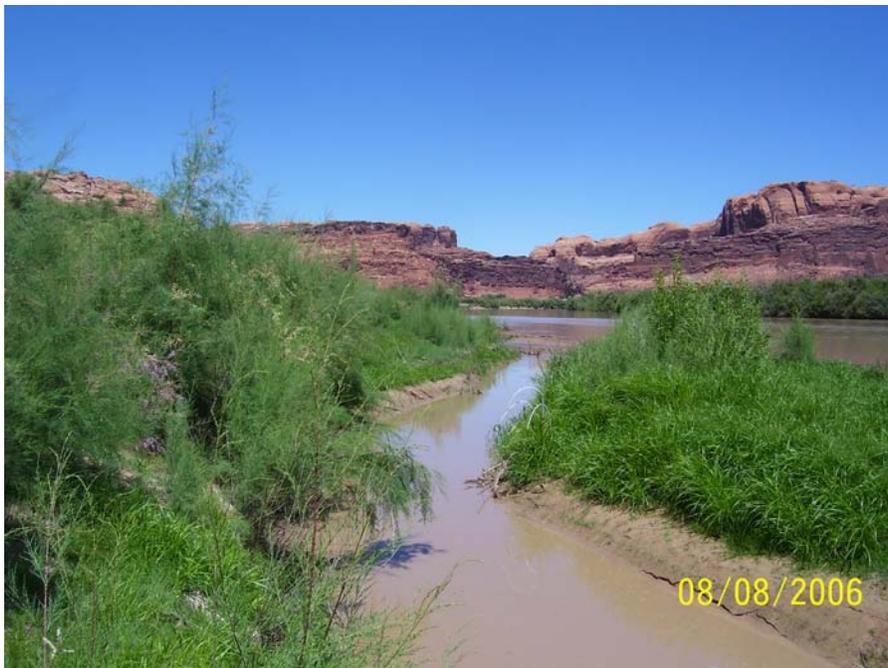
Photo 14. Main backwater channel near Configuration 3. Colorado River is in background. View is to the north.

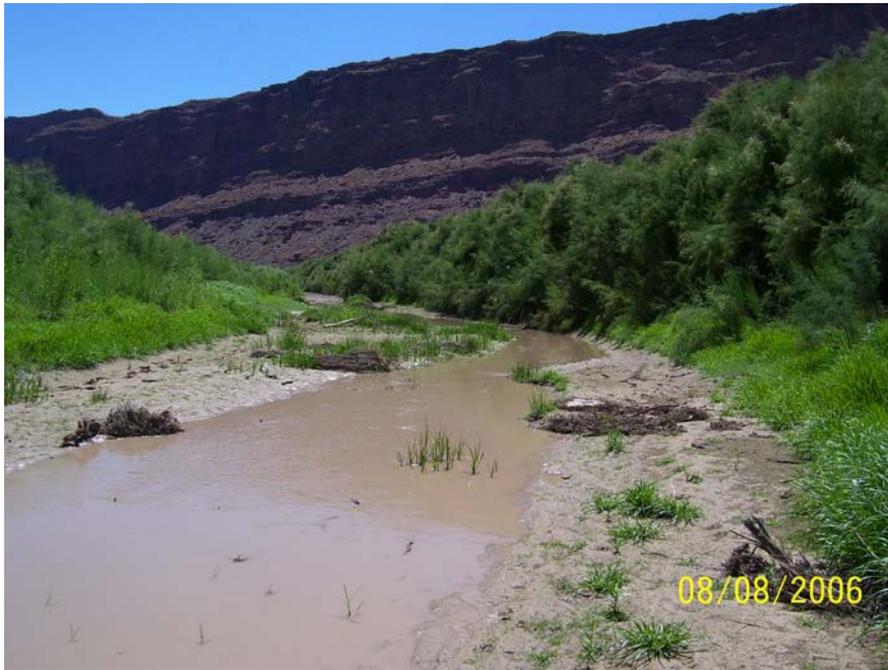
Configuration 2 (see Photo 15 in Appendix A). As a result, the conductivity of Location 0236 dropped to 1,063 $\mu\text{mhos/cm}$. Schools of small fish (1–2 cm) were observed in this water pocket during both high and low conductivity.

Photo 15. With slight increase in river flow, water returns to main backwater channel near Configuration 2. View is to the south.

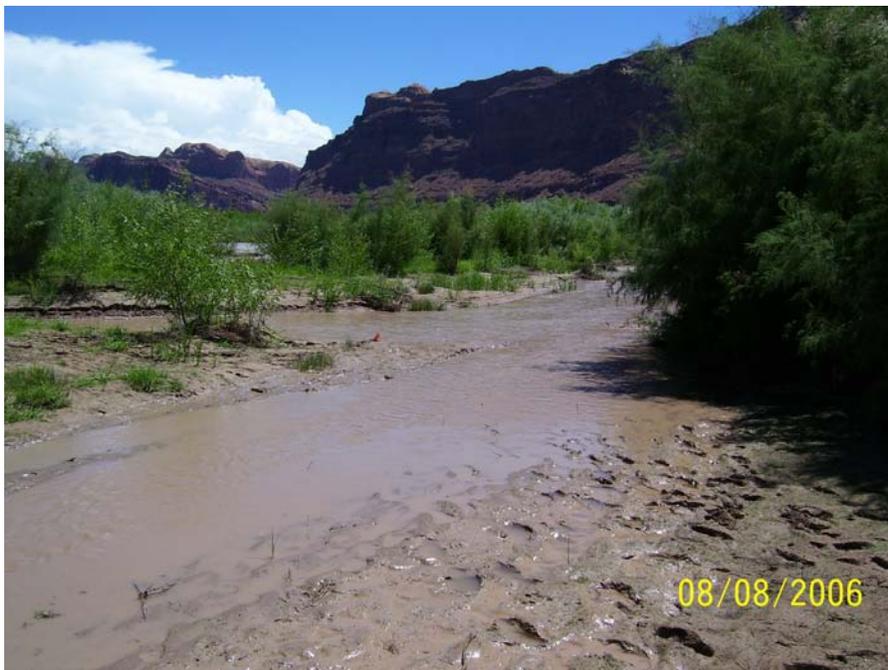
Photo 16. Confluence near Configurations 1 and 2. View is to the southeast.

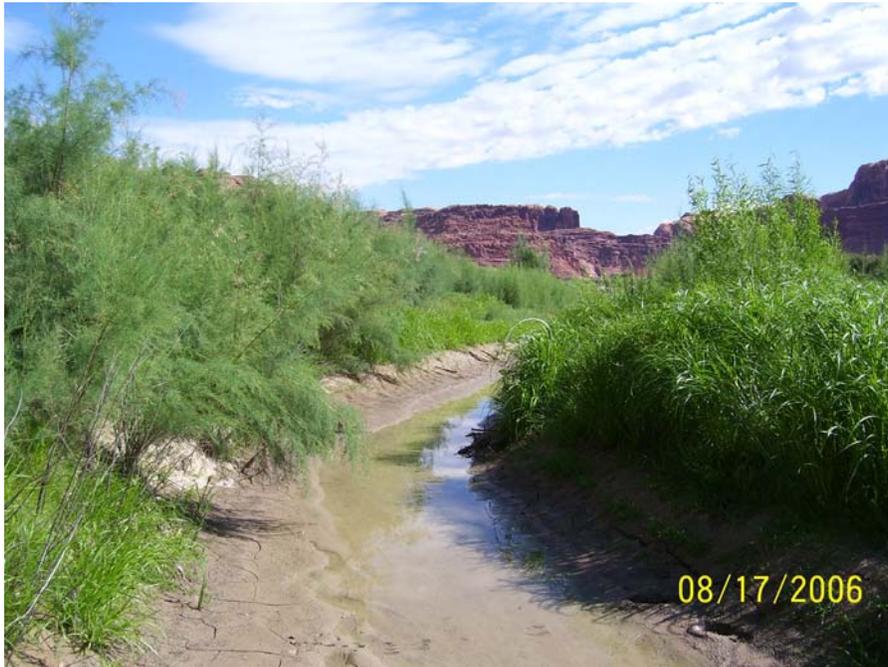
Photo 17. At this river flow, the main backwater channel is cut off from the river near Configuration 3. Compare with Photo 14. View is to the north.

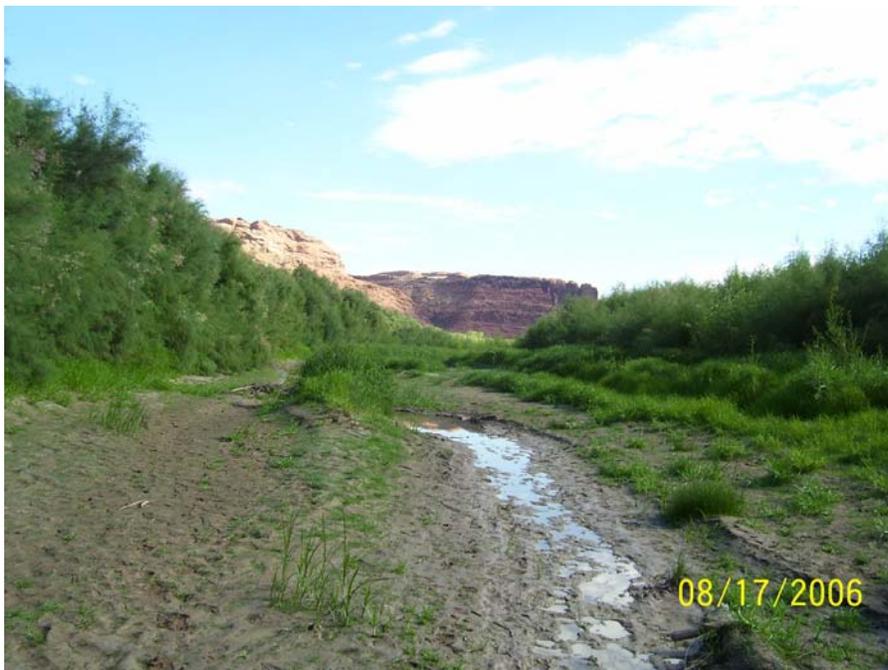
Photo 18. Isolated pockets of water near Configuration 2. View is to the north.

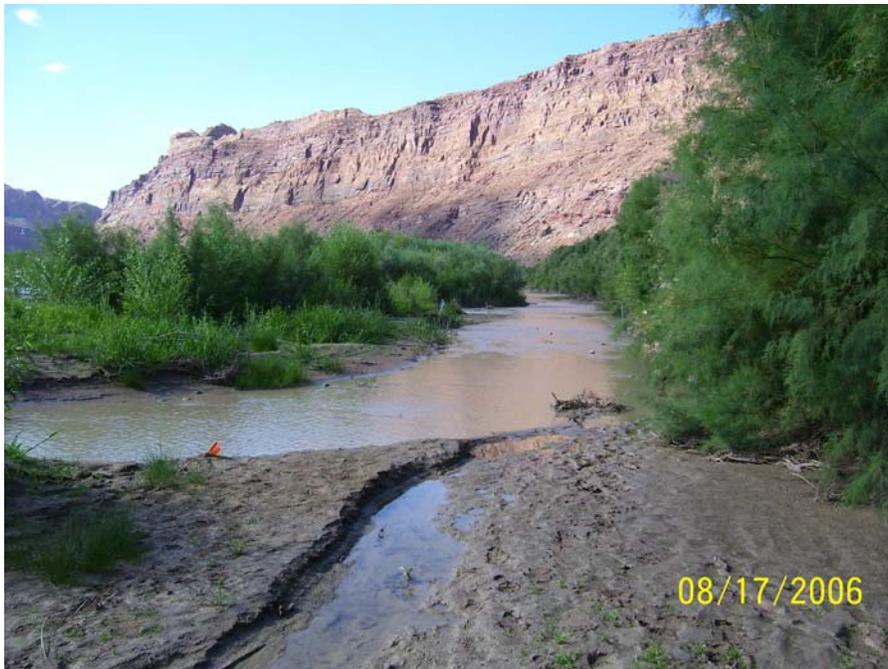
Photo 20. Backwater channels confluence near Configurations 1 and 2. Configuration 2 is almost shut off from channel flowing near Configuration 1 and farther south. View is to the south.

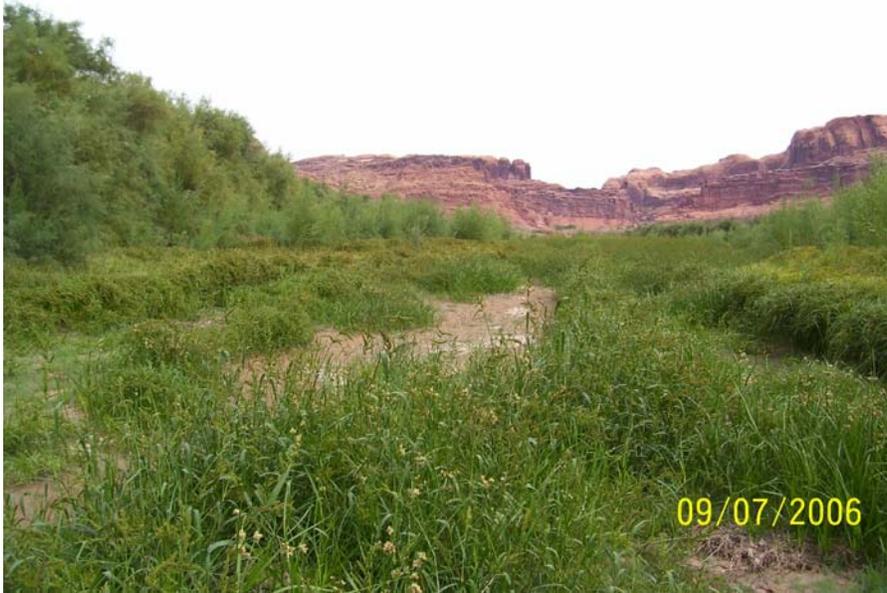
Photo 21. The area between Configurations 2 and 3 contained very few isolated pockets of water. View is to the north.

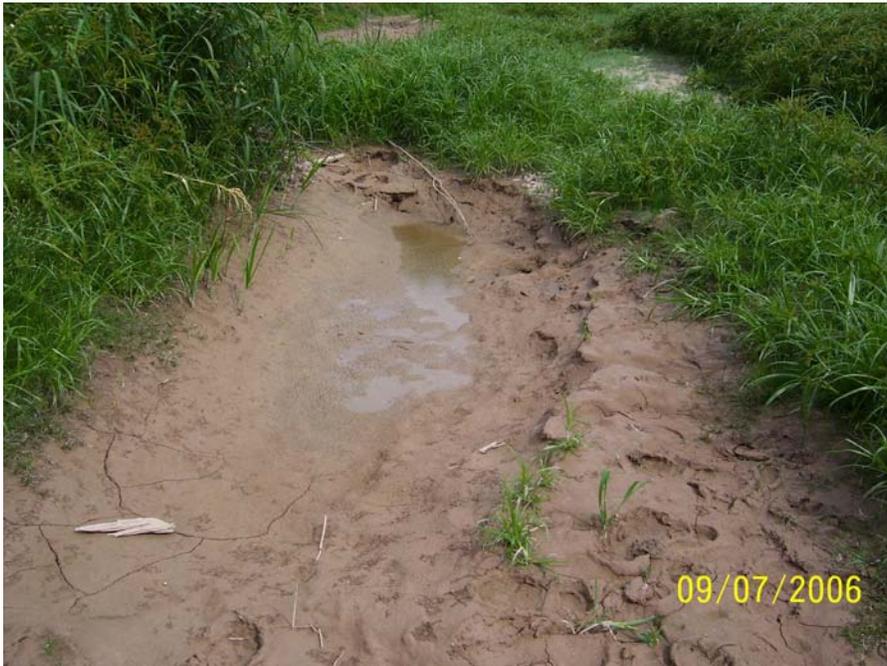
Photo 22. Surface Water Location 0236 is nearly dry at this low river flow.

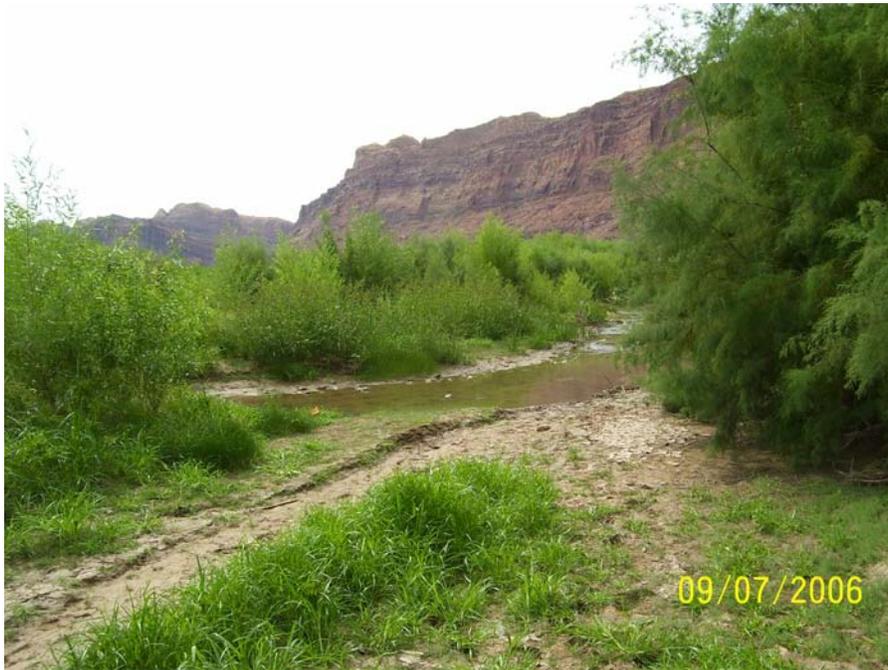
Photo 23. Channel near Configuration 2 is dry when the river is at this low stage. Compare with Photo 16 and note vegetation growth. View is to the south.

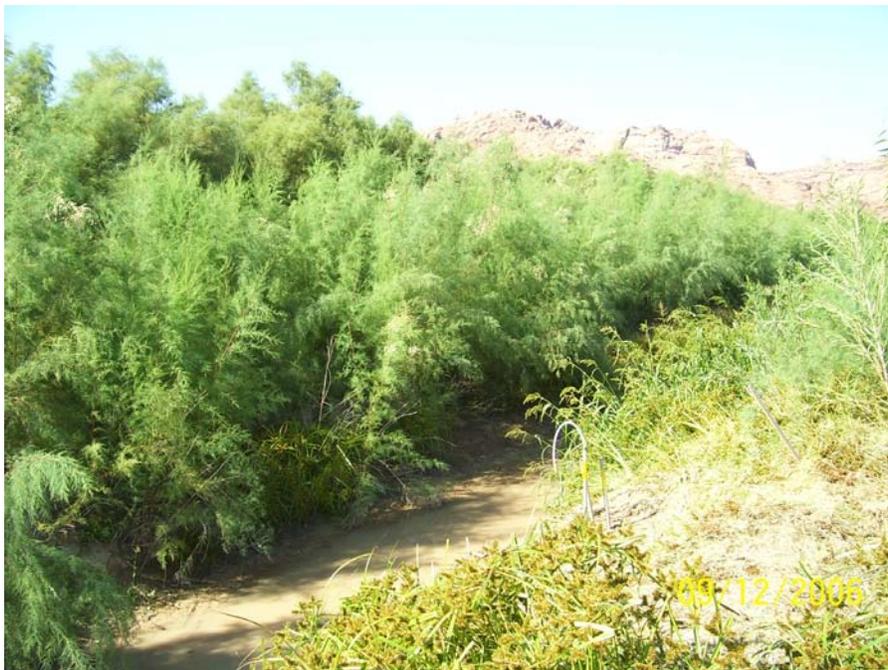
Photo 24. The backwater area near Configuration 3 is connected to the main river channel upstream.

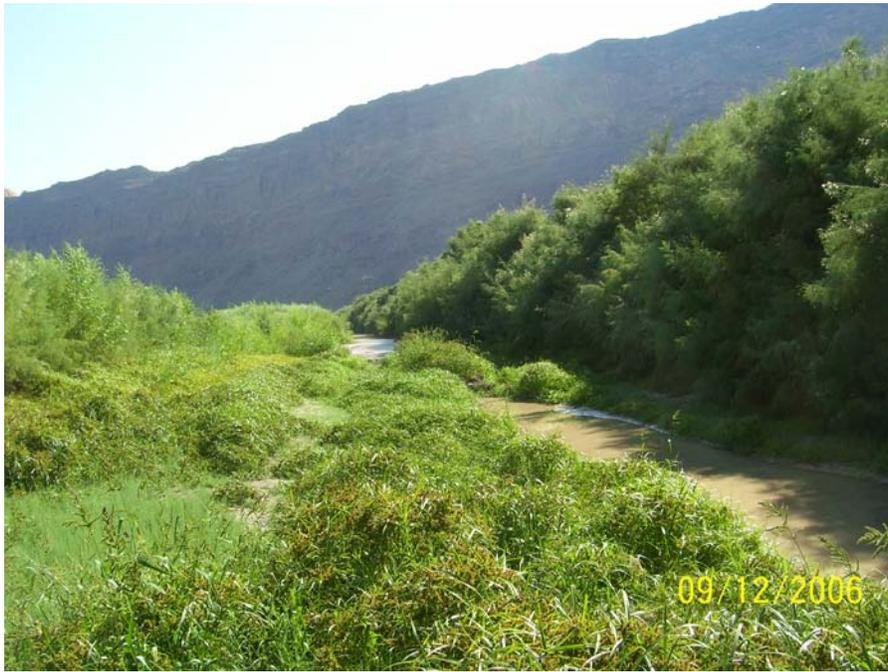
Photo 25. The main backwater channel flows through the Configuration 2 area.

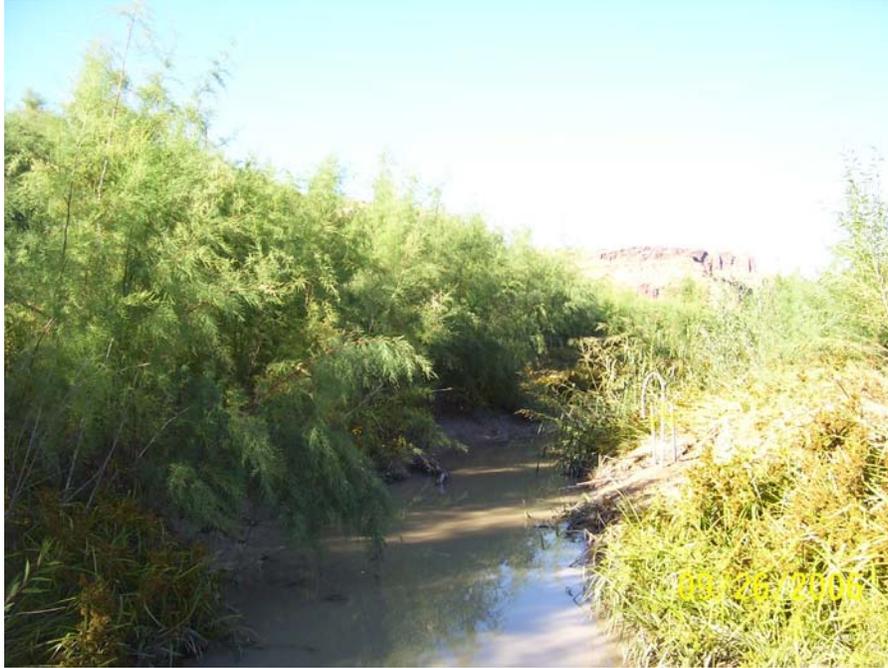
Photo 27. The backwater channel near Configuration 3 is connected to the river. View is to the north.

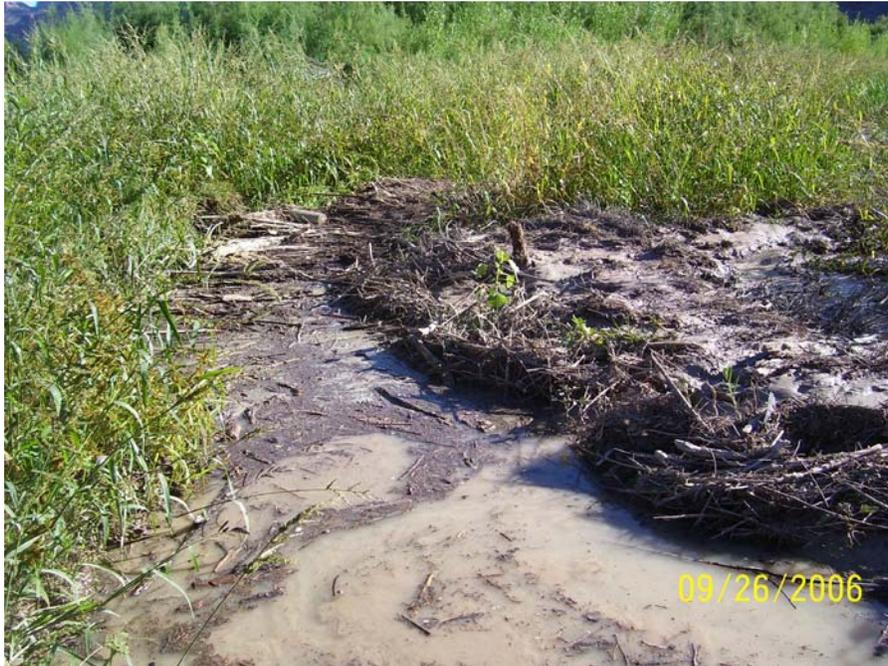
Photo 28. Abundant wood debris present between Configurations 2 and 3 following rain events earlier in the month.

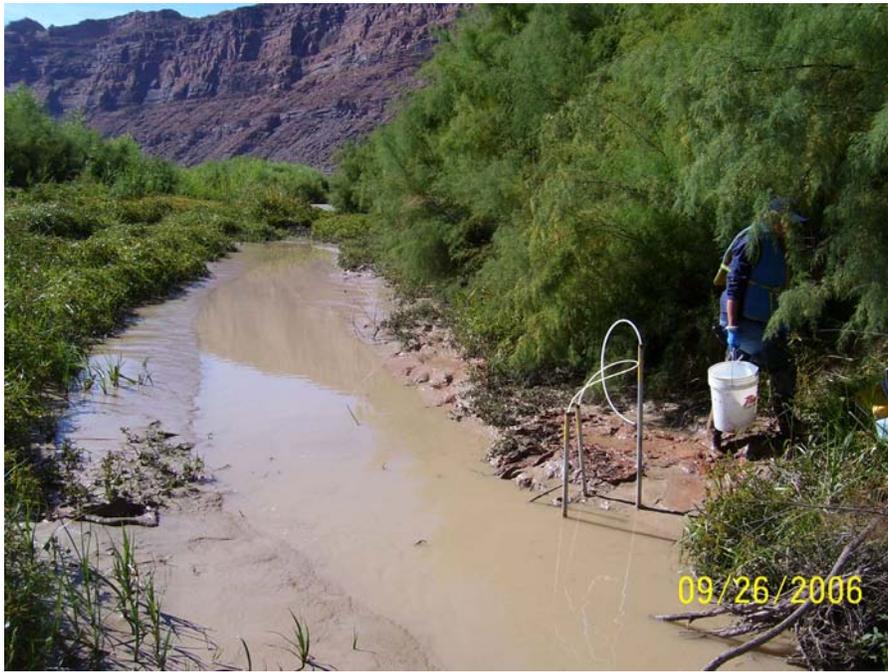
Photo 29. The backwater channel near Configuration 2. View is to the south.

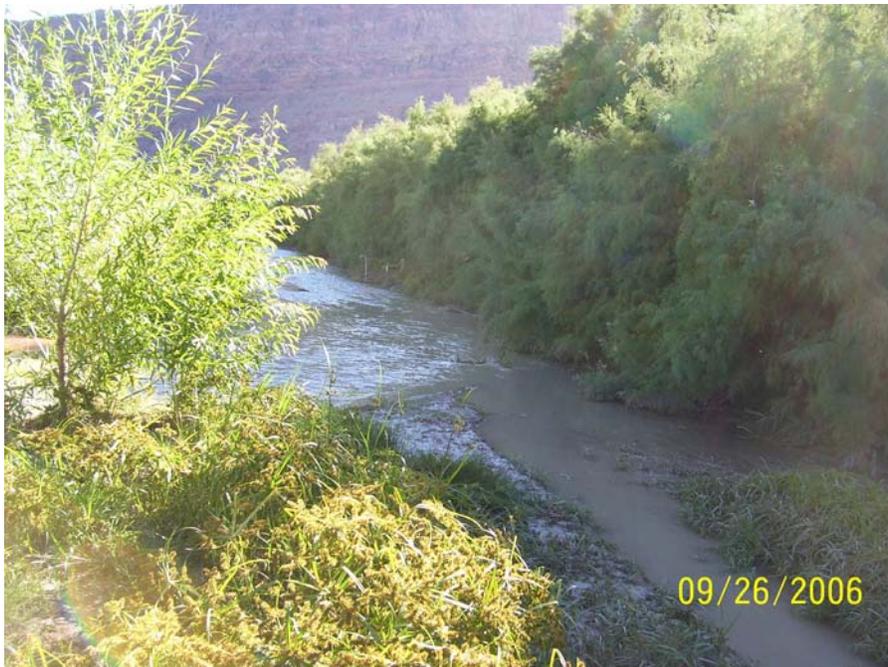
Photo 30. Channel confluence near Configurations 1 and 2. View is to the south.
