Moab UMTRA Project
Baseline Gamma Radiation Exposure
Rate Survey of a Portion of the
Union Pacific Cane Creek Branch Line
from Crescent Junction to the
Moab Project Site

March 2009

**Moab UMTRA Project
Baseline Gamma Radiation Exposure Rate Survey of a Portion of the
Cane Creek Branch Rail Line**

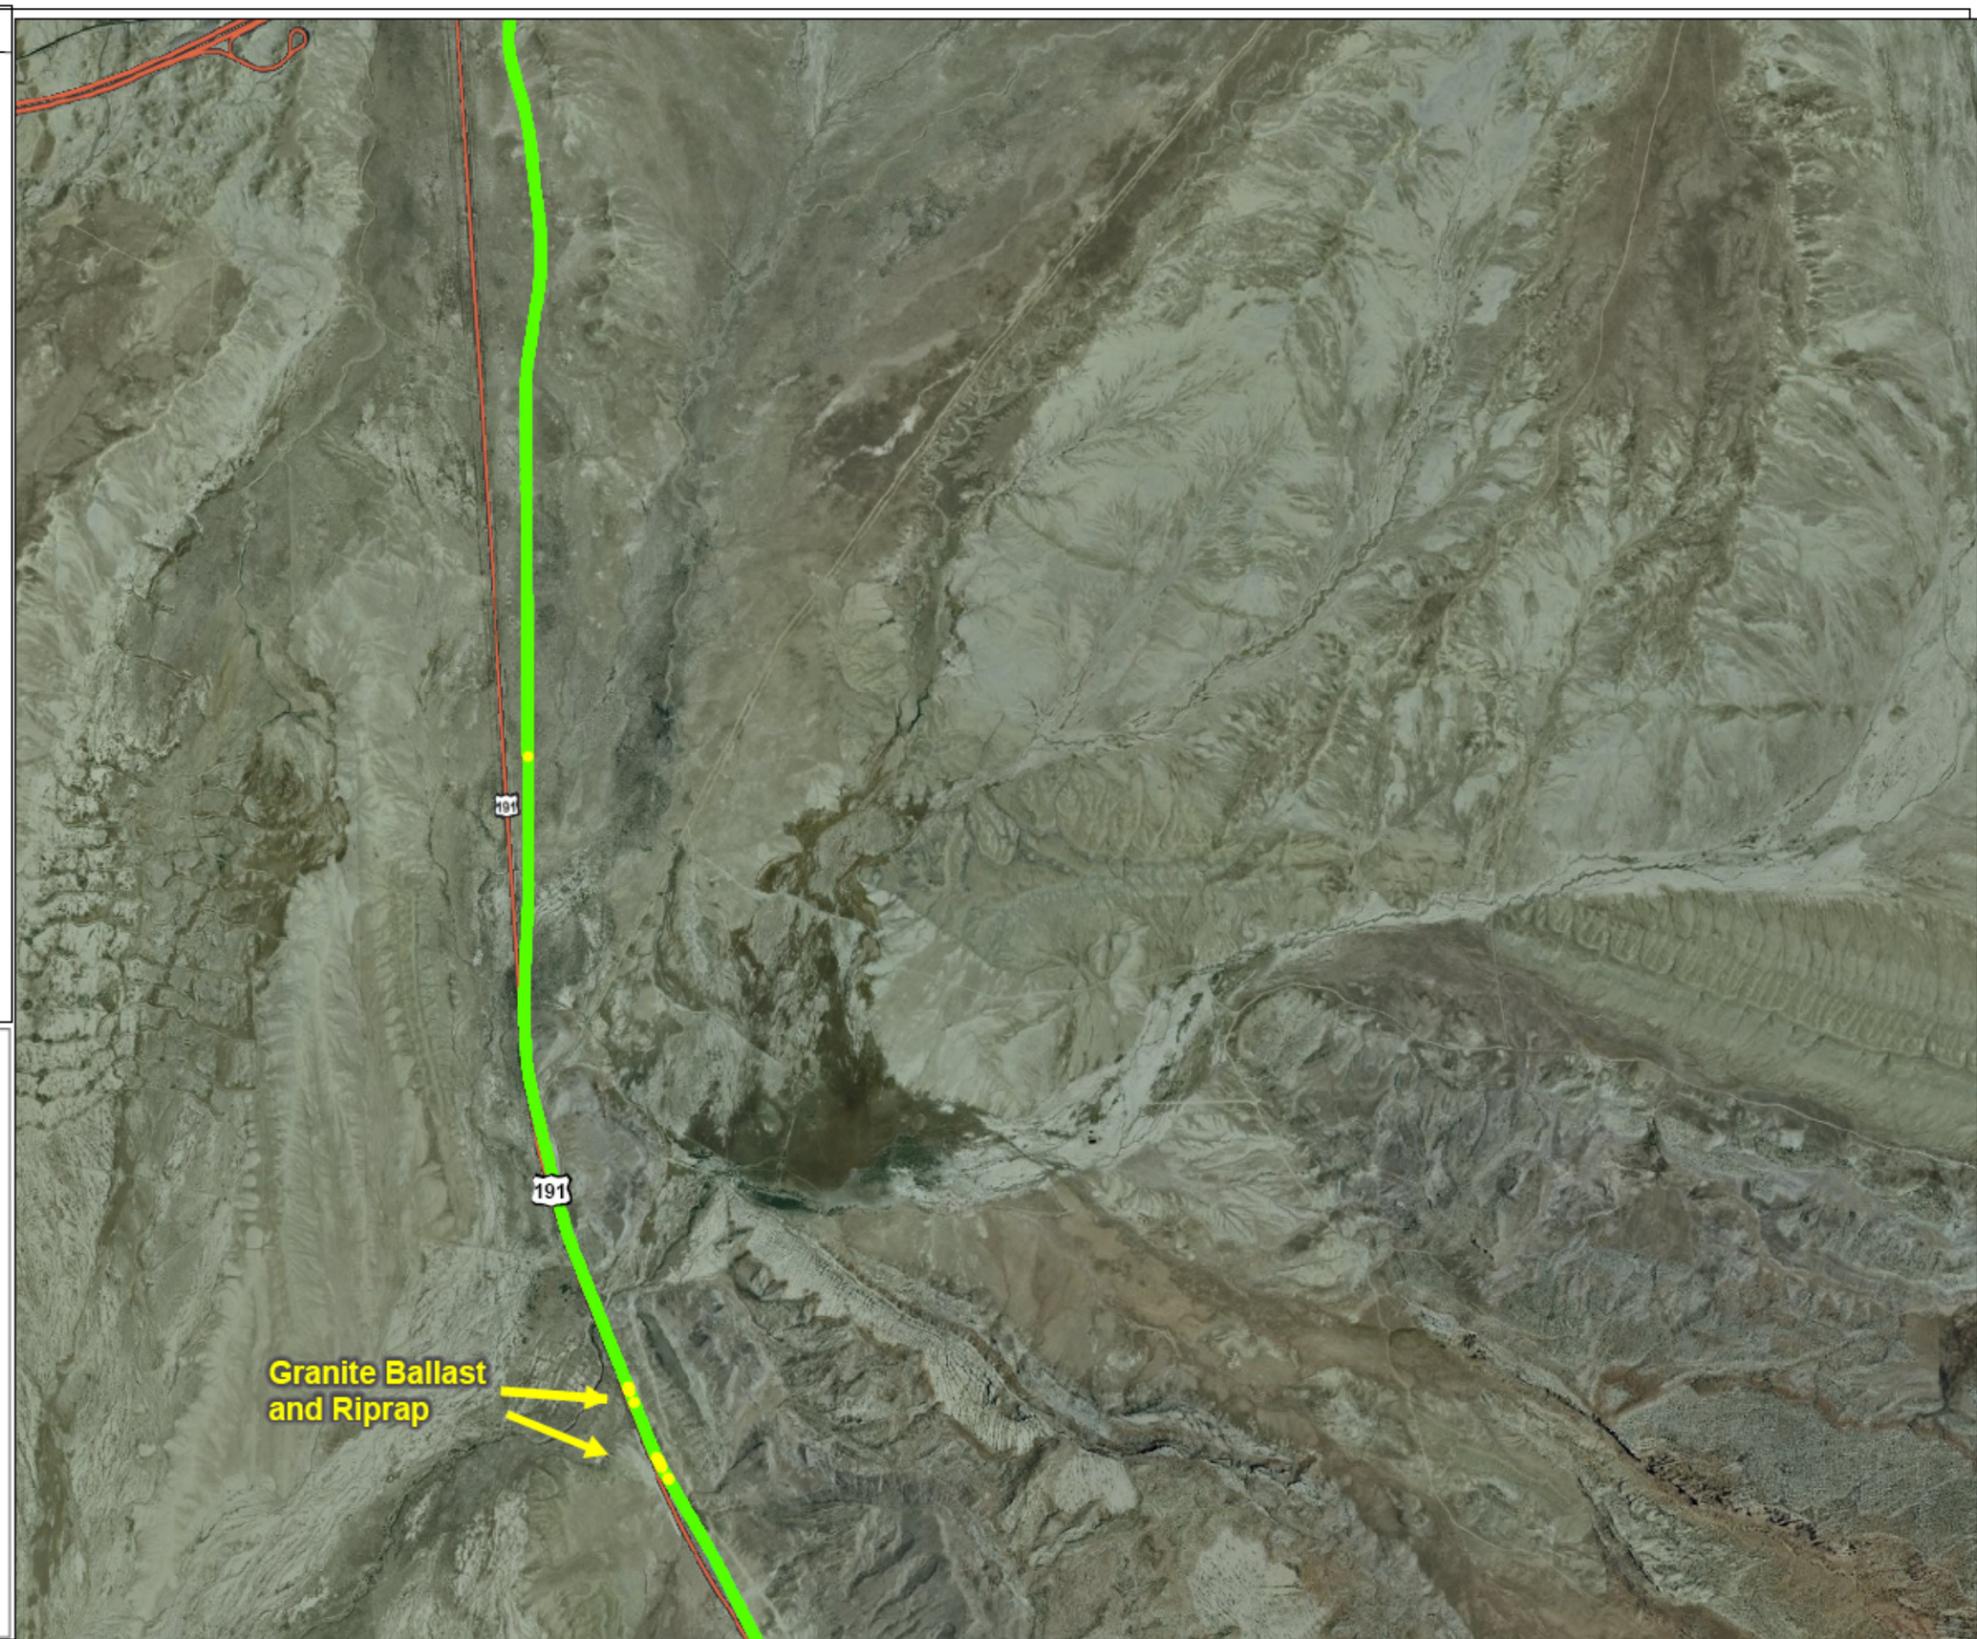
Gamma radiation exposure rate readings ranged from background values (12 to 13 $\mu\text{R/h}$) to approximately 30 percent above background (16 to 17 $\mu\text{R/h}$) which were observed and recorded for the first part of the UP rail survey south of mile marker 0.00 to approximately mile marker 6.00 (see Figure 1A). Slightly elevated gamma readings for a small portion (approximately 0.5 mile) of the rail depicted in Figure 1A were noted and were due to imported granite fill used for track ballast and riprap to fill and stabilize a small portion of the track that had been affected by a previous wash-out due to flooding conditions (Photo 2B). The granitic ballast/riprap material contains NORM (typically uranium) and is not associated with RRM originating from the Moab site.

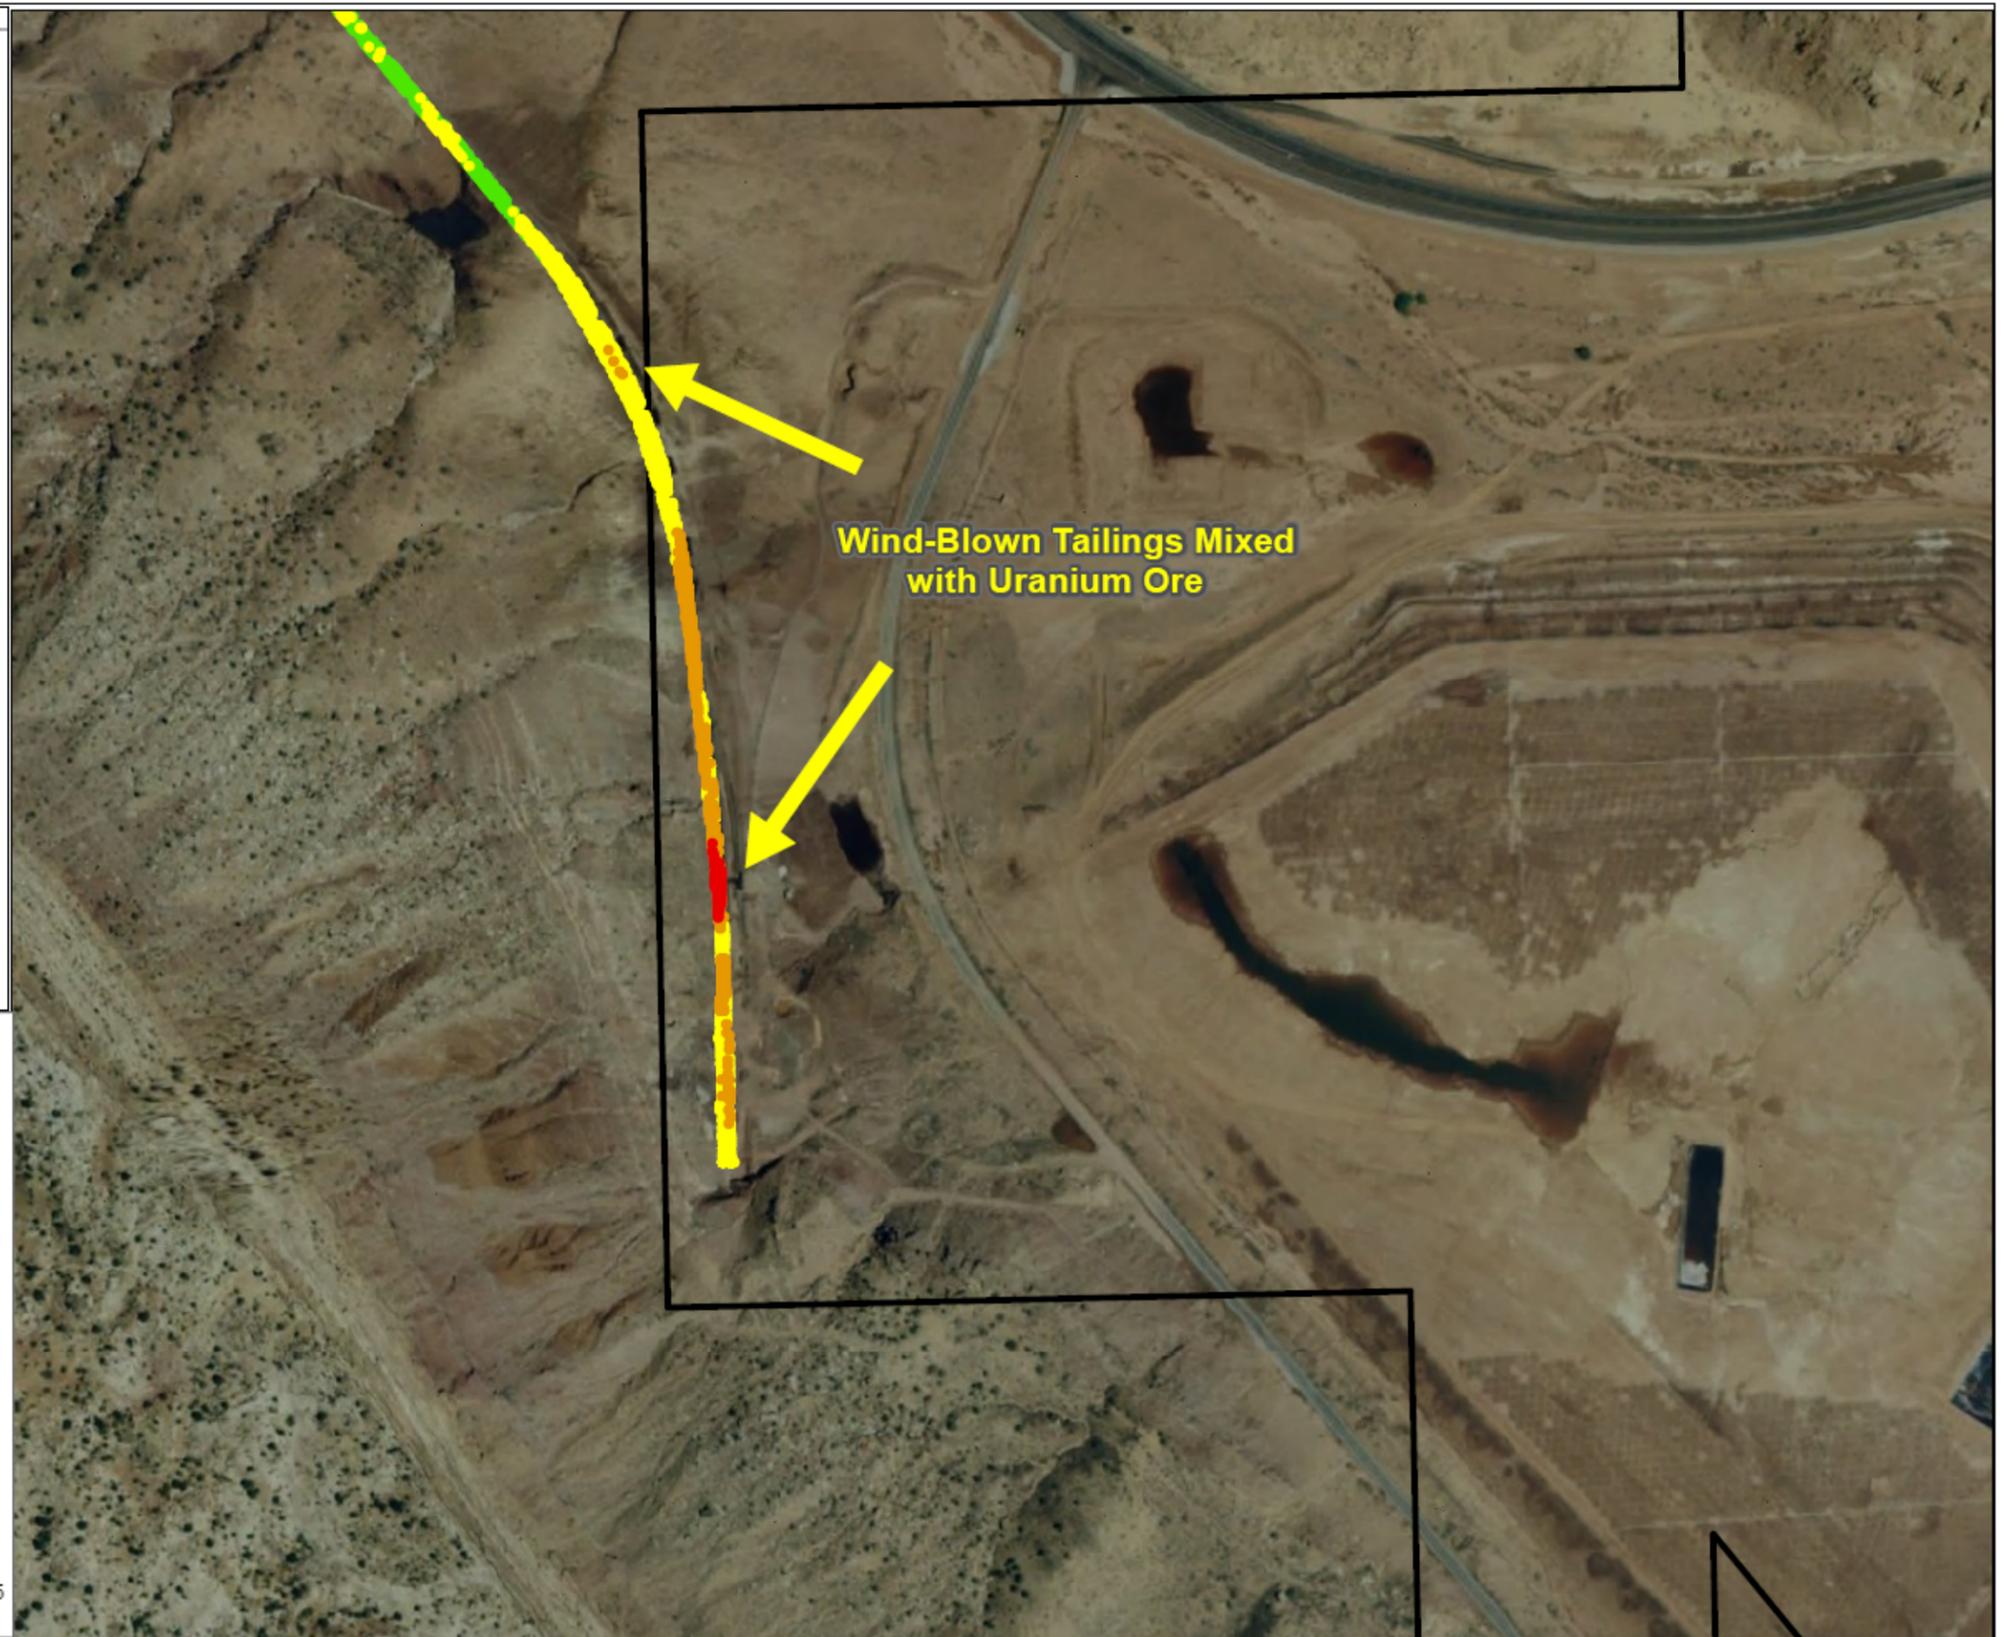
Gamma radiation exposure rate readings ranging from 17 to more than 35 $\mu\text{R}/\text{h}$ were observed along the UP branch line during the last part of the rail survey west/northwest of the Moab site (see Figure 1D). This portion of the UP main rail, the rail spur that was recently removed by the Remedial Action Contractor (RAC), and the adjacent areas along the UP-owned right-of-way (ROW) had a formal radiological assessment performed, which was documented in the final *Radiological Assessment for Non-Pile Areas of the Moab Project Site*. Windblown tailings material ranging in depth from 6 to 18 inches and abundant uranium ore was identified in this portion of the UP rail and ROW. Subsequent partial remedial action in this general area by the RAC has reduced the amount of uranium ore and higher level soil contamination, especially with the removal of the rail spur, the site of a gantry crane, and the adjacent soil areas (Photo 2H). Primarily lower level soil contamination and uranium ore in the UP branch line were detected during the rail survey activities. The gamma radiation exposure rate survey ended at mile marker 28.54, which is the north portal entrance of the Bootlegger Tunnel, located along the west boundary of the Moab site.

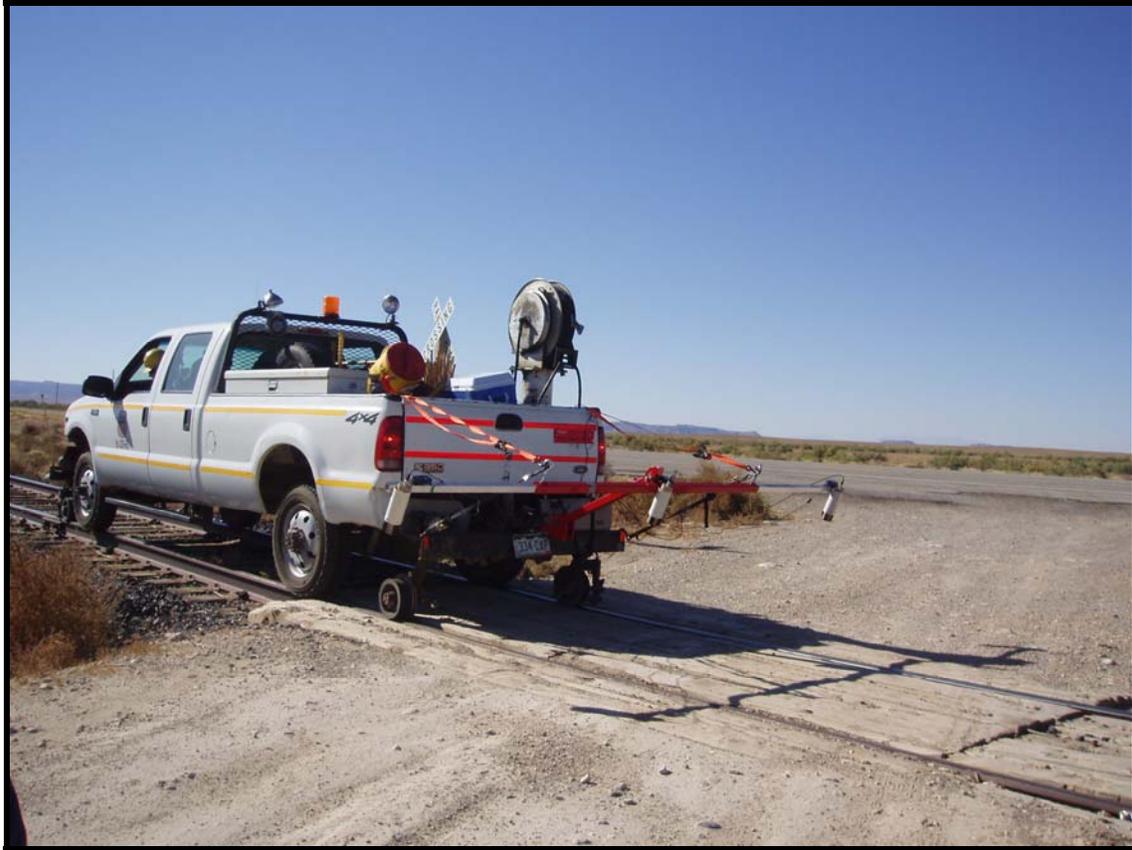
Photo 2A. Hy-Rail Truck with Gamma Radiation Exposure Rate Survey Equipment Attached

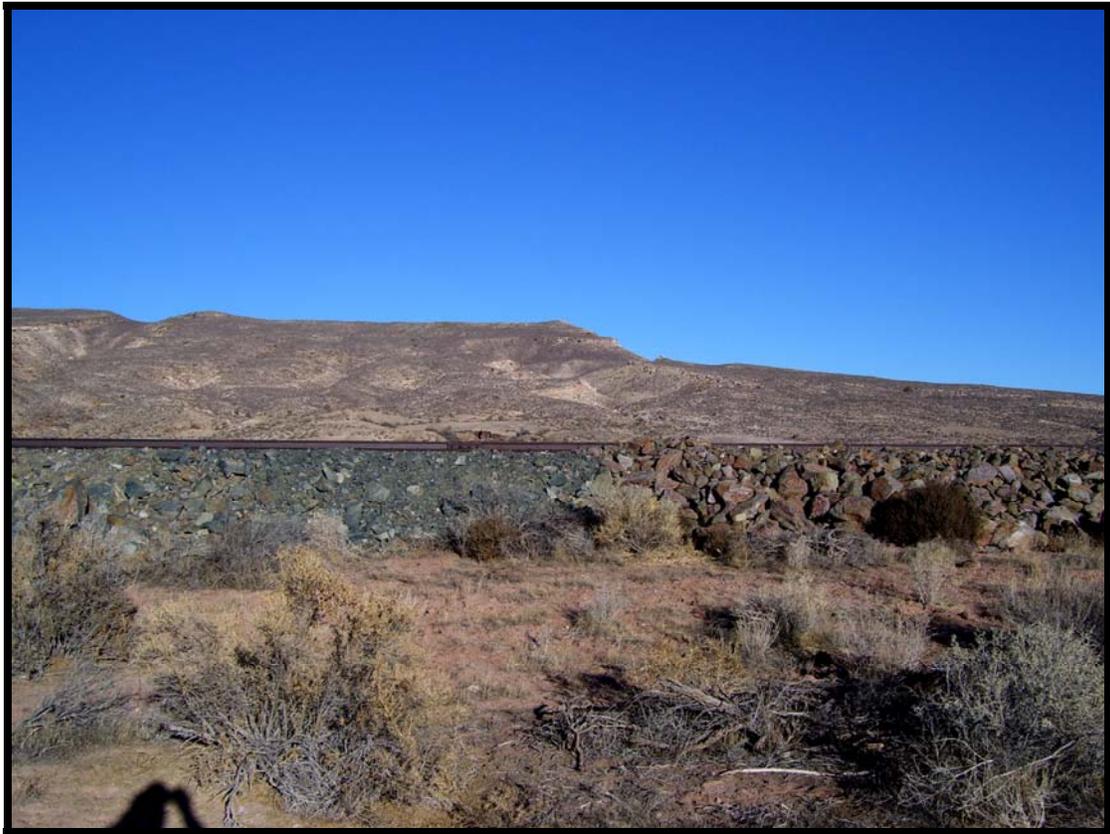
Photo 2B. Imported Granite Ballast and Riprap Fill – Looking East

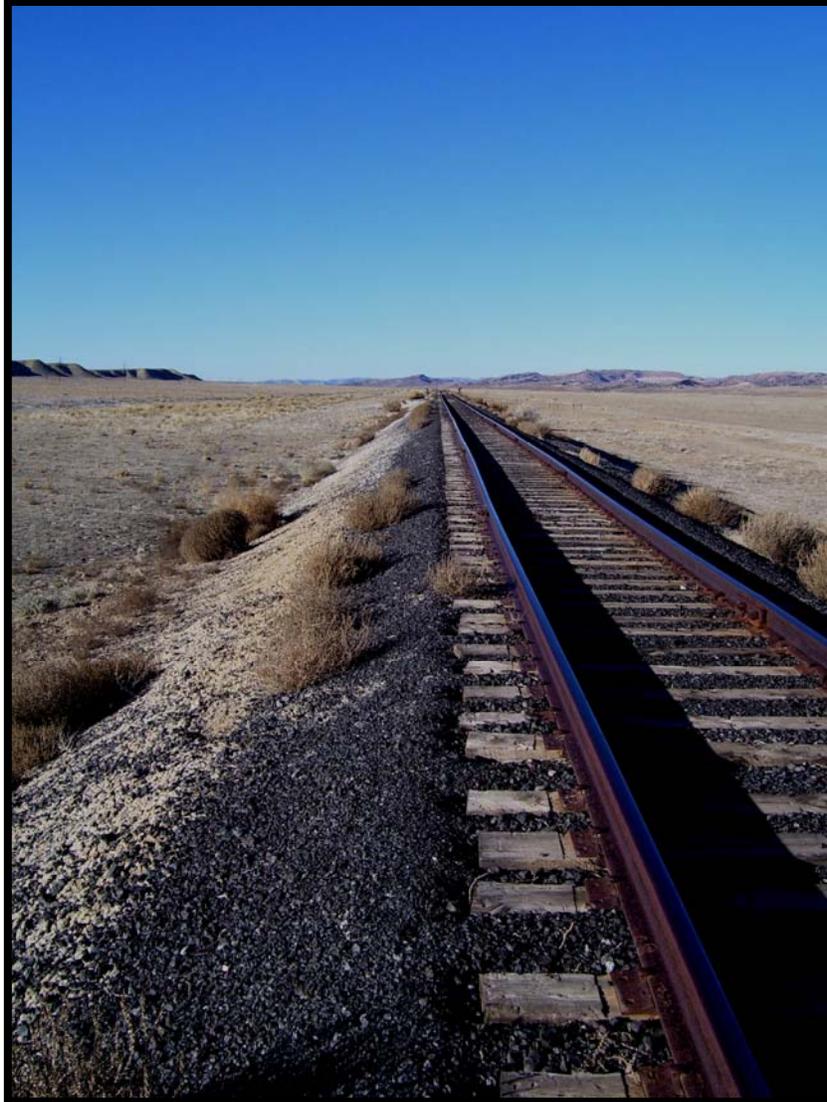
Gamma radiation exposure rate readings ranging from 17 to 25 $\mu\text{R}/\text{h}$ were observed north of the Canyonlands Field Airport (Figure 1B). A revisit to this portion of the rail bed following the original rail survey was performed with a sample of the clay material used to construct the rail bed. The material was analyzed using the Opposed Crystal System counting system and contained a Radium-226 concentration of 3.2 pCi/g. The elevated readings were found to be from the imported clay materials used to construct the rail bed in combination with igneous (basalt and granite) rock that was used for the track ballast (Photo 2C). The elevated exposure rate readings observed, from the use of the described track bed and ballast materials, extended for approximately 2.25 miles in this general track area.

*Photo 2C. Imported Clay Fill Materials Mixed with Igneous Ballast Rock.
North of Canyonlands Field Airport – Looking North*

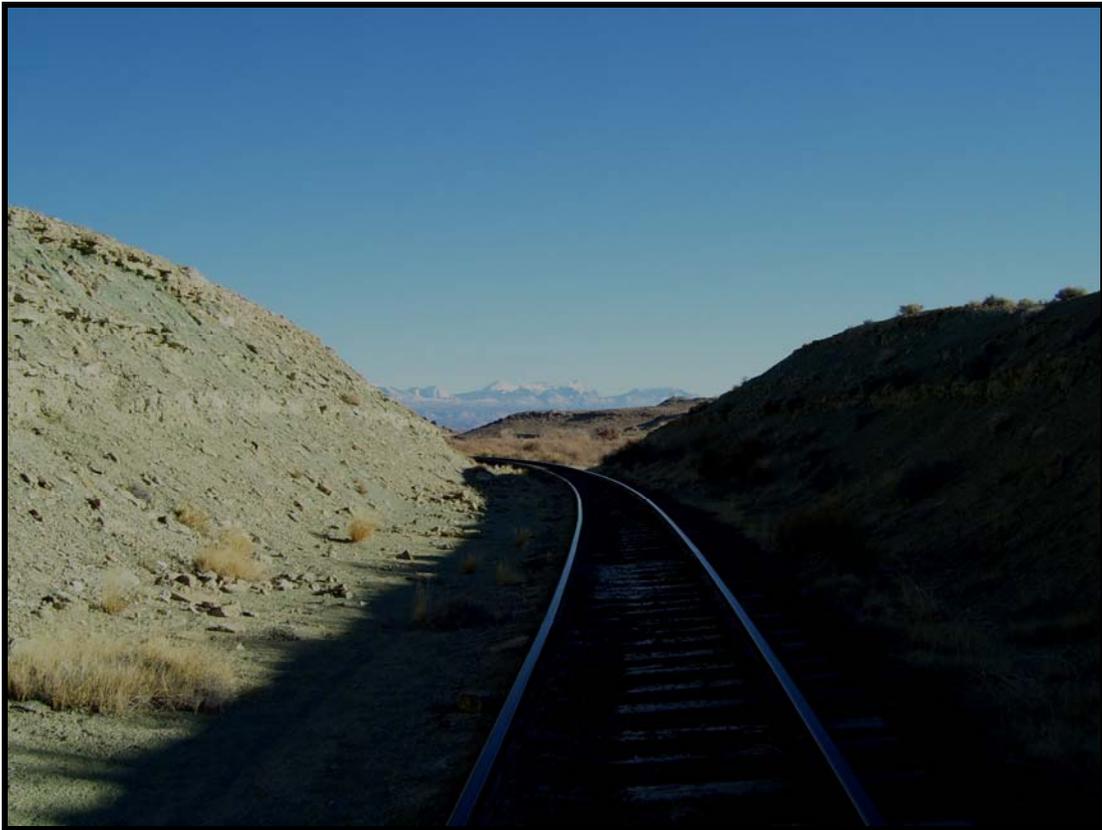
The material appears to be NORM-related and not RRM originating from the Moab site. An outcrop of the Morrison Fm that the UP rail runs through was observed south of the Canyonlands Field Airport and displayed gamma radiation exposure rate readings from 17 to 35 $\mu\text{R}/\text{h}$ (see Figure 1B). At the time of the survey, this area was further investigated using hand held crutch-type scintillometer instruments and found to contain NORM-related material to 800 cps (65 $\mu\text{R}/\text{h}$). The Morrison Fm typically contains volcanic ash and as a result may have elevated levels of uranium present (Photos 2D and 2E). These elevated uranium levels are due to NORM-related materials and not a result of RRM-related materials originating from the Moab site.

Photo 2D. Morrison Formation South of Canyonlands Field Airport – Looking Southeast

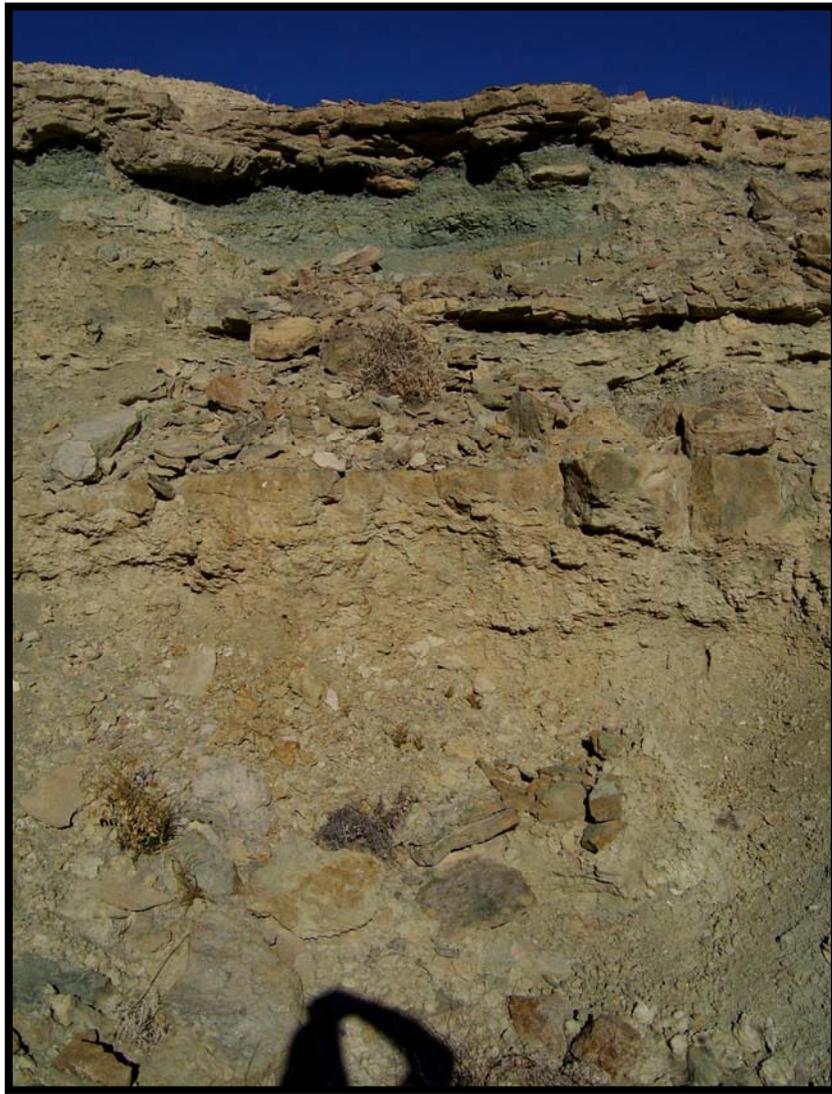
Photo 2E. Morrison Formation. South of Canyonlands Field Airport – Looking East

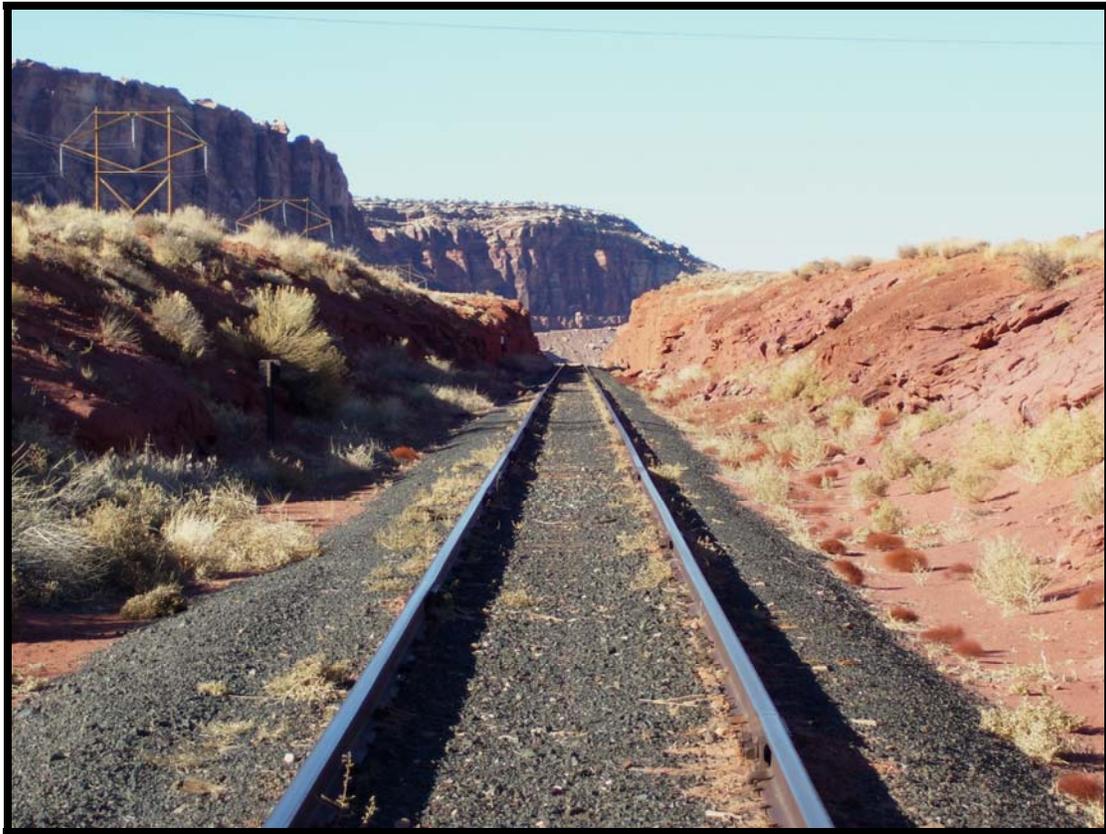
To the south of the crest of the topographic rise near Seven-mile Hill (intersection of State Highway 191 and State Route SR 313) (Photo 2F), the UP rail transects the Chinle Fm as it approaches the Moab site. The Big Cut (see Figure 1C) exposure rate readings that were observed while performing the rail survey ranged from 17 to 25 $\mu\text{R}/\text{h}$. In places, the actual vertical cut for the rail bed through the Chinle approached 100 feet in depth (Photo 2G). Due to the slightly elevated gamma readings associated with the Chinle Fm combined with the “scatter effect” as a result of the geometry and limits in the measurement of the gamma radiation associated with the deep, solid, rock cut through the Chinle Fm, the observed exposure rate readings were normal, and to be expected.

Photo 2F. Seven-mile Hill – Looking North

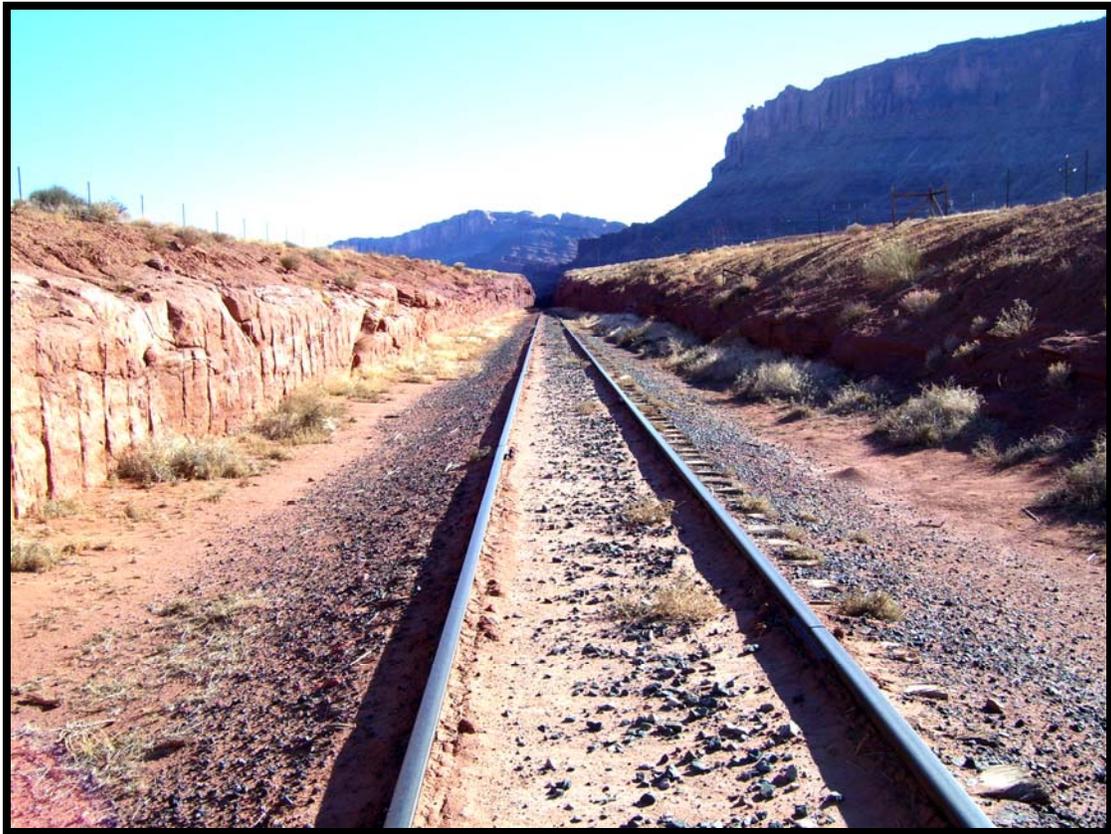
Photo 2G. Big Cut Through the Chinle Formation – Looking South
