Moab UMTRA Project
Final Report
2008 Biota Monitoring

March 2009

U.S. Department
of Energy

Office of Environmental Management

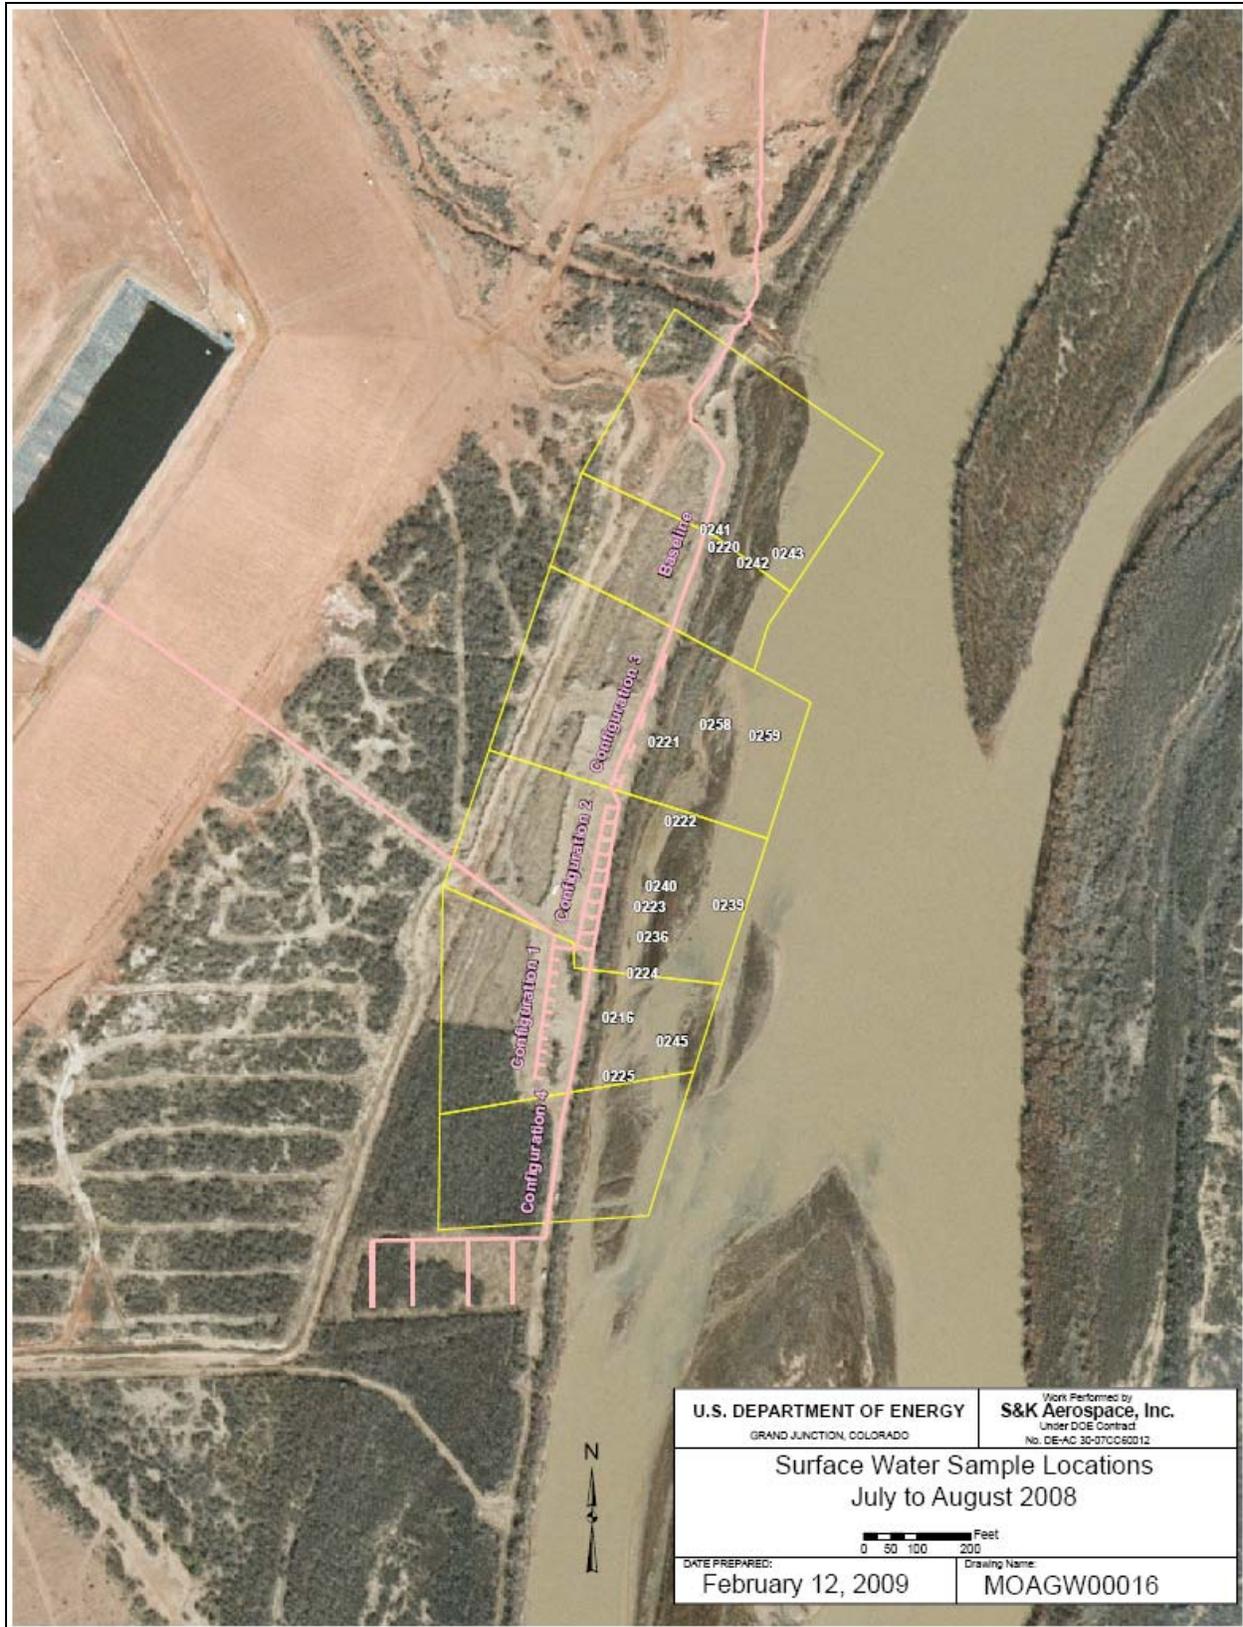
Figure 1. Map of Channel Locations

The configuration of the backwater channel varies from year to year. During the 2008 monitoring season, one main backwater channel flowed from Configuration 3 to Configuration 4 (Figure 1). Throughout varying river flows, certain portions of the channel would be shut off on the upstream or downstream side or sometimes both. In 2008, the backwater channel flowed more consistently through Configurations 1 and 4, or the southernmost portion adjacent to the interim action well field. The backwater channel locations in this report are referred to in relation to the adjacent portion of the interim action well field. For instance, the Configuration 2 backwater channel refers to the portion of the backwater channel, east of Configuration 2 (Figure 1).

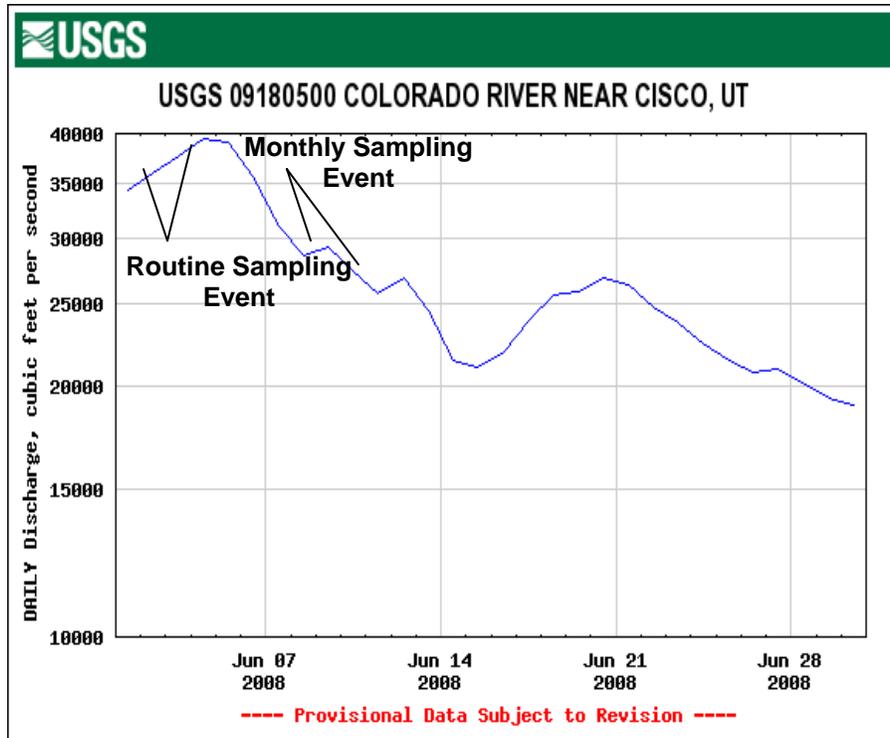
Figure 2. Colorado River Cisco Gaging Station Hydrograph for June 2008

The Colorado River discharge along the Moab site varied from 18,900 to 39,500 cfs (Figure 2) in June 2008. The June monthly sampling took place from June 9 to 11, 2008, and the site-wide routine sampling was conducted from June 2 to 4, 2008. At this time, the river flow varied between 27,400 and 39,500 cfs, which is too high for the formation of suitable backwater habitats. Sample results from early to mid June indicate that the ammonia levels in the surface water were all 0.1 mg/L (the detection limit).

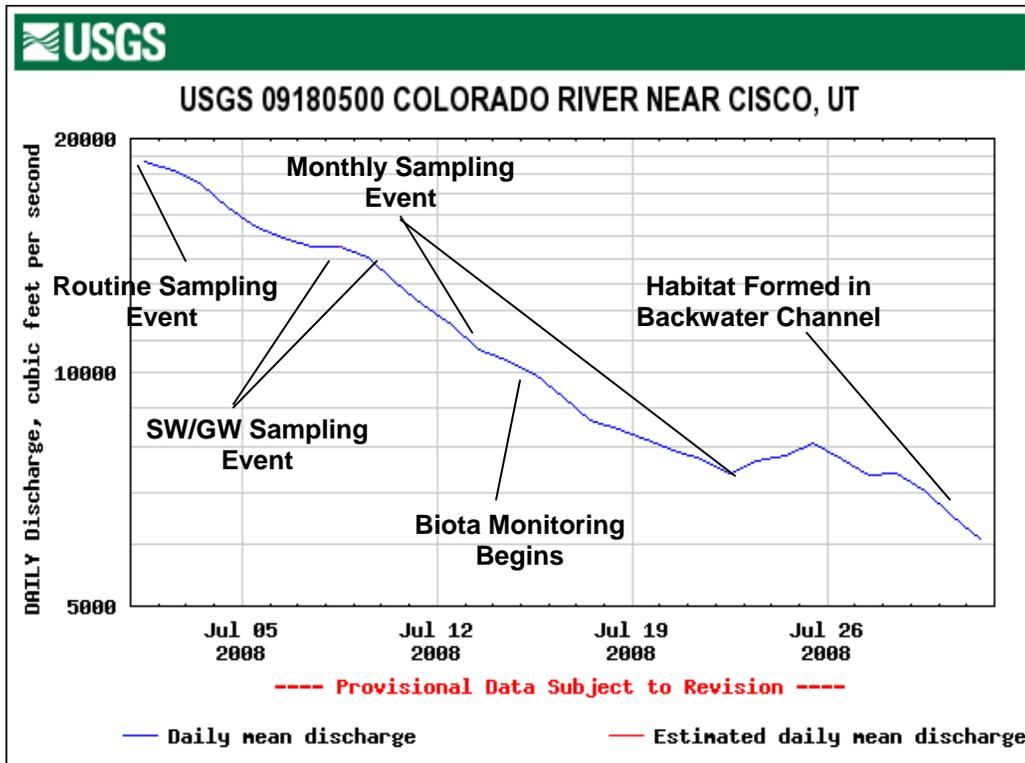
Figure 3. Colorado River Cisco Gaging Station Hydrograph for July 2008

The Colorado River discharge along the Moab site varied from 6,100 to 18,700 cfs (Figure 3) in July 2008. In response to the high runoff, up to 3 feet of sediment was deposited in the backwater channels, significantly changing the morphology observed in previous years. The July routine sampling took place from June 30 to July 1, the July surface water/ground water (SW/GW) interaction sampling took place July 8 to 10, and the July monthly sampling took place July 14 to 24. Sample results from July indicate that most of the ammonia levels in the surface water were 0.1 mg/L (the detection limit). Surface water location 0226 (approximately 450 ft downriver from the Moab site) had an ammonia concentration of 0.18 mg/L on June 30, and surface water location 0241 (adjacent to the baseline area) had an ammonia concentration of 0.24 mg/L on July 10. These values are below the acute and chronic action levels based on pH and temperature.

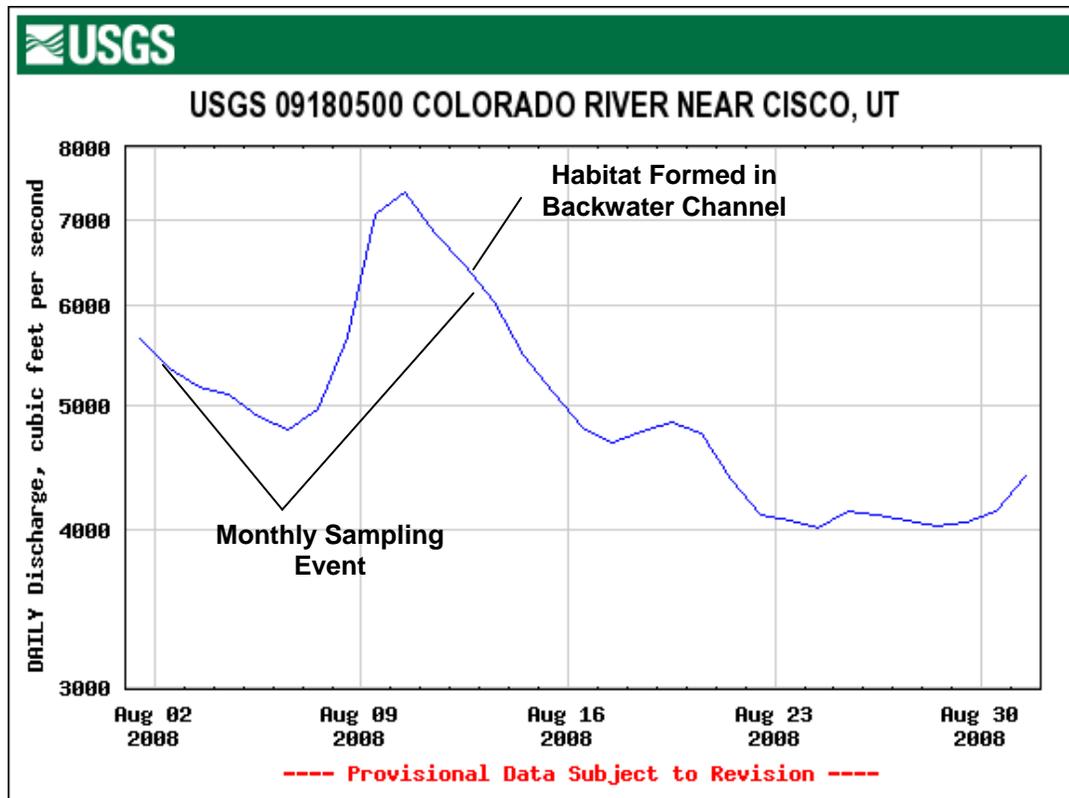
Figure 4. Colorado River Cisco Gaging Station Hydrograph for August 2008

The Colorado River discharge along the Moab site varied from 4,010 to 7,360 cfs (Figure 4) in August 2008. The August monthly sampling took place from August 3 to 14. Sample results from August indicate that most of the ammonia levels in the surface water were 0.1 mg/L (the detection limit).

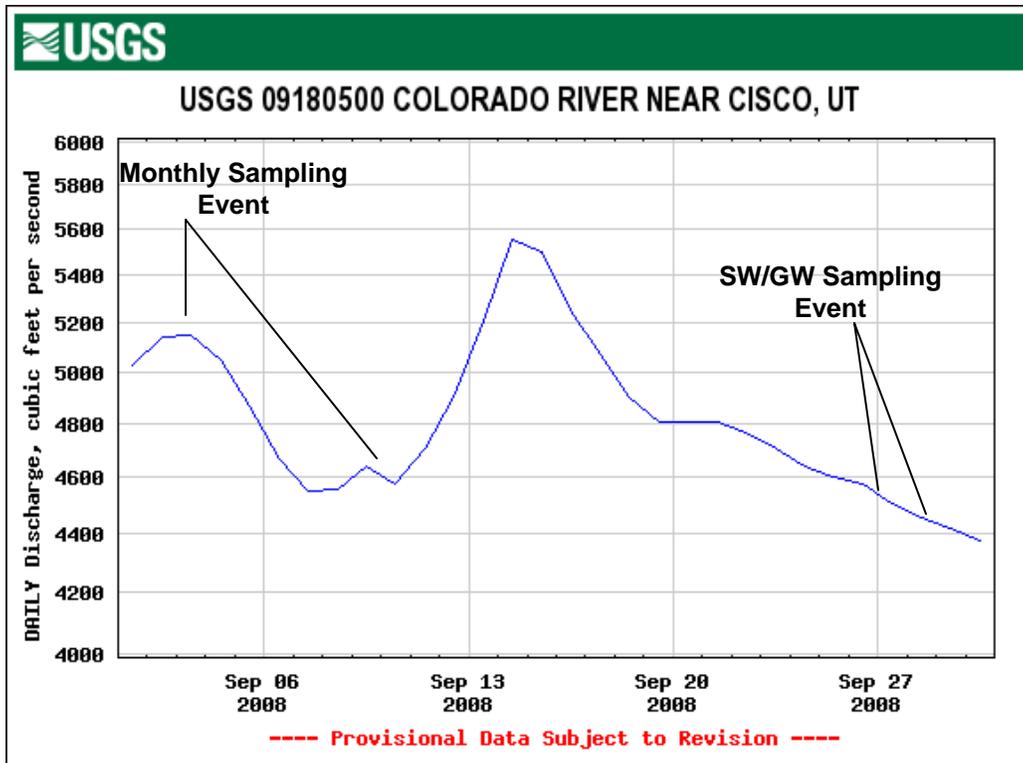
Figure 5. Colorado River Cisco Gaging Station Hydrograph for September 2008

The Colorado River discharge along the Moab site varied from 4,380 to 5,550 cfs (Figure 5) in September 2008. The September monthly sampling took place from September 2 to 11, and the SW/GW investigation sampling took place September 29 to 30. Analytical results from surface water locations 0216 (adjacent to Configuration 1) and 0243 (adjacent to the baseline area on the river edge) consisted of ammonia concentrations of 0.31 and 0.27 mg/L. These values are below the acute and chronic action levels based on pH and temperature.

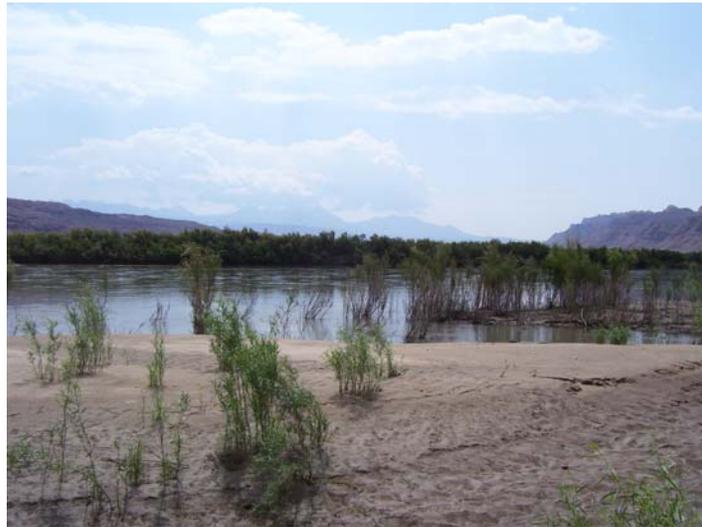
On July 14, the main backwater channel was connected to the river on the upstream side (Photo 1). This channel extended from the area adjacent to Configuration 3, south towards Configuration 1 (Photo 2).

Photo 1. Area Adjacent to Configuration 3, Facing East, July 14, 2008

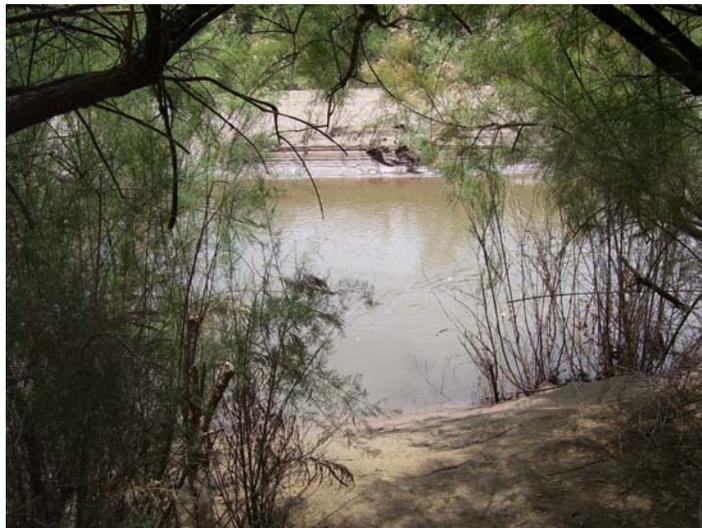
Photo 2. Area Adjacent to Configuration 2, Looking West, July 14, 2008

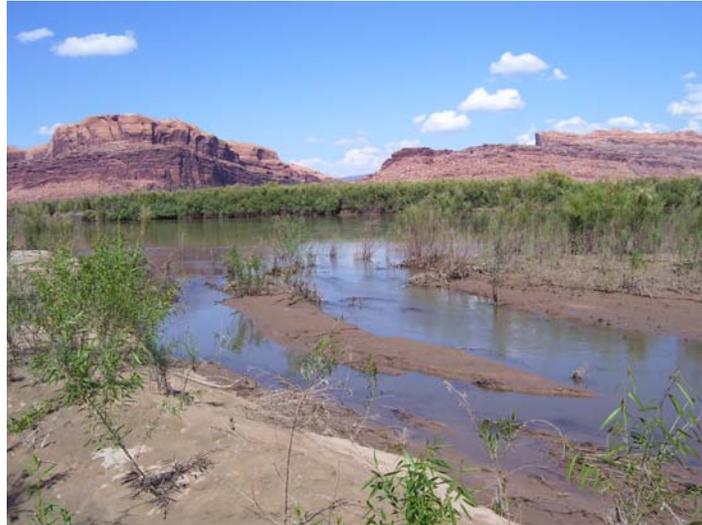
On July 17, the main backwater channel was still open upstream (Photo 3) and continued through the areas adjacent to Configuration 2 (Photos 4 and 5) and 1 (Photo 6).

Photo 3. Area Adjacent to Configuration 3, Facing North, July 17, 2008

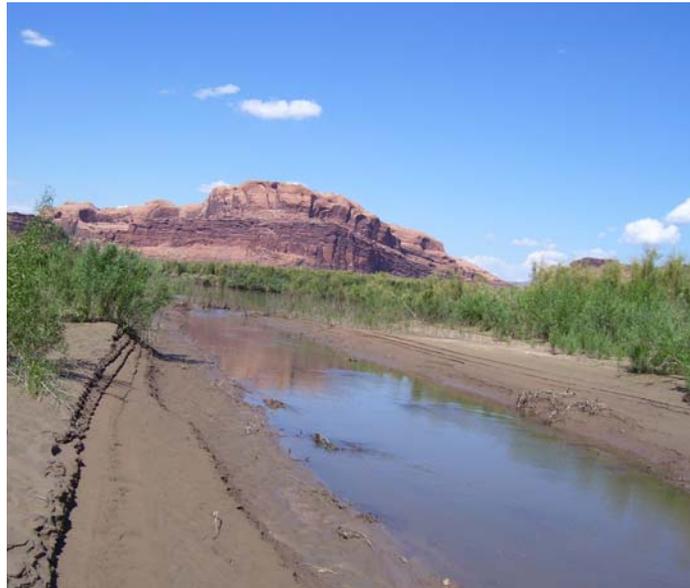
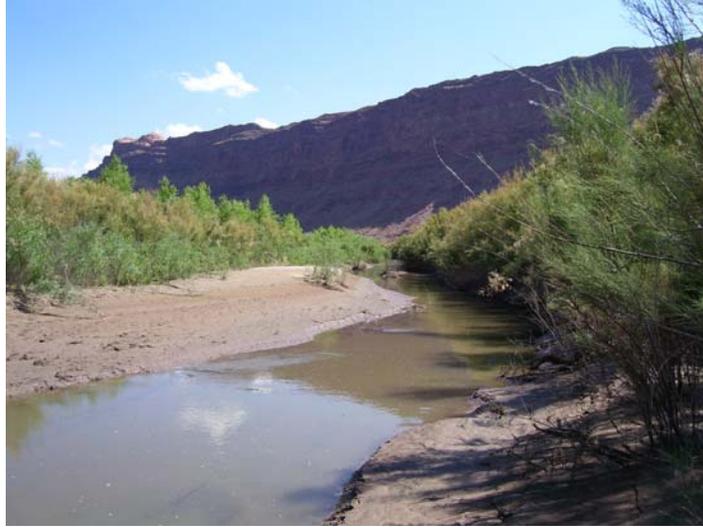
Photo 4. Area Adjacent to Configuration 2, Facing North, July 17, 2008

Photo 5. Area Adjacent to Configuration 2, Facing South, July 17, 2008

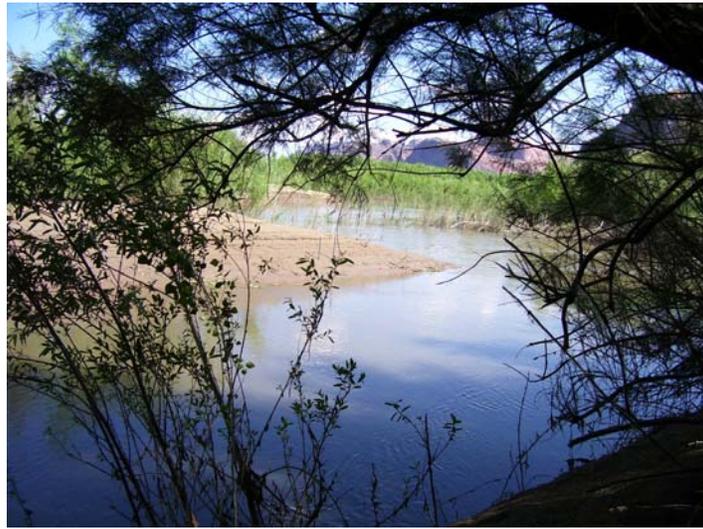
Photo 6. Area Adjacent to Configuration 1, Facing East, July 17, 2008

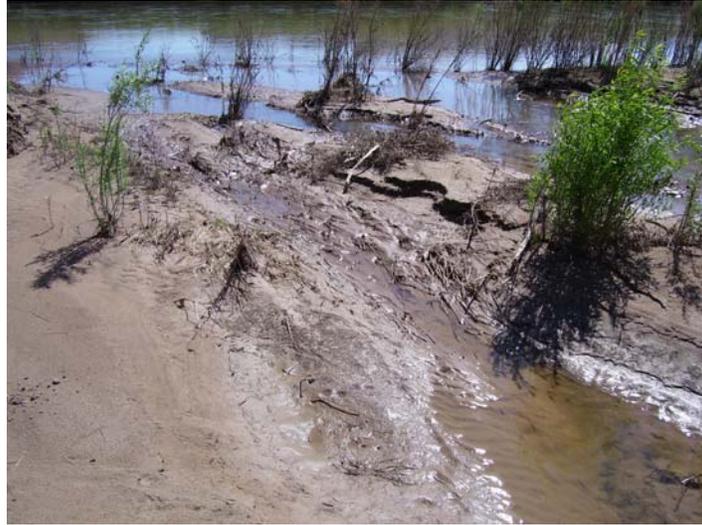
On July 24, the main backwater channel was barely connected upstream adjacent to Configuration 3 (Photo 7). A stagnant pocket of water was located adjacent to Configuration 2 (Photo 8).

Photo 7. Area Adjacent to Configuration 3, Facing North, July 24, 2008

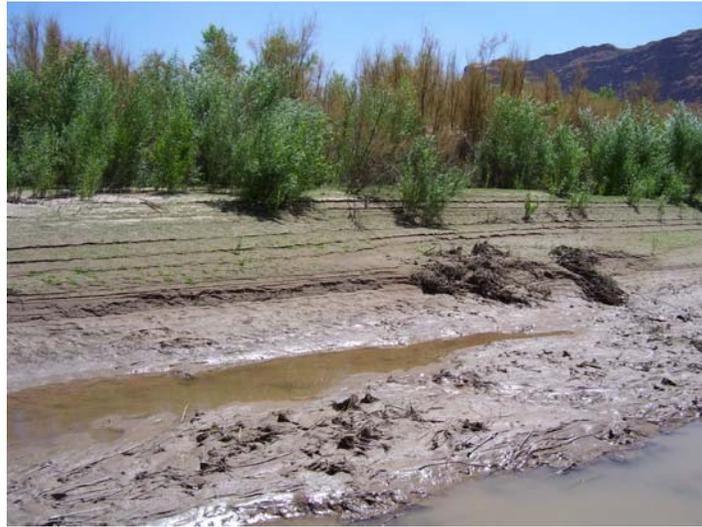
On July 29, the main backwater channel was more discontinuous and contained some isolated pockets of water (Photo 9). The channel was still connected to the river downstream through the areas adjacent to Configurations 2 and 1 (Photos 10 and 11).

Photo 9. Area Adjacent to Configuration 2, Facing Southeast, July 29, 2008

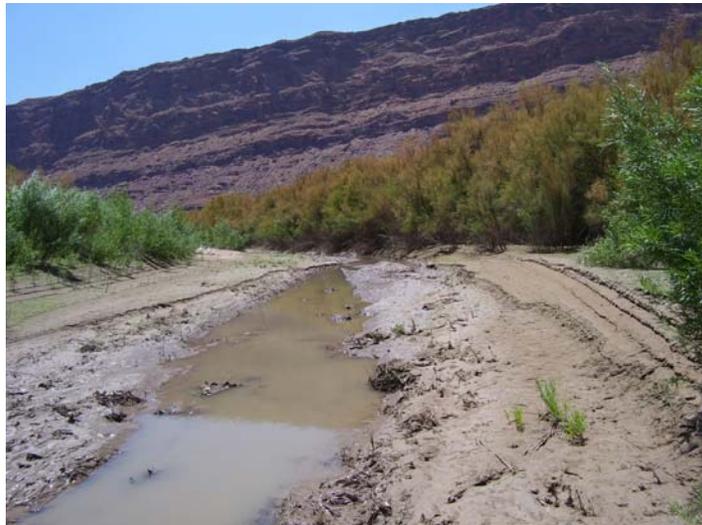
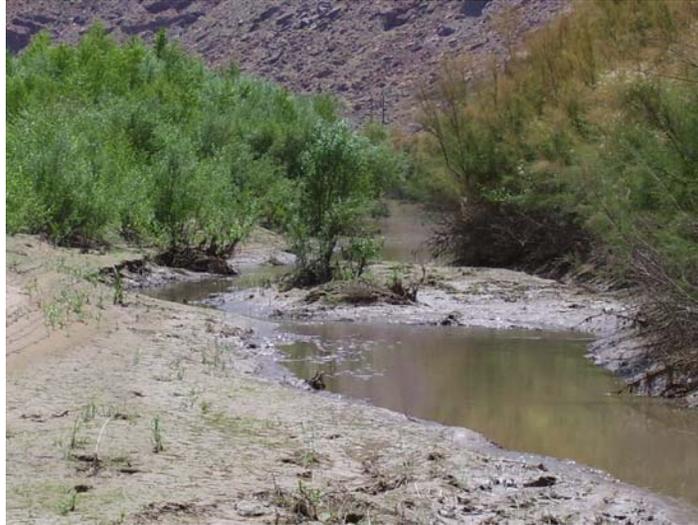
Photo 10. Area Adjacent to Configuration 2, Facing South, July 29, 2008

Photo 11. Backwater Channel Adjacent to Configurations 2 and 1, Facing South, July 29, 2008

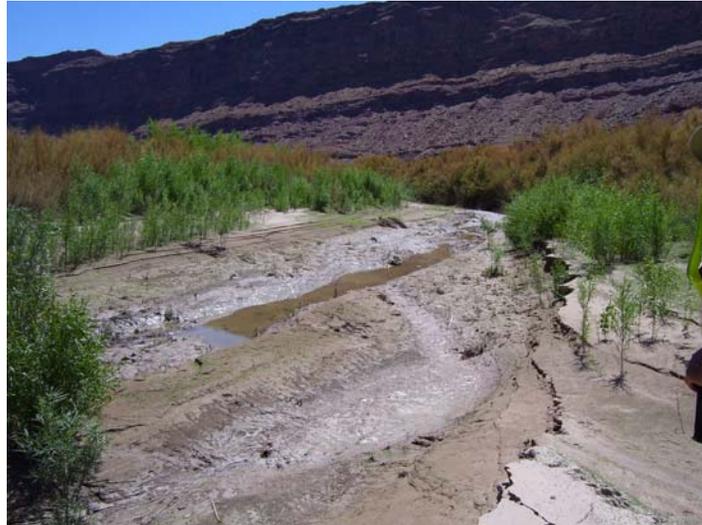
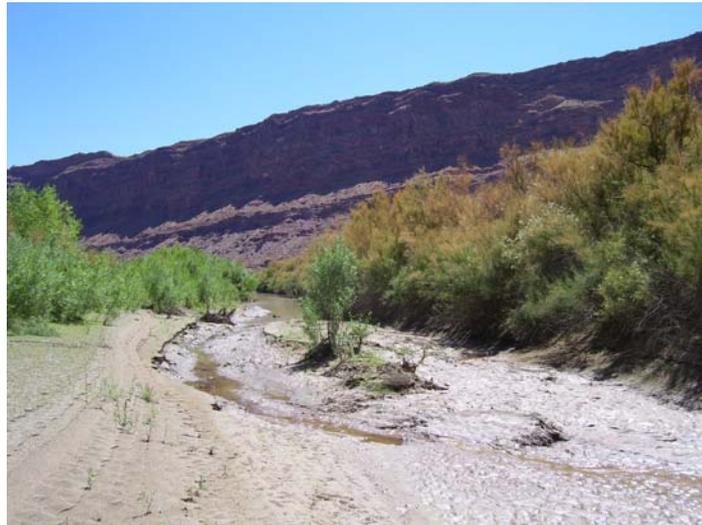
On July 31, the main backwater channel was nearly dry and consisted of isolated pockets of water (Photos 12 and 13).

Photo 12. Area Adjacent to Configuration 3, Facing South, July 31, 2008

Photo 13. Area Adjacent to Configuration 2, Facing South, July 31, 2008

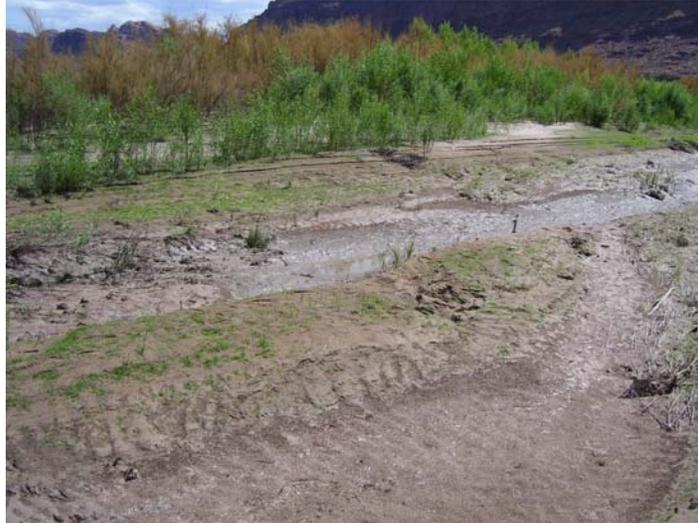
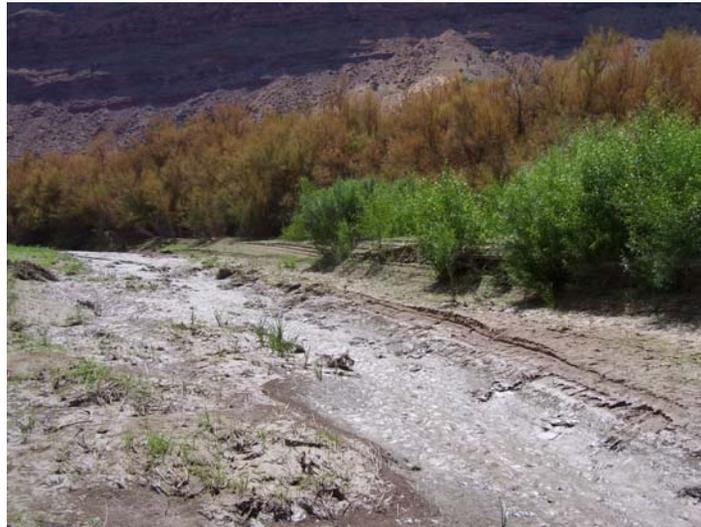
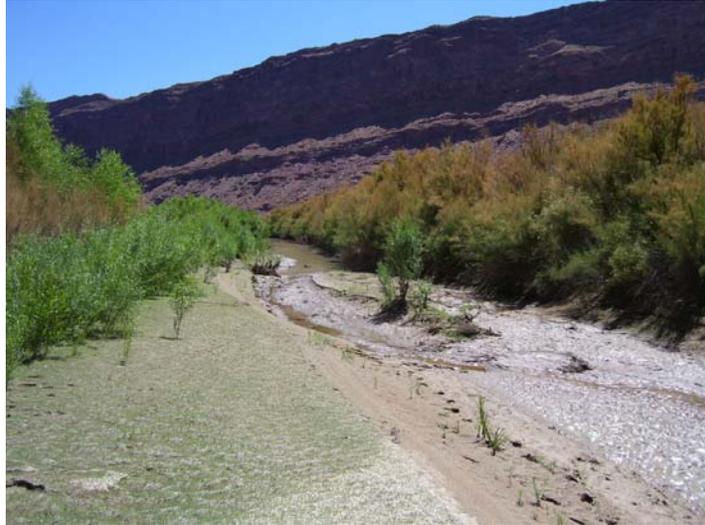
On August 4, the main backwater channel was dry up to the area adjacent to Configuration 1 (Photos 14, 15, and 16).

Photo 14. Area Adjacent to Configuration 3, Facing Southeast, August 4, 2008

Photo 15. Area Adjacent to Configuration 2, Facing Southwest, August 4, 2008

Photo 16. Area Adjacent to Configuration 2, Facing South, August 4, 2008

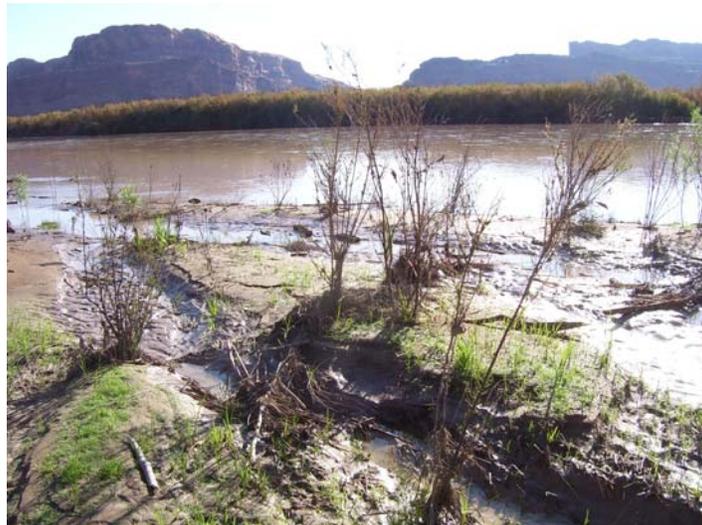
An early August monsoonal storm led to an increase in river flow. As a result, the main backwater channel was barely connected to the river on the upstream side (Photo 17). The backwater channel flowed through to the area adjacent to Configurations 2 and 1 (Photos 18 and 19).

Photo 17. Area Adjacent to Configuration 3, Facing Northeast, August 12, 2008

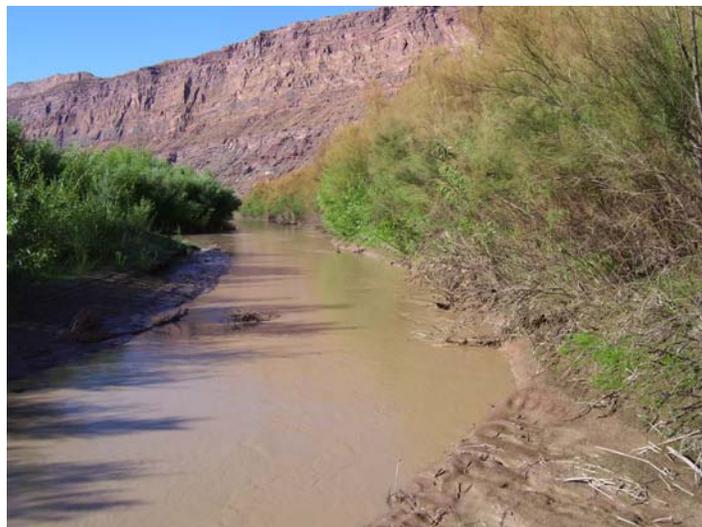
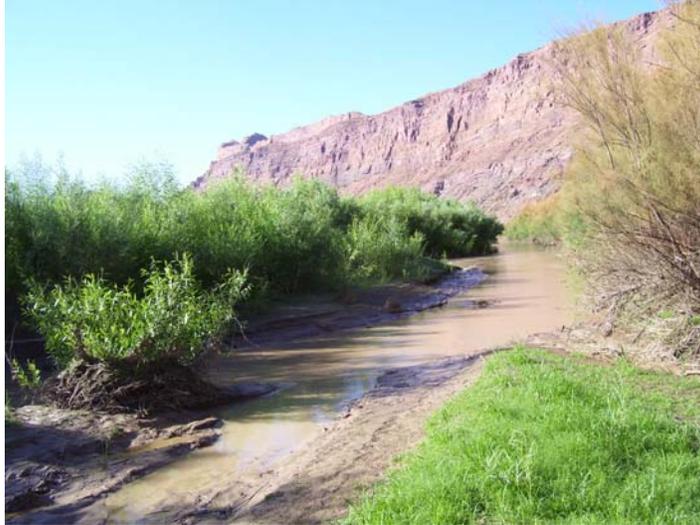
Photo 18. Area Adjacent to Configuration 2, Facing South, August 12, 2008

Photo 19. Area Adjacent to Configurations 1 and 2, Facing South, August 12, 2008

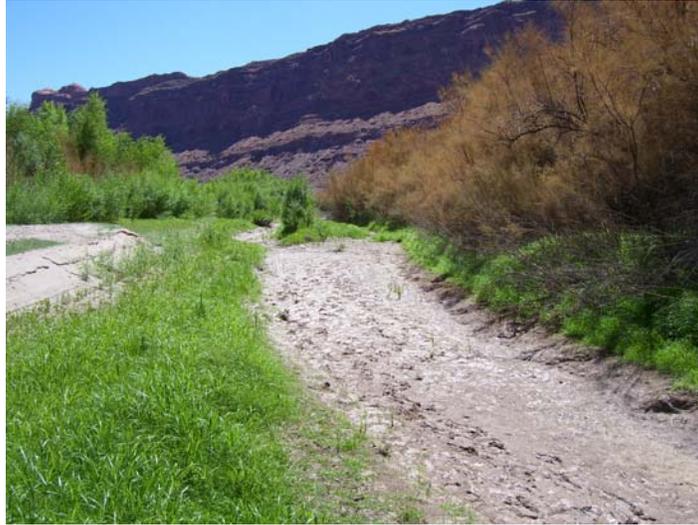
On August 27, the main backwater channel was dry once again and vegetation began to grow on the banks of the channel (Photo 20). The channel still flowed both upstream and downstream adjacent to Configuration 1 (Photo 21).

Photo 20. Area Adjacent to Configuration 2, Facing South, August 27, 2008

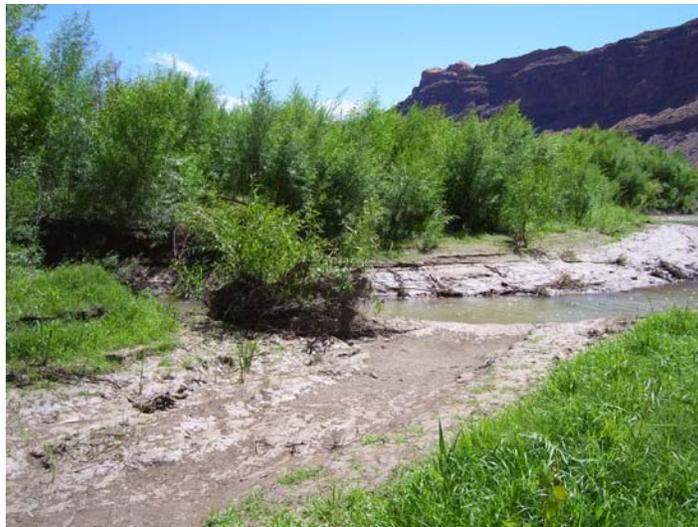
Photo 21. Area Adjacent to Configurations 1 and 2, Facing South, August 27, 2008
