*Office of Environmental Management – Grand Junction*

December 2013

**Moab UMTRA Project  
Environmental Air Monitoring Data Quarterly Report  
for the Moab and Crescent Junction, Utah, Sites  
Third Quarter 2013  
(July through September 2013)**

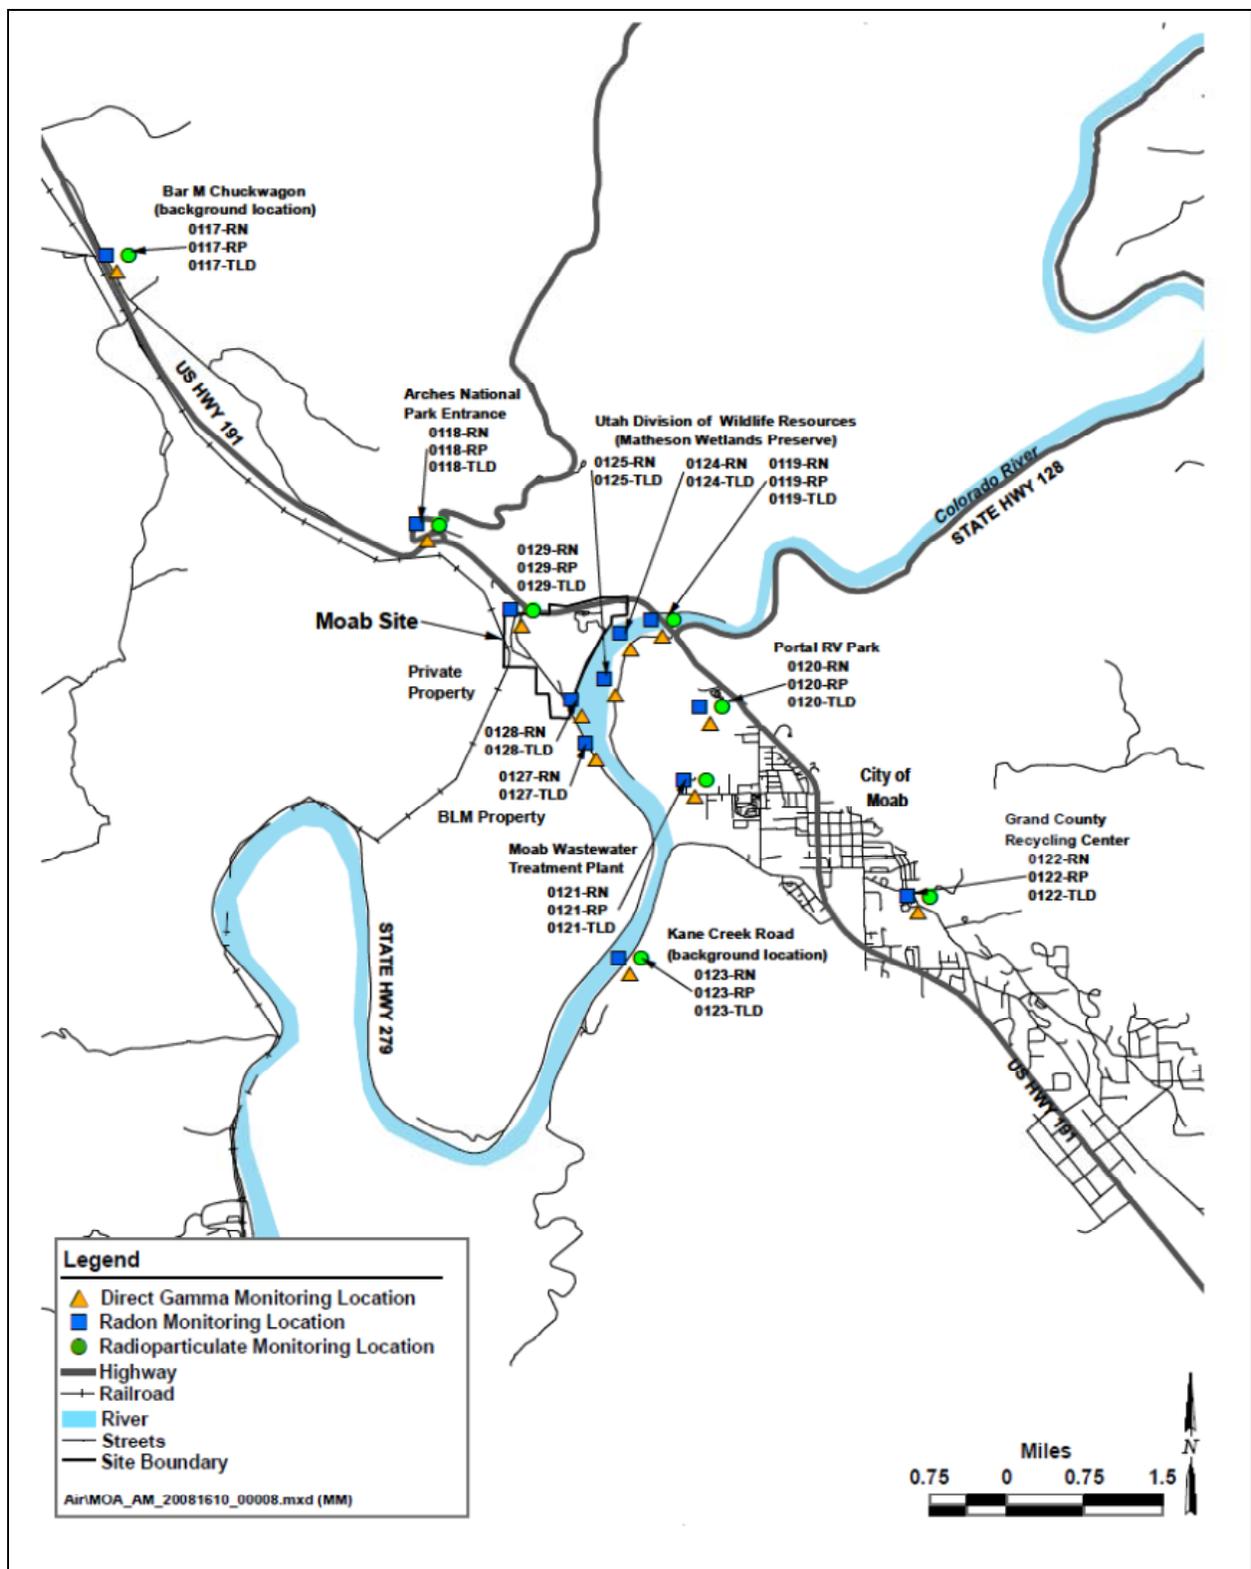
Figure 1. Moab Off-site Environmental Air-monitoring Locations

U.S. Department of Energy (DOE) Order (O) 458.1, Administrative Change 2, "Radiation Protection of the Public and Environment," establishes a guideline for atmospheric emissions of radon-222 that is applicable to the Moab Uranium Mill Tailings Remedial Action (UMTRA) Project. This guideline is 3.0 picocuries per liter (pCi/L) above background. Based on 5 years of data from 2003 through 2008, the average background concentration (established from stations 0117 and 0123) of radon-222 in the Moab area was established as 0.7 pCi/L; therefore, the guideline for radon-222 emissions at the Moab site is 3.7 pCi/L. Monitoring data collected during the third quarter of 2013 indicate that this quarterly guideline was not exceeded at any on- or off-site station. In general, results were similar to previous third quarter data. Remote locations were in line with historical data. Table 1 shows the data for the monitoring locations with no annual guideline exceedance. Table 2 shows summary radon-222 data for the Moab site. Monitoring locations for the Moab site are presented in Figures 1 and 2.

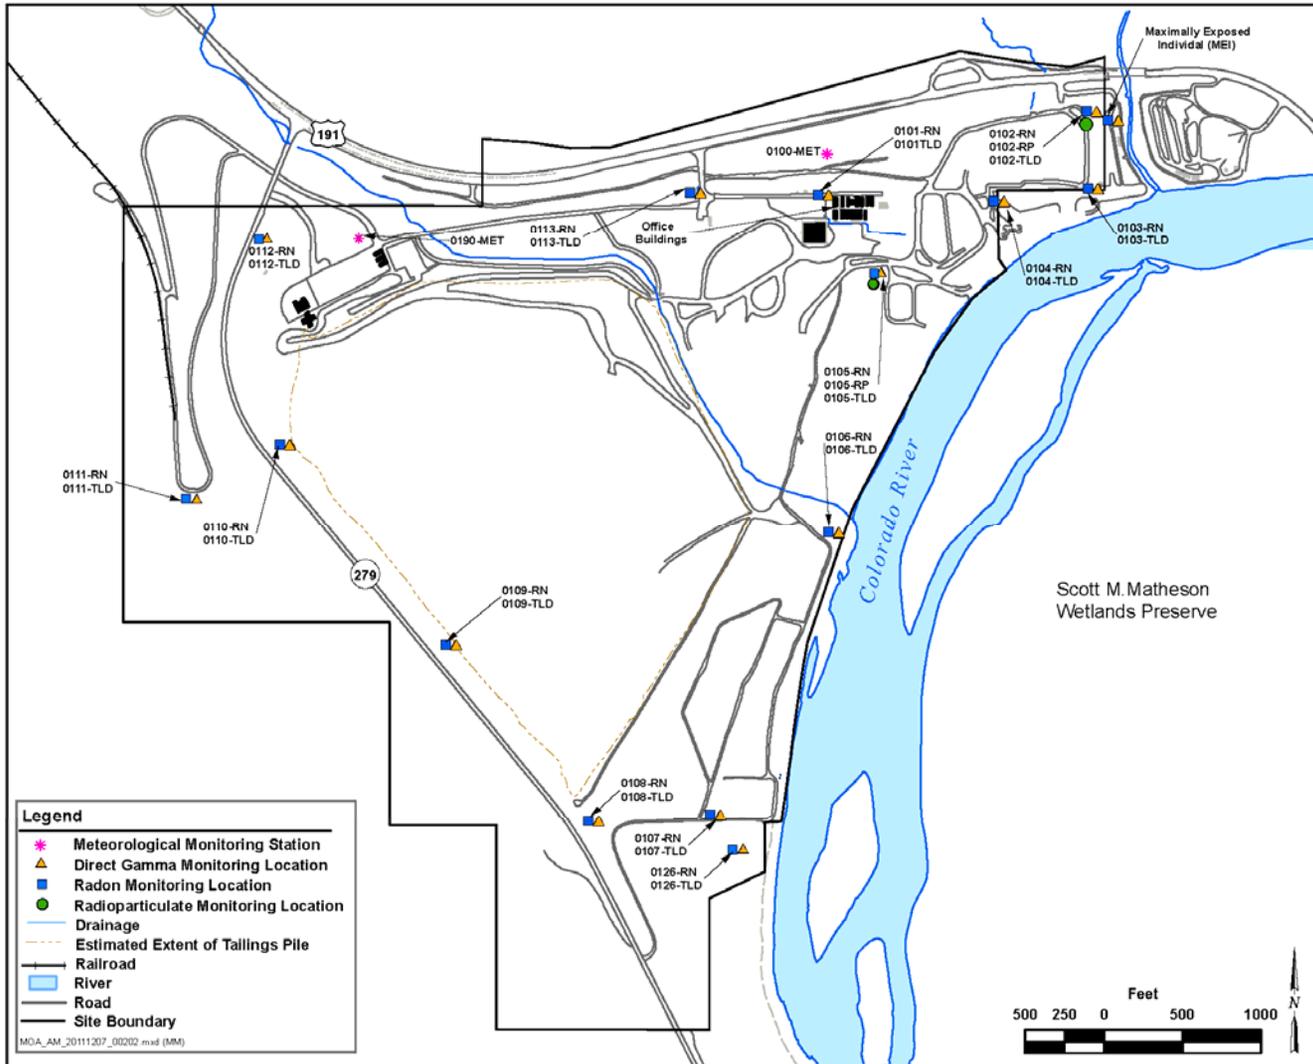
Figure 2. Moab On-site and MEI Environmental Air-monitoring Locations

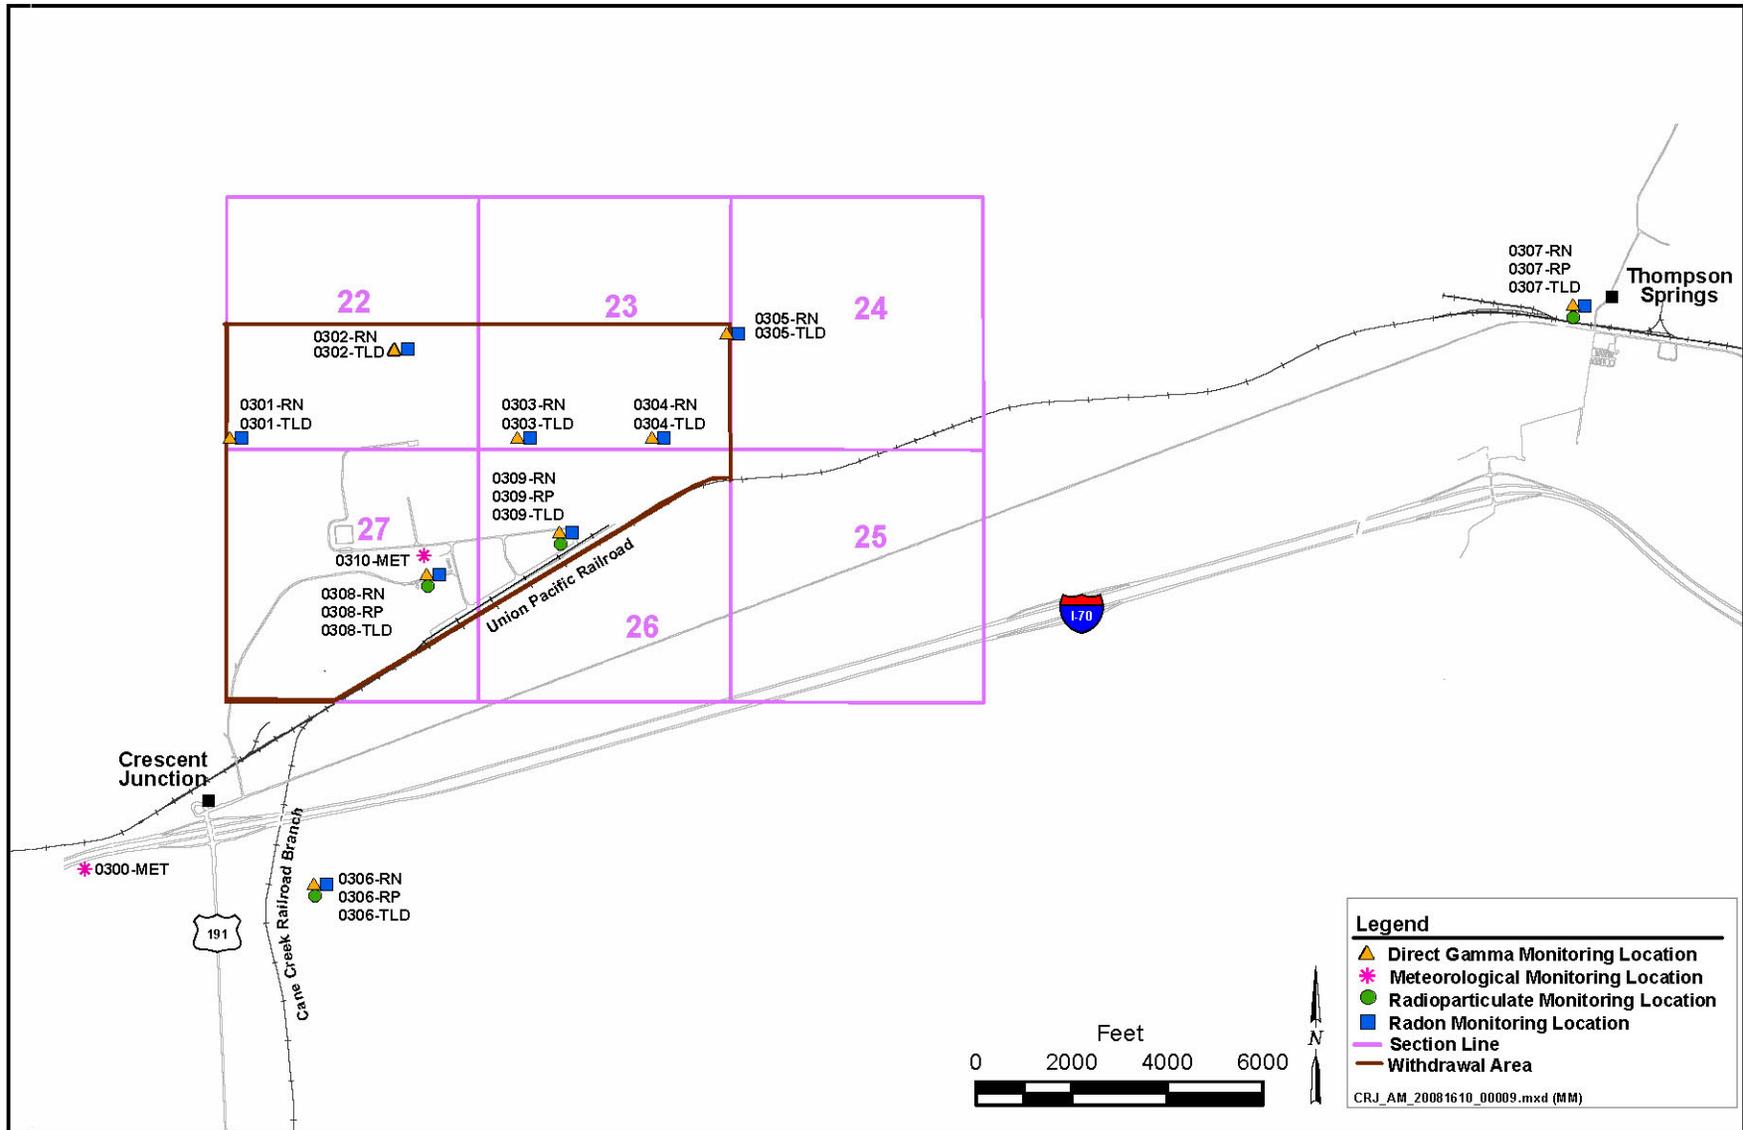
Figure 3. Crescent Junction Site Environmental Air-monitoring Locations

Monitoring locations for the Crescent Junction site are presented in Figure 3. After mill-tailings disposal began in 2009, monitoring location 0308 at the Crescent Junction site became the closest to operations, and station 0306 became the MEI location. Location 0307, approximately 5 miles east of the disposal site, represents the second greatest risk to the public after the MEI location, and locations 0301, 0305, and 0309 provide property-line data for the disposal site. Stations 0306, 0307, and 0308 were utilized as background locations from the period before tailings disposal.

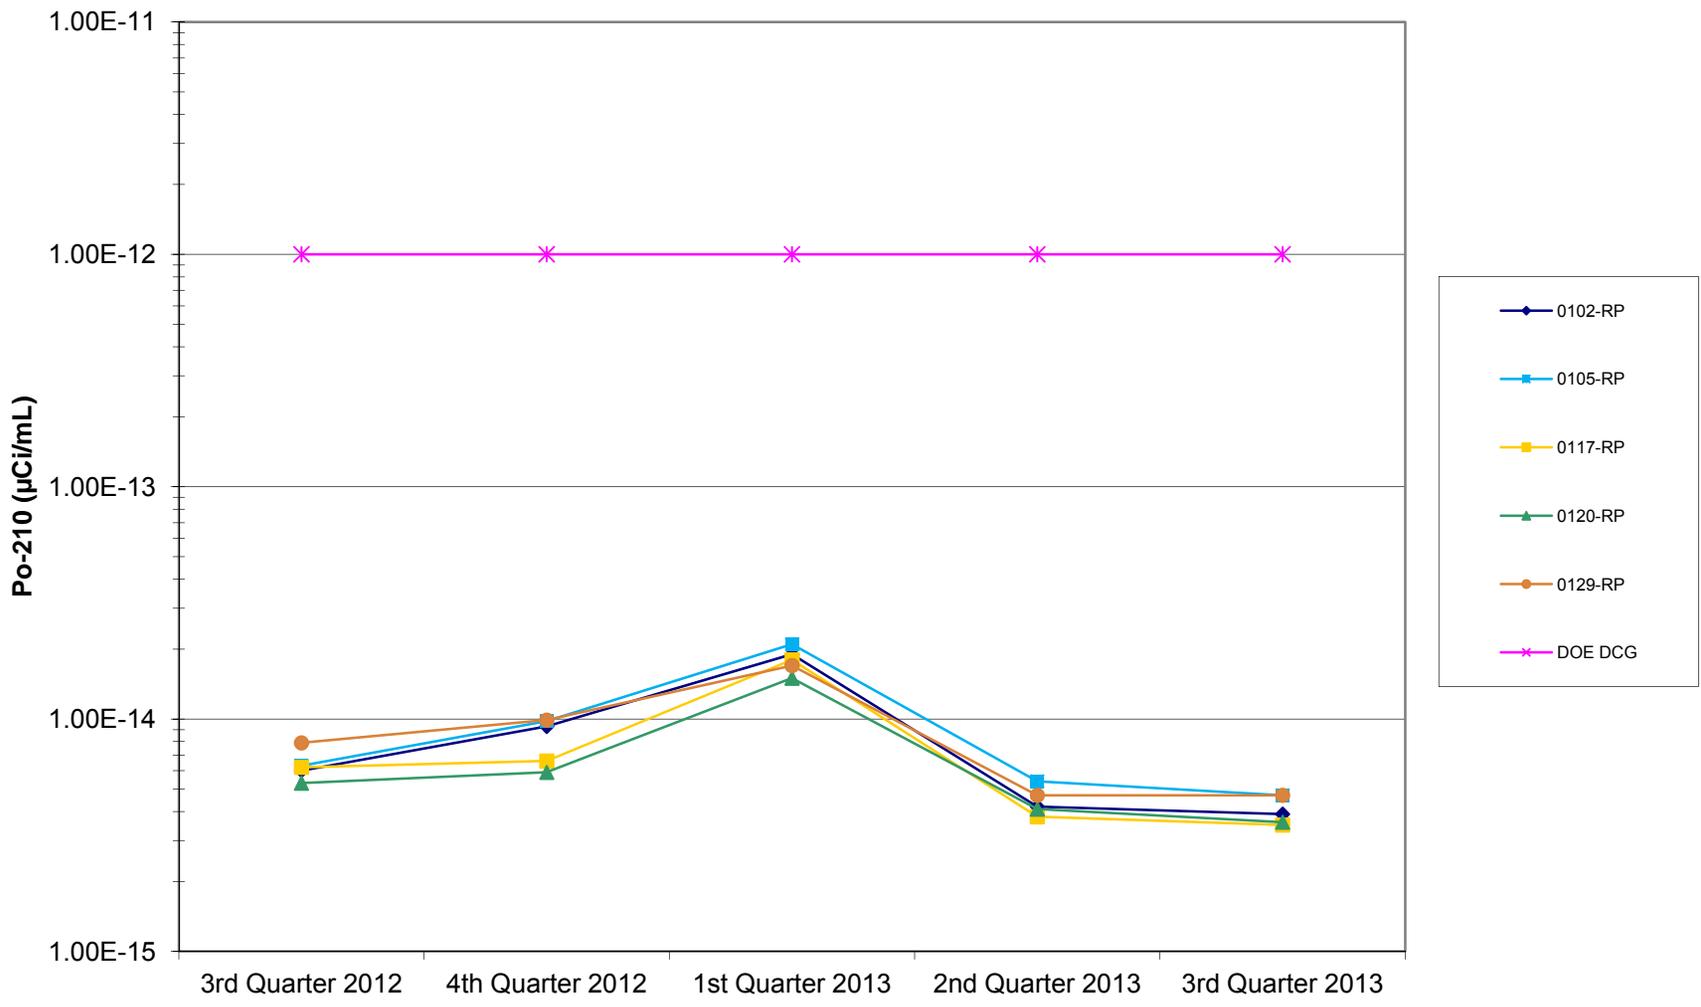
Figure 4. Polonium-210 Concentrations at Select Moab Monitoring Locations

Radioparticulate-monitoring data were plotted on graphs (Figures 4 through 7) for the following Moab site locations: (1) 0102, which is the station closest to the MEI; (2) 0105, which is closest to the emissions source (i.e., the mill-tailings pile); (3) 0117, which is a background-monitoring location approximately 5 miles northwest of the Moab site property and represents ambient or naturally occurring conditions; (4) 0120, which is approximately 1 mile southeast of the Moab site and represents an off-site location between the site and Moab; and (5) 0129, which is directly downwind of operations with the greatest potential impact from operations.

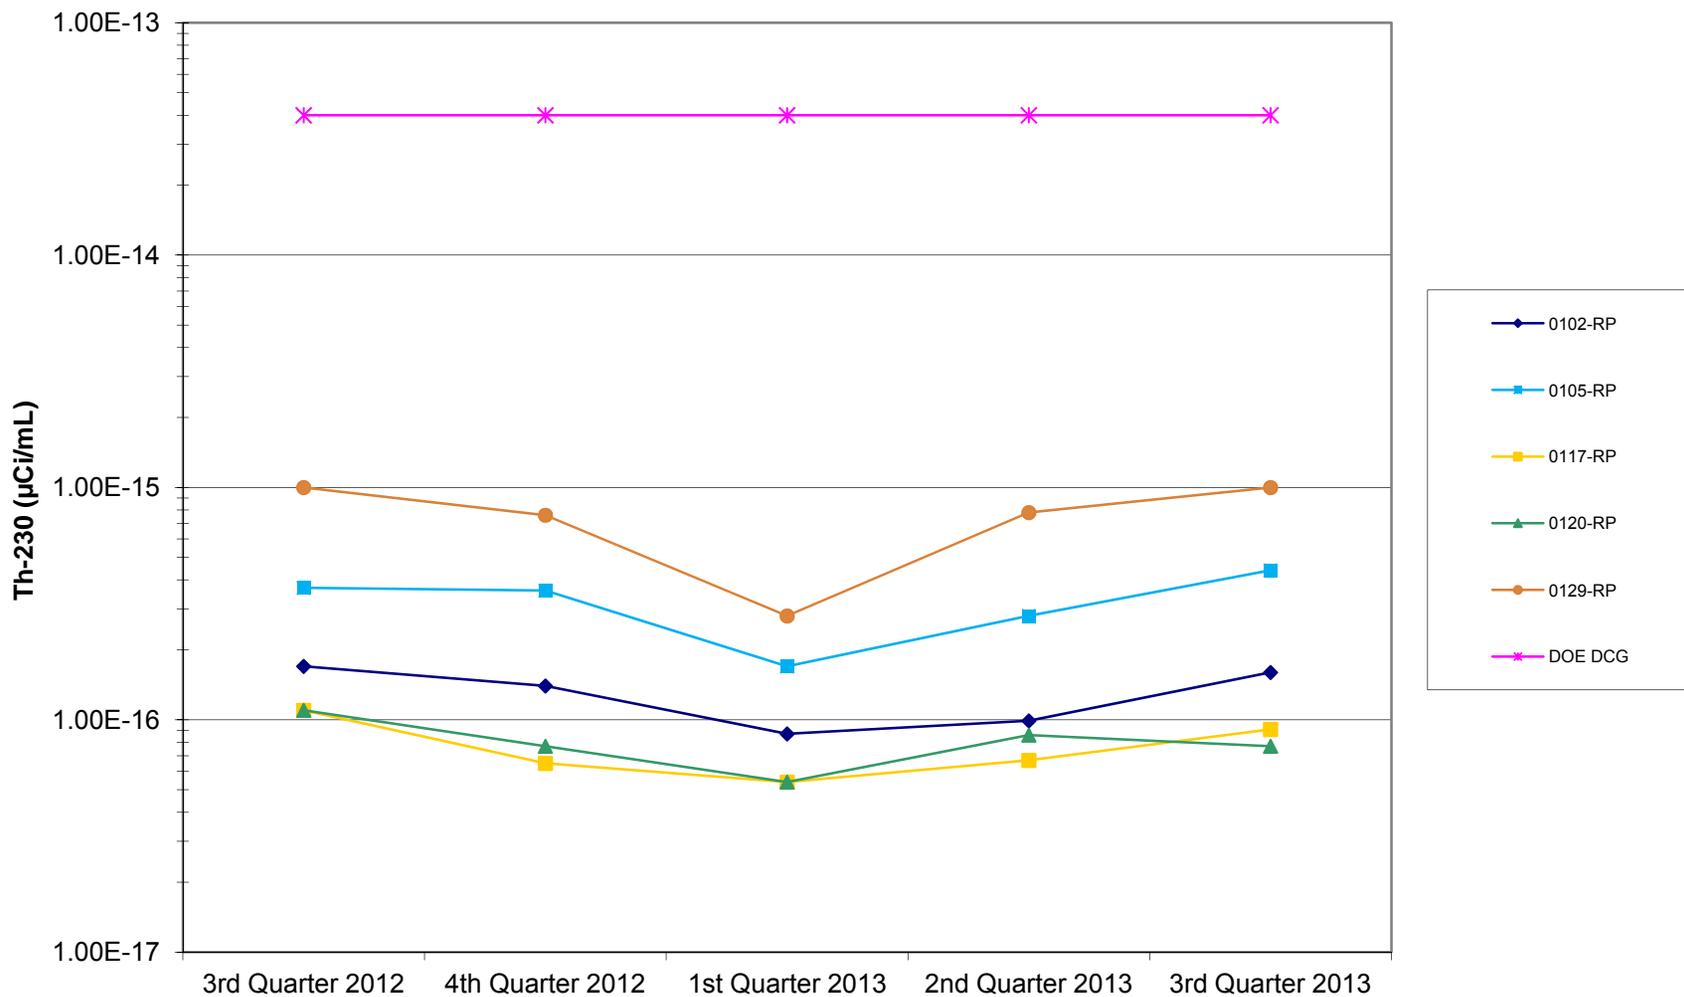
Figure 5. Thorium-230 Concentrations at Select Moab Monitoring Locations

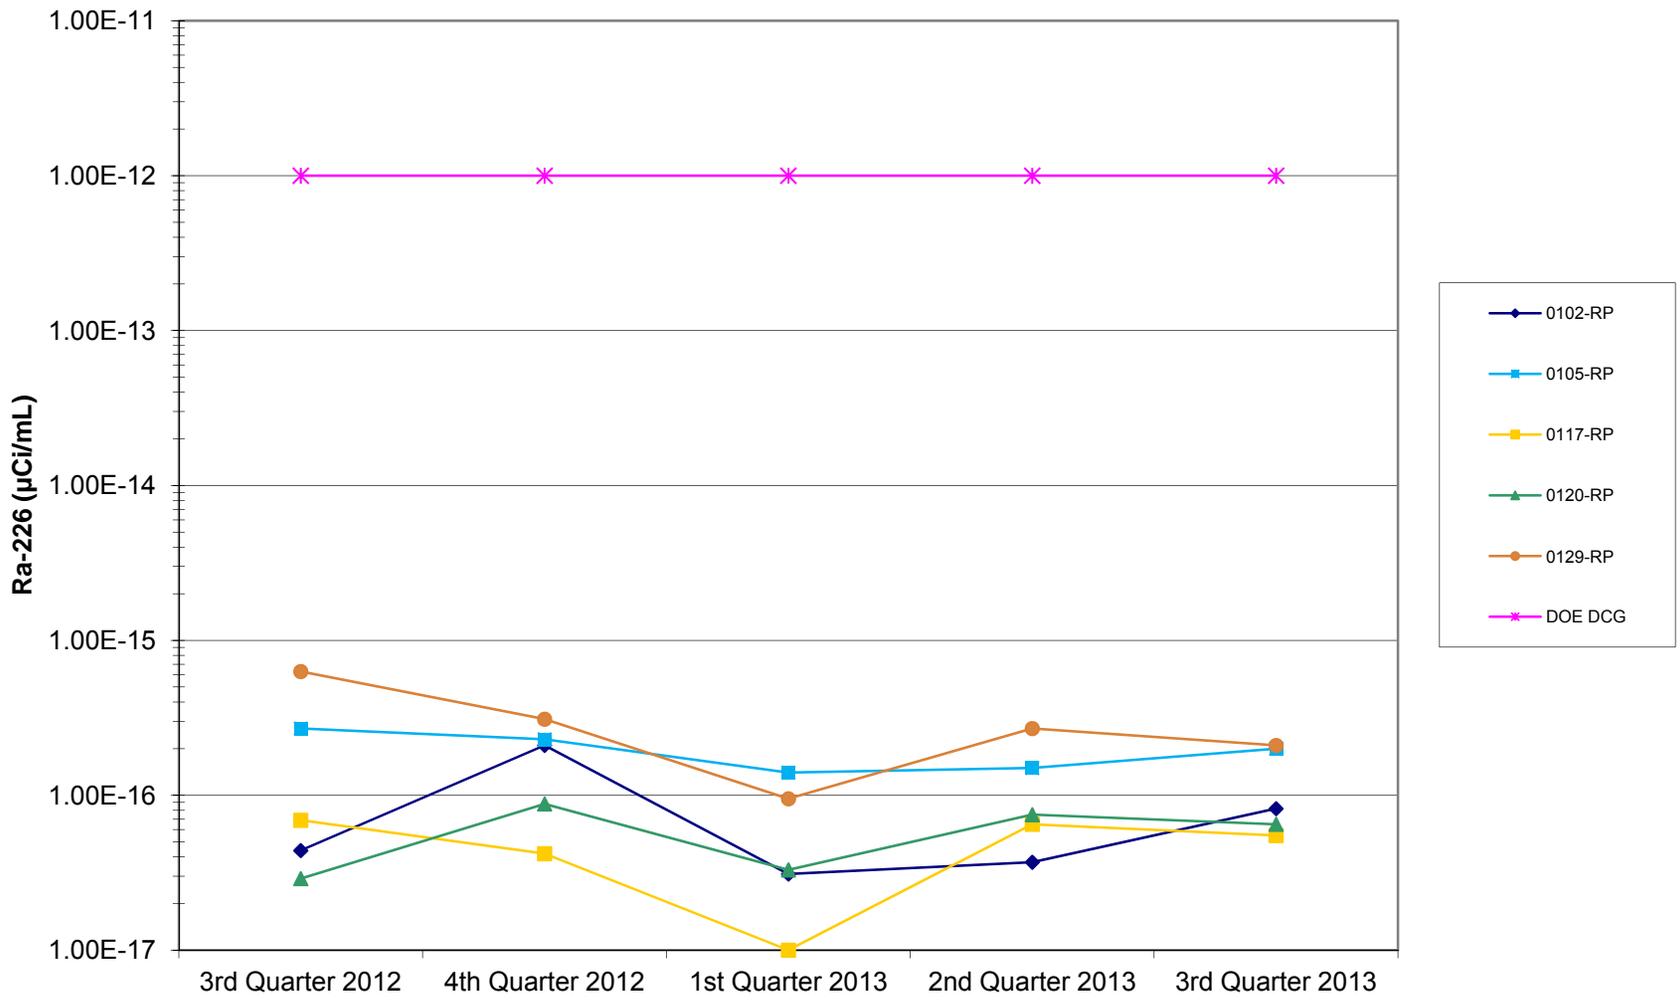
Figure 6. Radium-226 Concentrations at Select Moab Monitoring Locations

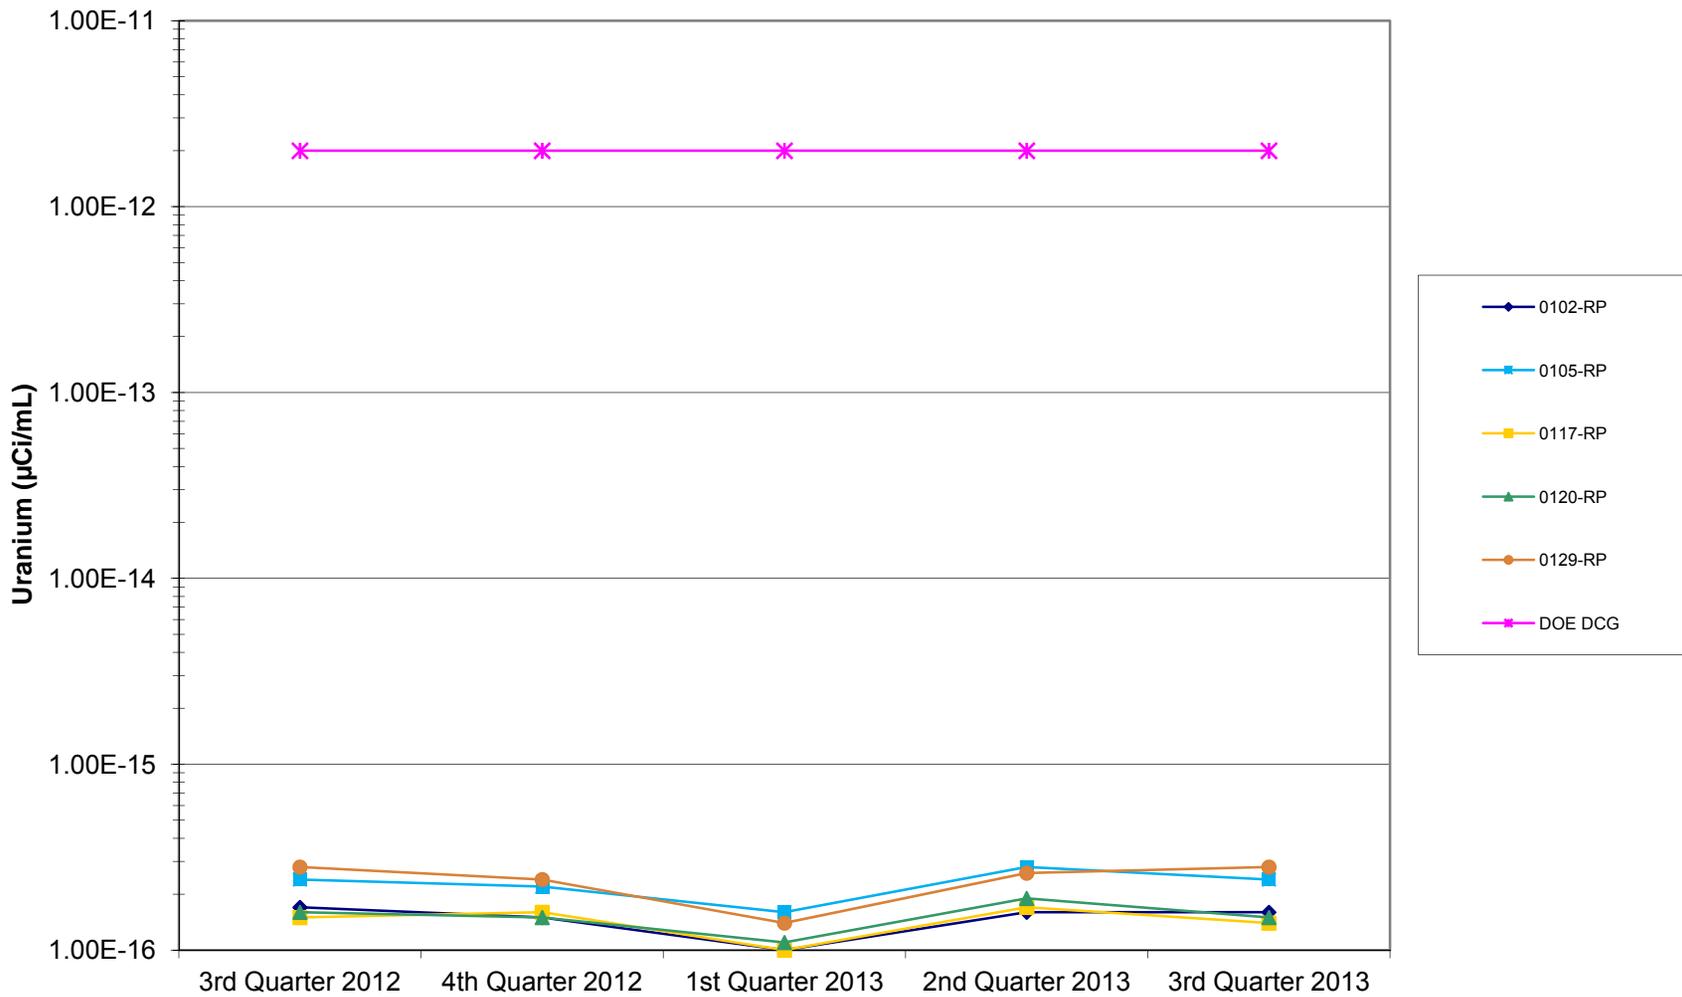
Figure 7. Total Uranium Concentrations at Select Moab Monitoring Locations

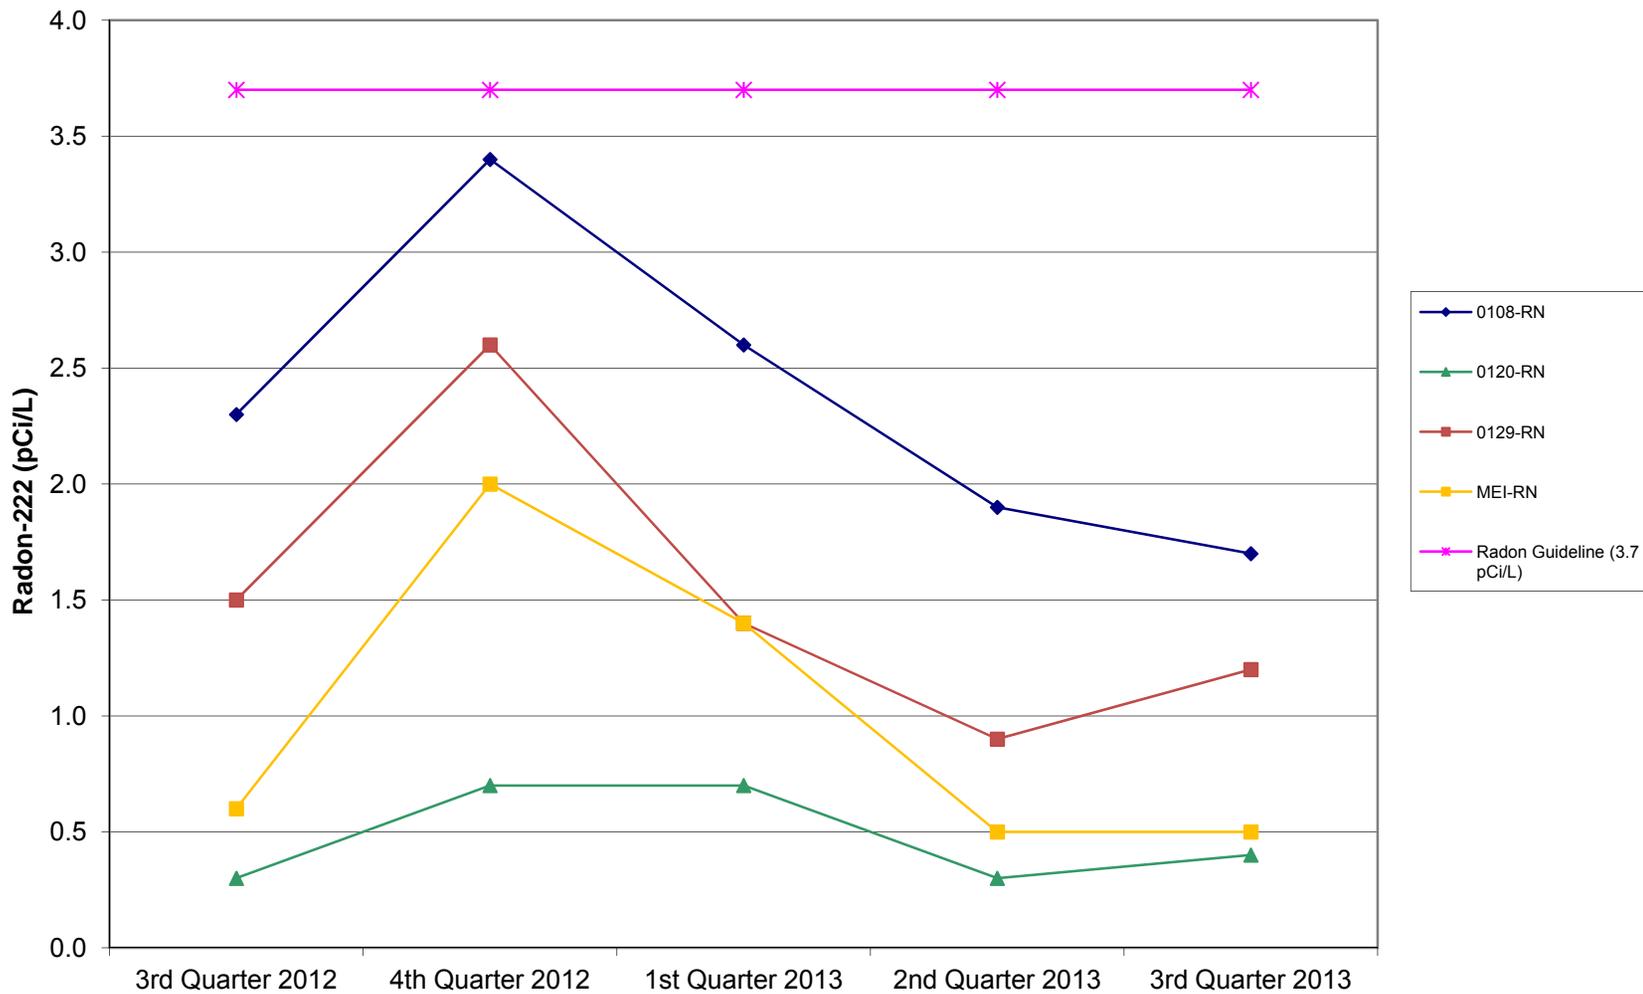
Figure 8. Atmospheric Radon-222 Concentrations at Select Moab Monitoring Locations

Radon-222 data were plotted on a graph (Figure 8) for the following Moab site monitoring locations: (1) 0108, which occasionally has elevated radon levels; (2) location 0120, which is near the Portal RV Park, approximately 1 mile southeast of the Moab site, and represents potential exposure to the public; (3) 0129, which is directly downwind of operations; and (4) the MEI.

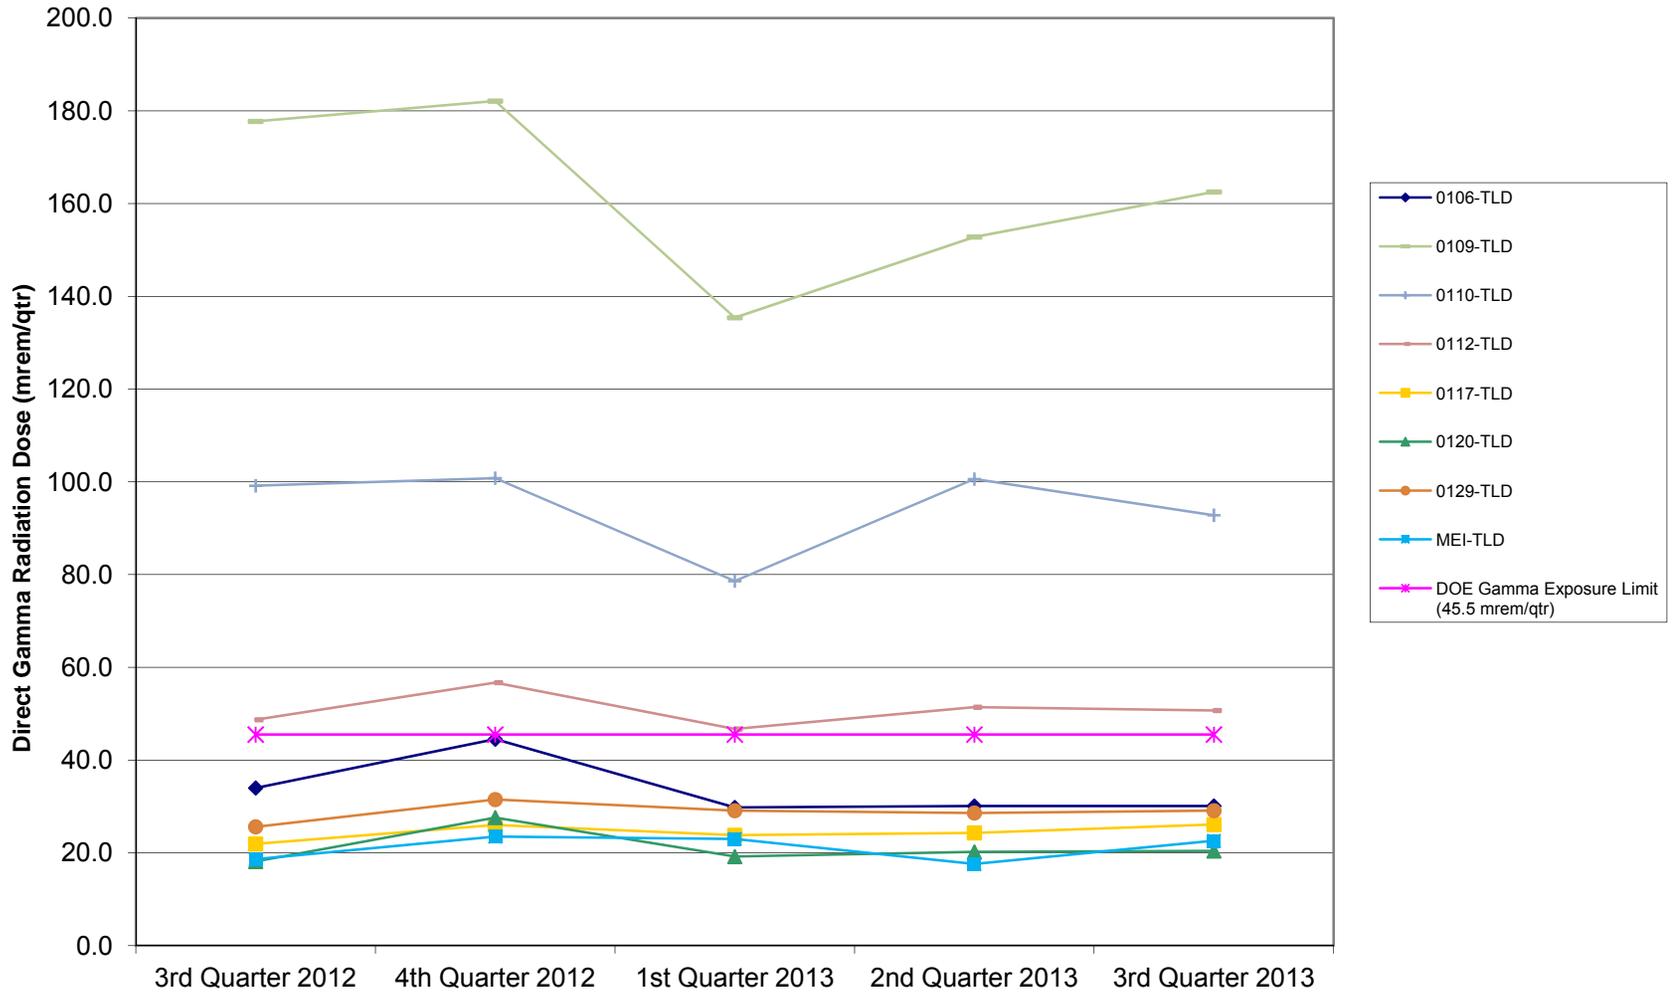
Figure 9. Direct Gamma Radiation Dose at Select Moab Monitoring Locations

Gamma-radiation data were plotted on a graph (Figure 9) for the following Moab site monitoring locations: (1) 0106, which is along the eastern property boundary and has previously recorded elevated direct-gamma radiation; (2) 0110 and 0112, which were both plotted as on-site locations directly adjacent to the tailings pile with high readings; (3) 0117, which is approximately 5 miles northwest of the Moab site property and is a background-monitoring location; (4) 0120, an off-site location between the site and Moab; (5) 0129, which is downwind and near the northern property boundary; and (6) the MEI.

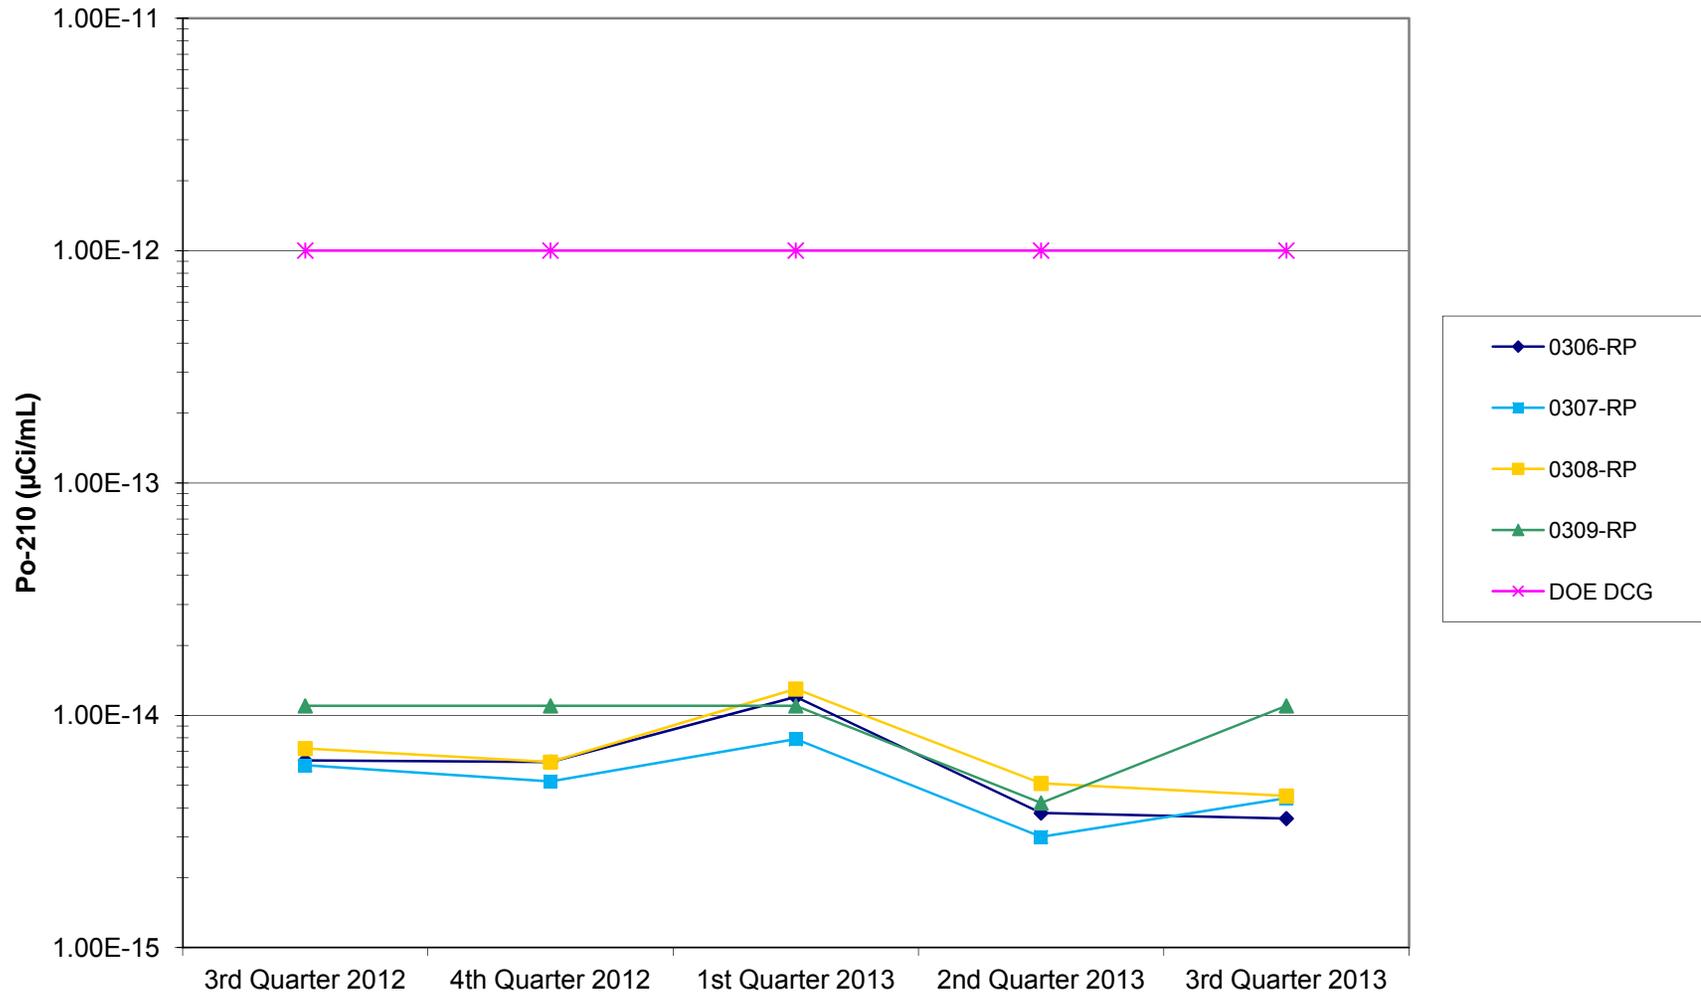
Figure 10. Polonium-210 Concentrations at Select Crescent Junction Monitoring Locations

Radioparticulate-monitoring data were plotted on graphs (Figures 10 through 13) for the following Crescent Junction site locations: 0306, 0307, 0308, and 0309. These locations were selected for the same reasons as stated for radon-222 and gamma radiation.

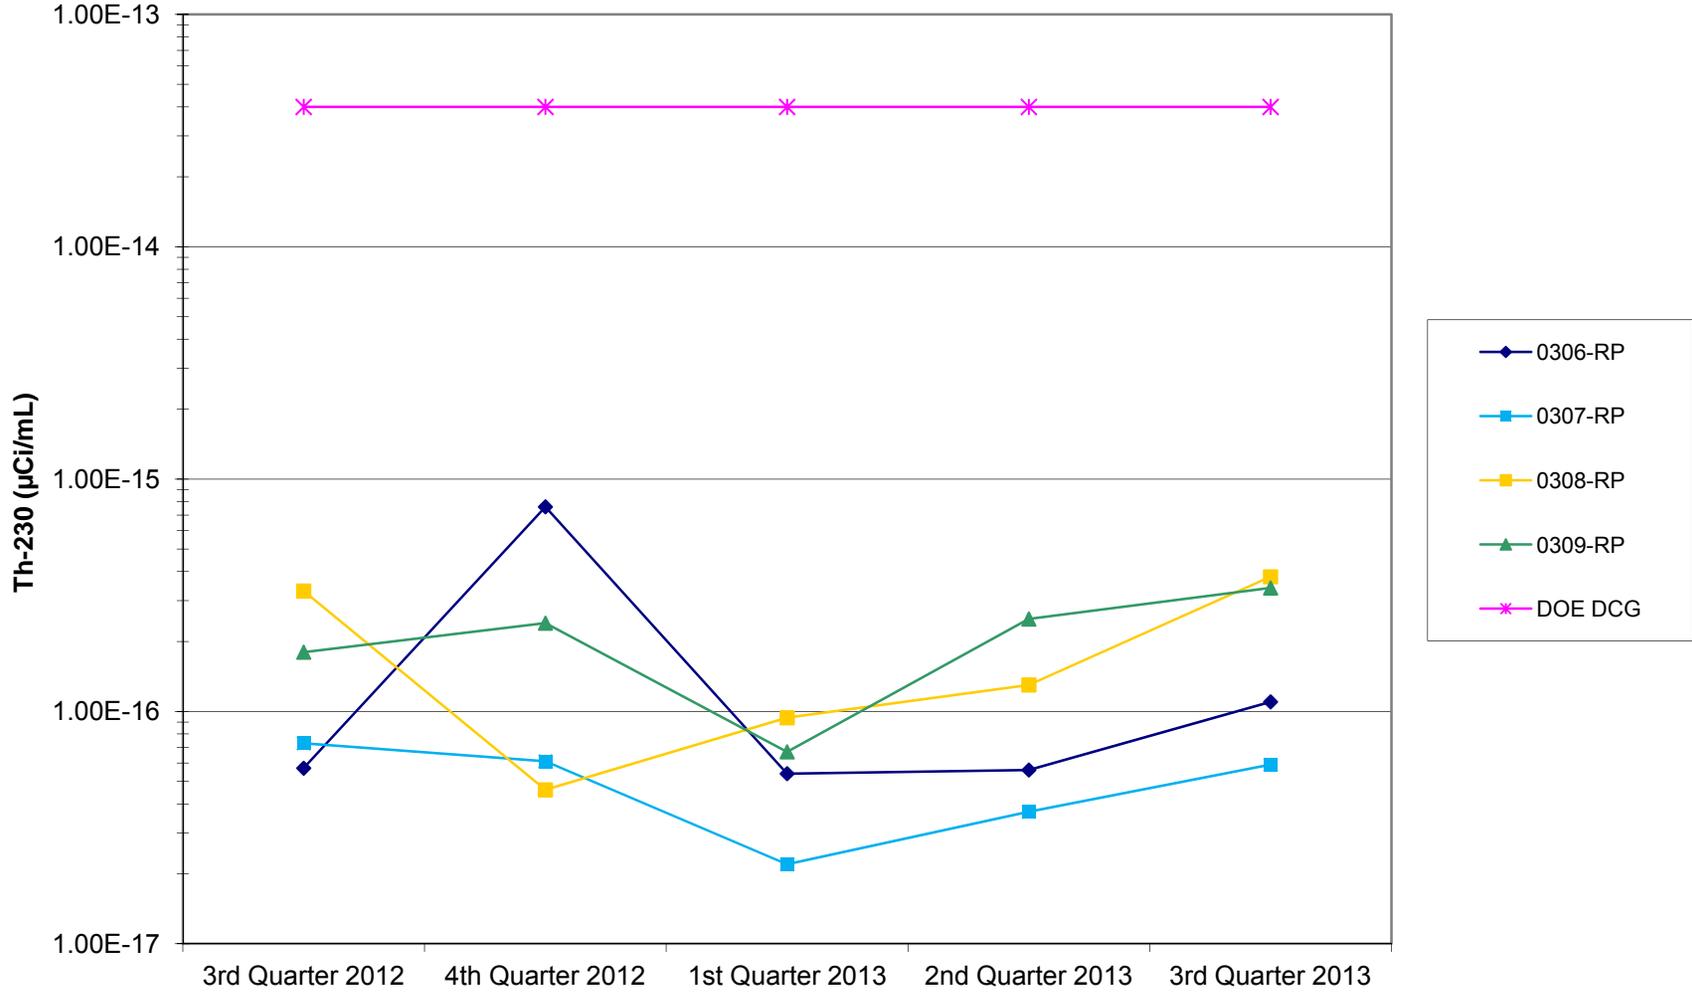
Figure 11. Thorium-230 Concentrations at Select Crescent Junction Monitoring Locations

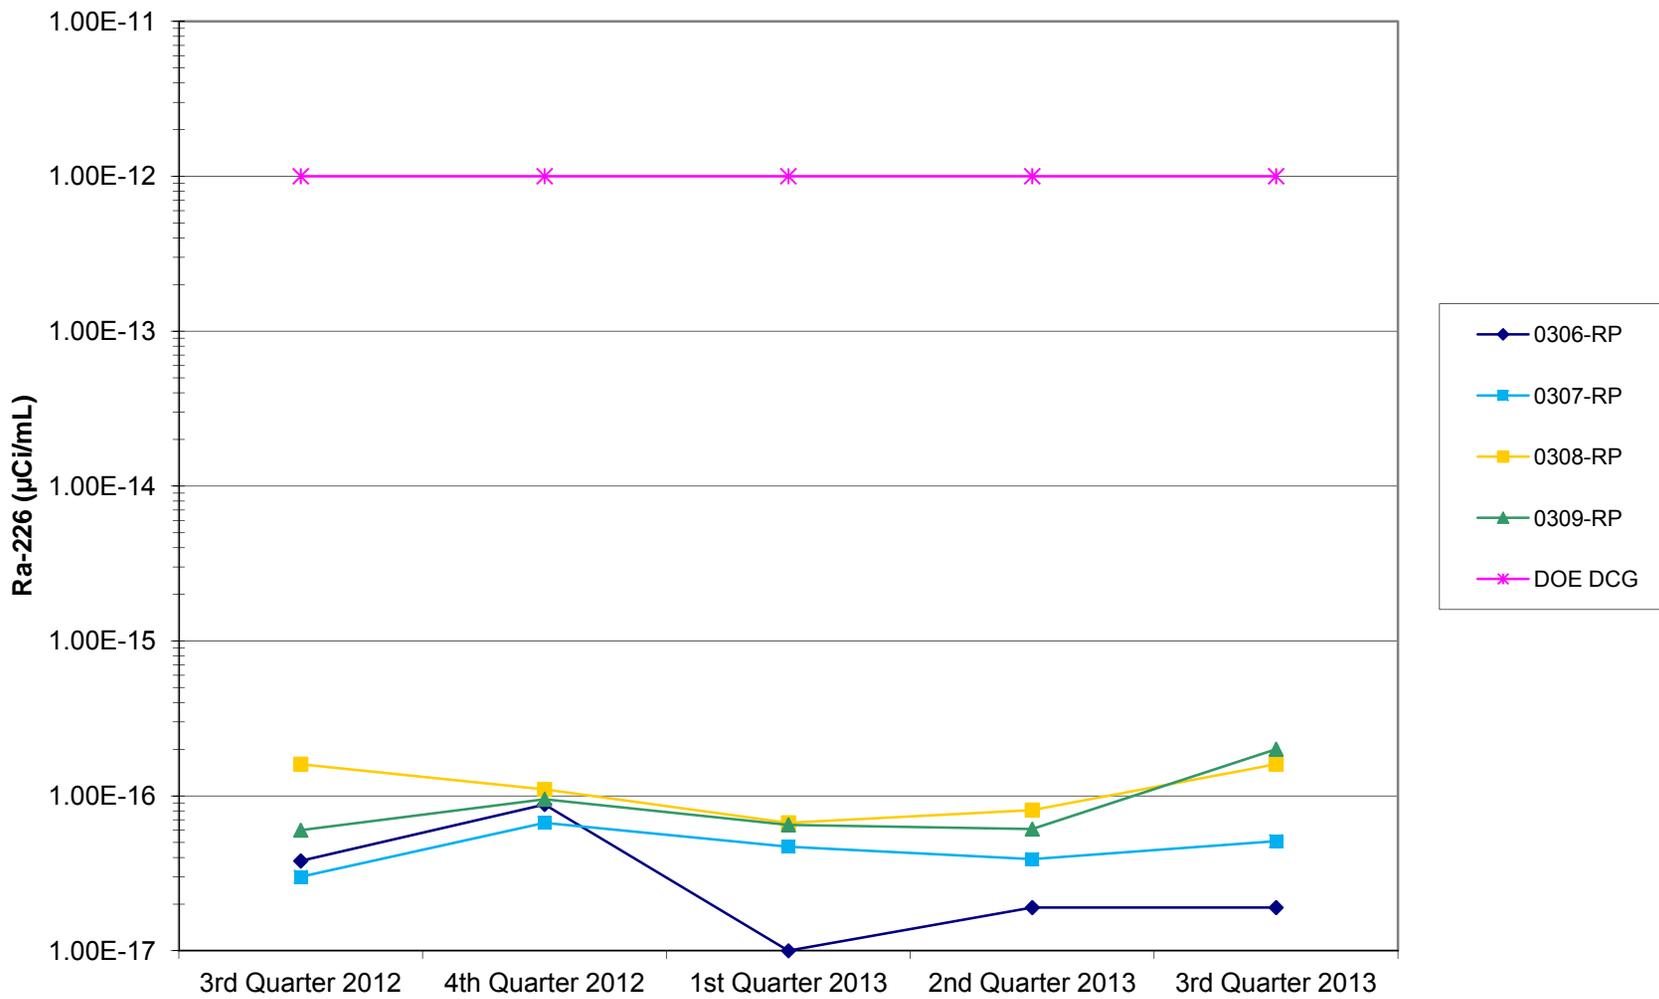
Figure 12. Radium-226 Concentrations at Select Crescent Junction Monitoring Locations
