*Office of Environmental Management – Grand Junction*

December 2013

**Moab UMTRA Project  
Environmental Air Monitoring Data Quarterly Report  
for the Moab and Crescent Junction, Utah, Sites  
Third Quarter 2013  
(July through September 2013)**

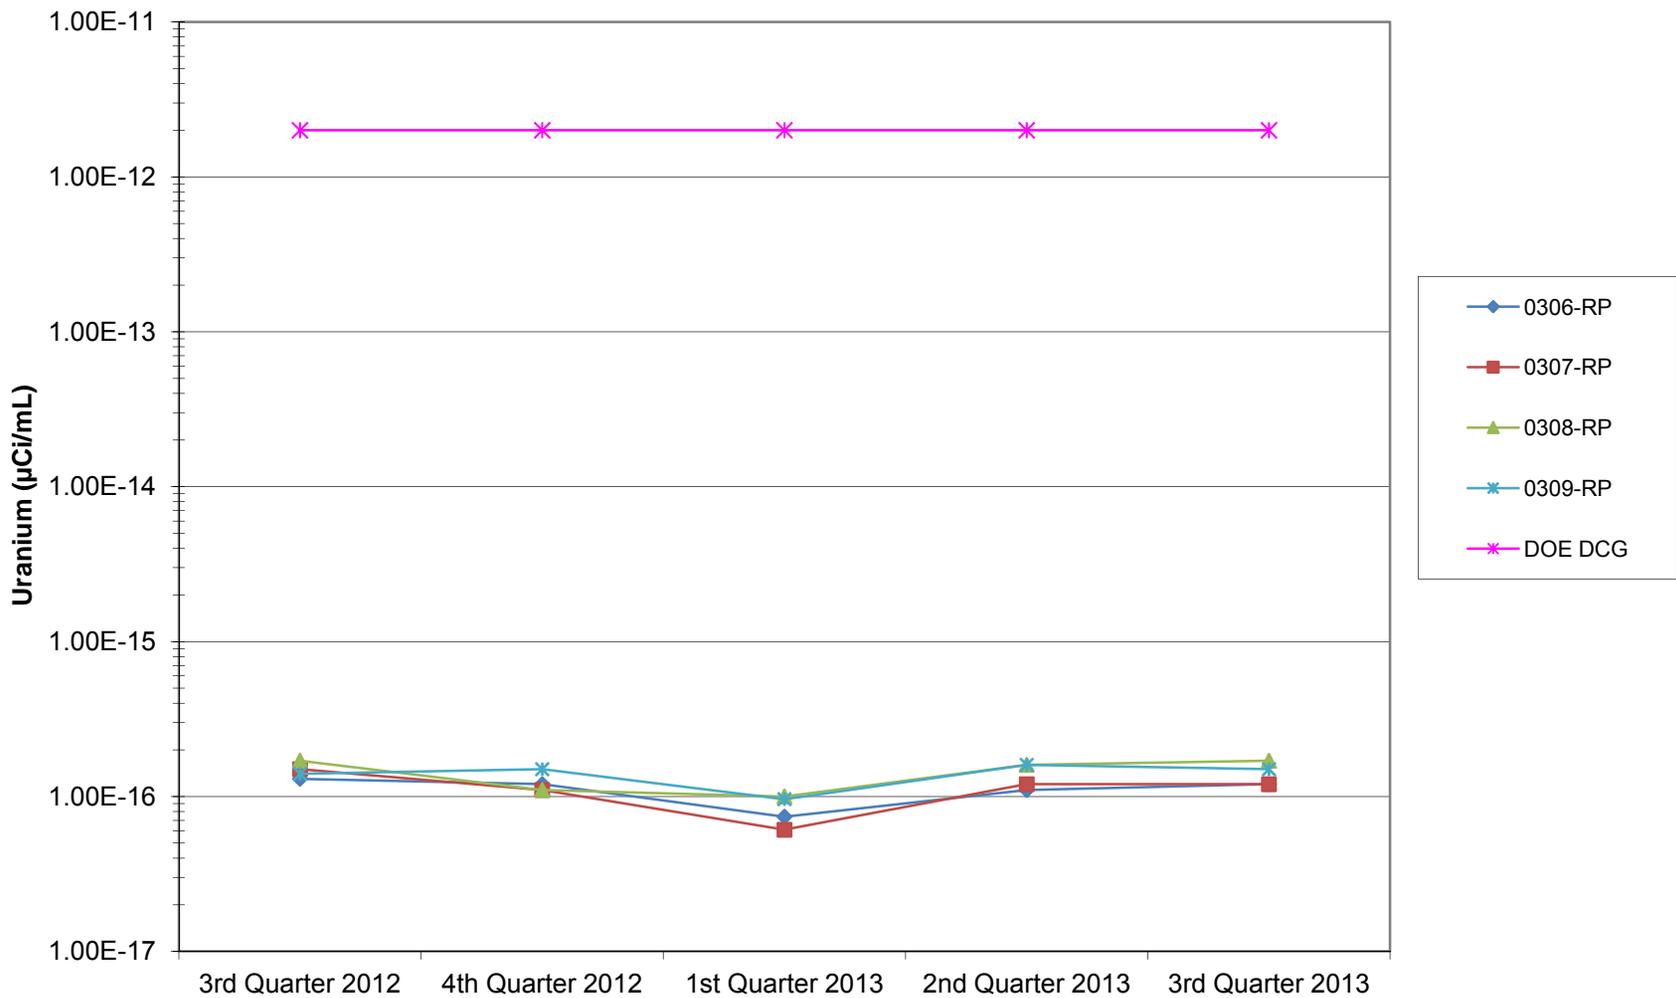
*Figure 13. Total Uranium Concentrations at Select Crescent Junction Monitoring Locations*

Radioparticulate-monitoring data were plotted on graphs (Figures 10 through 13) for the following Crescent Junction site locations: 0306, 0307, 0308, and 0309. These locations were selected for the same reasons as stated for radon-222 and gamma radiation.

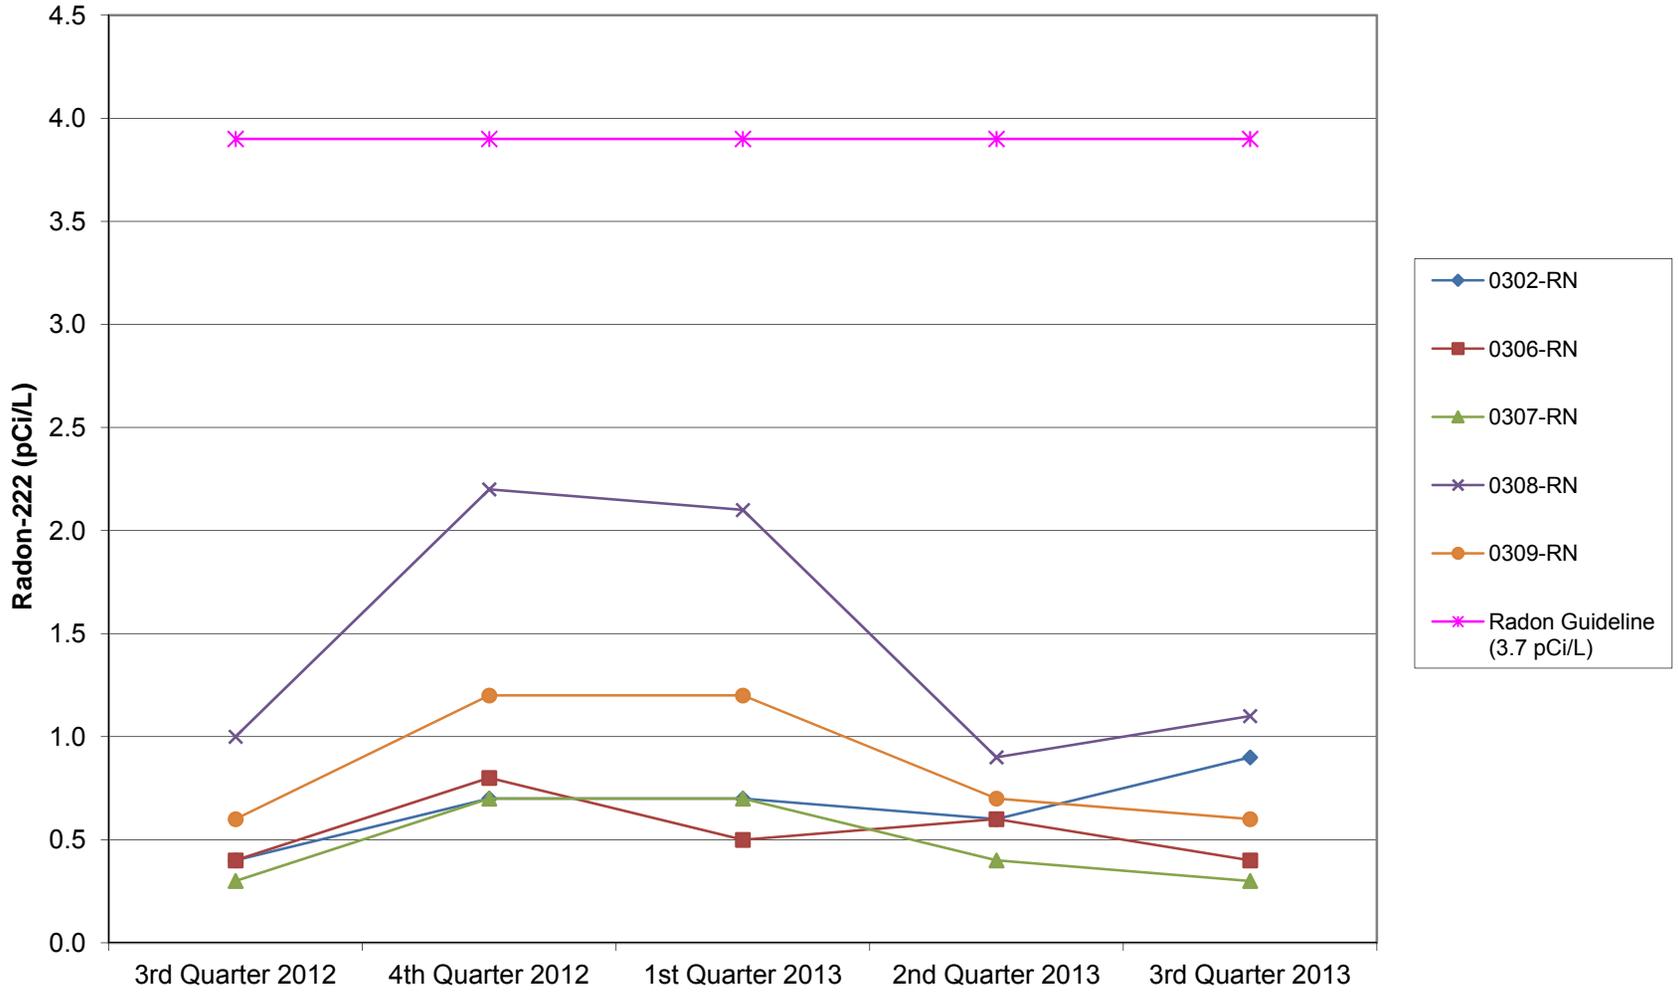
Figure 14. Atmospheric Radon-222 Concentrations at Select Crescent Junction Monitoring Locations

Radon-222 and gamma-radiation data were plotted on graphs (Figures 14 and 15, respectively) for the following Crescent Junction monitoring locations: (1) 0302, which is close to the northern side of operations; (2) 0306 and 0307, which are off-site stations closest to members of the public; (3) 0308, which is close to the southern side of operations; and (4) 0309, which is downwind of operations.

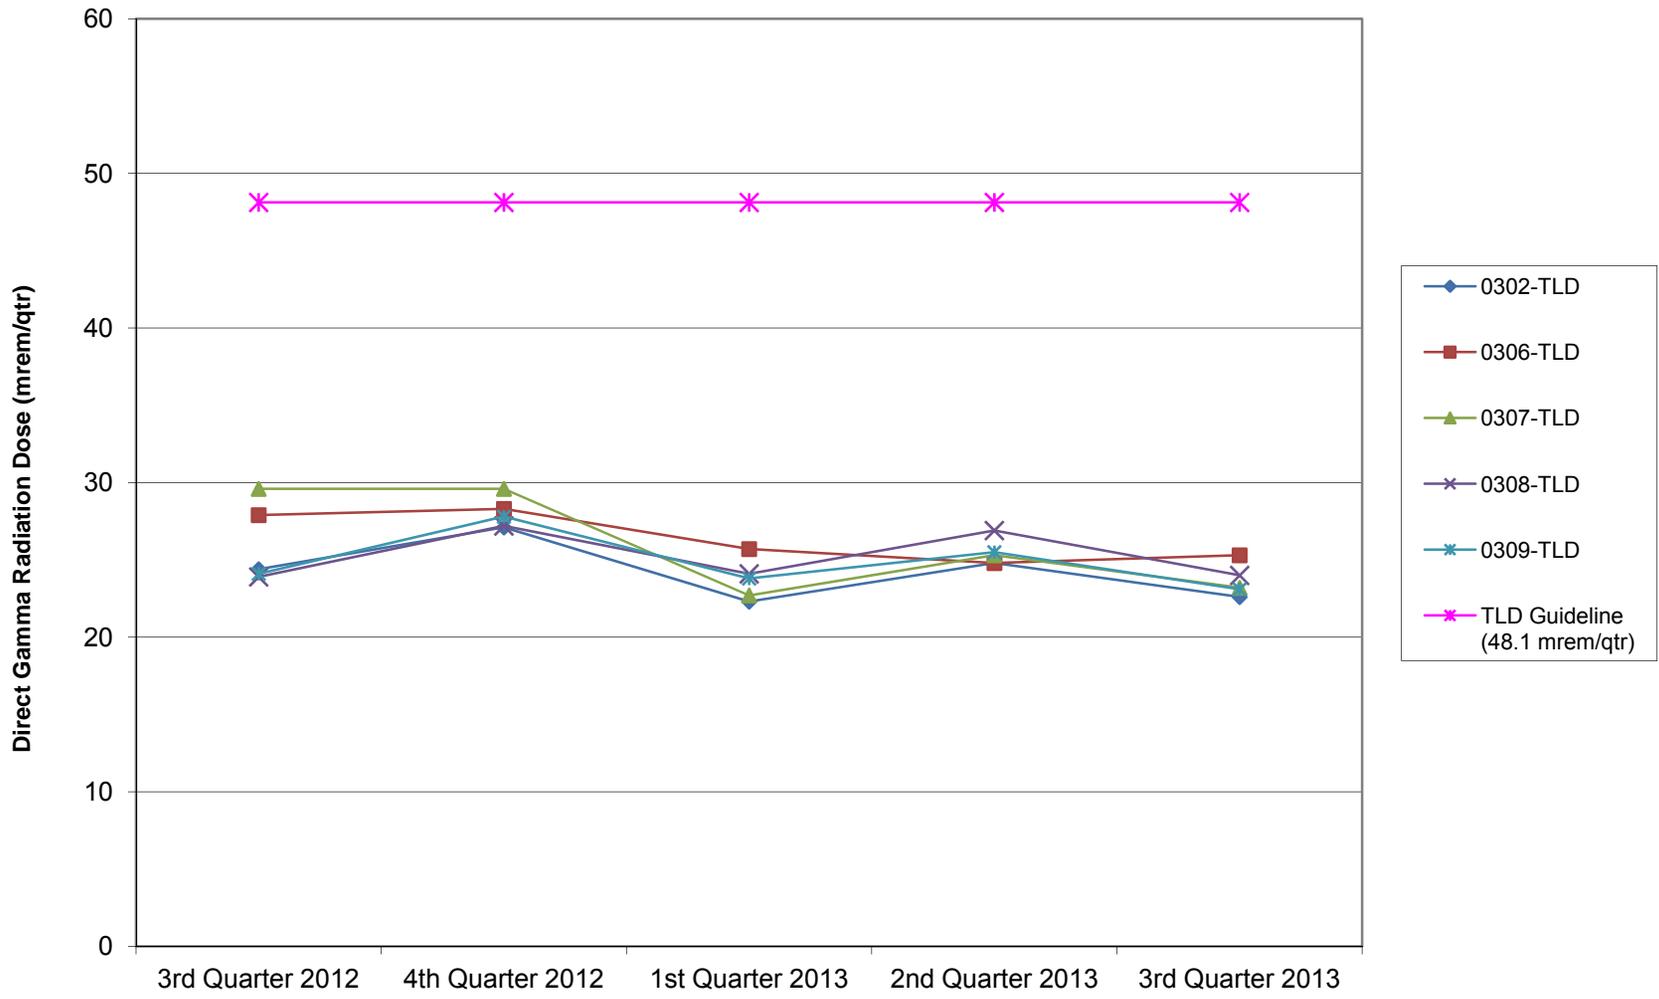
Figure 15. Direct Gamma Radiation Dose at Select Crescent Junction Monitoring Locations
