Moab UMTRA Project  
Flood and Drought Mitigation Plan

Revision 10

April 2021

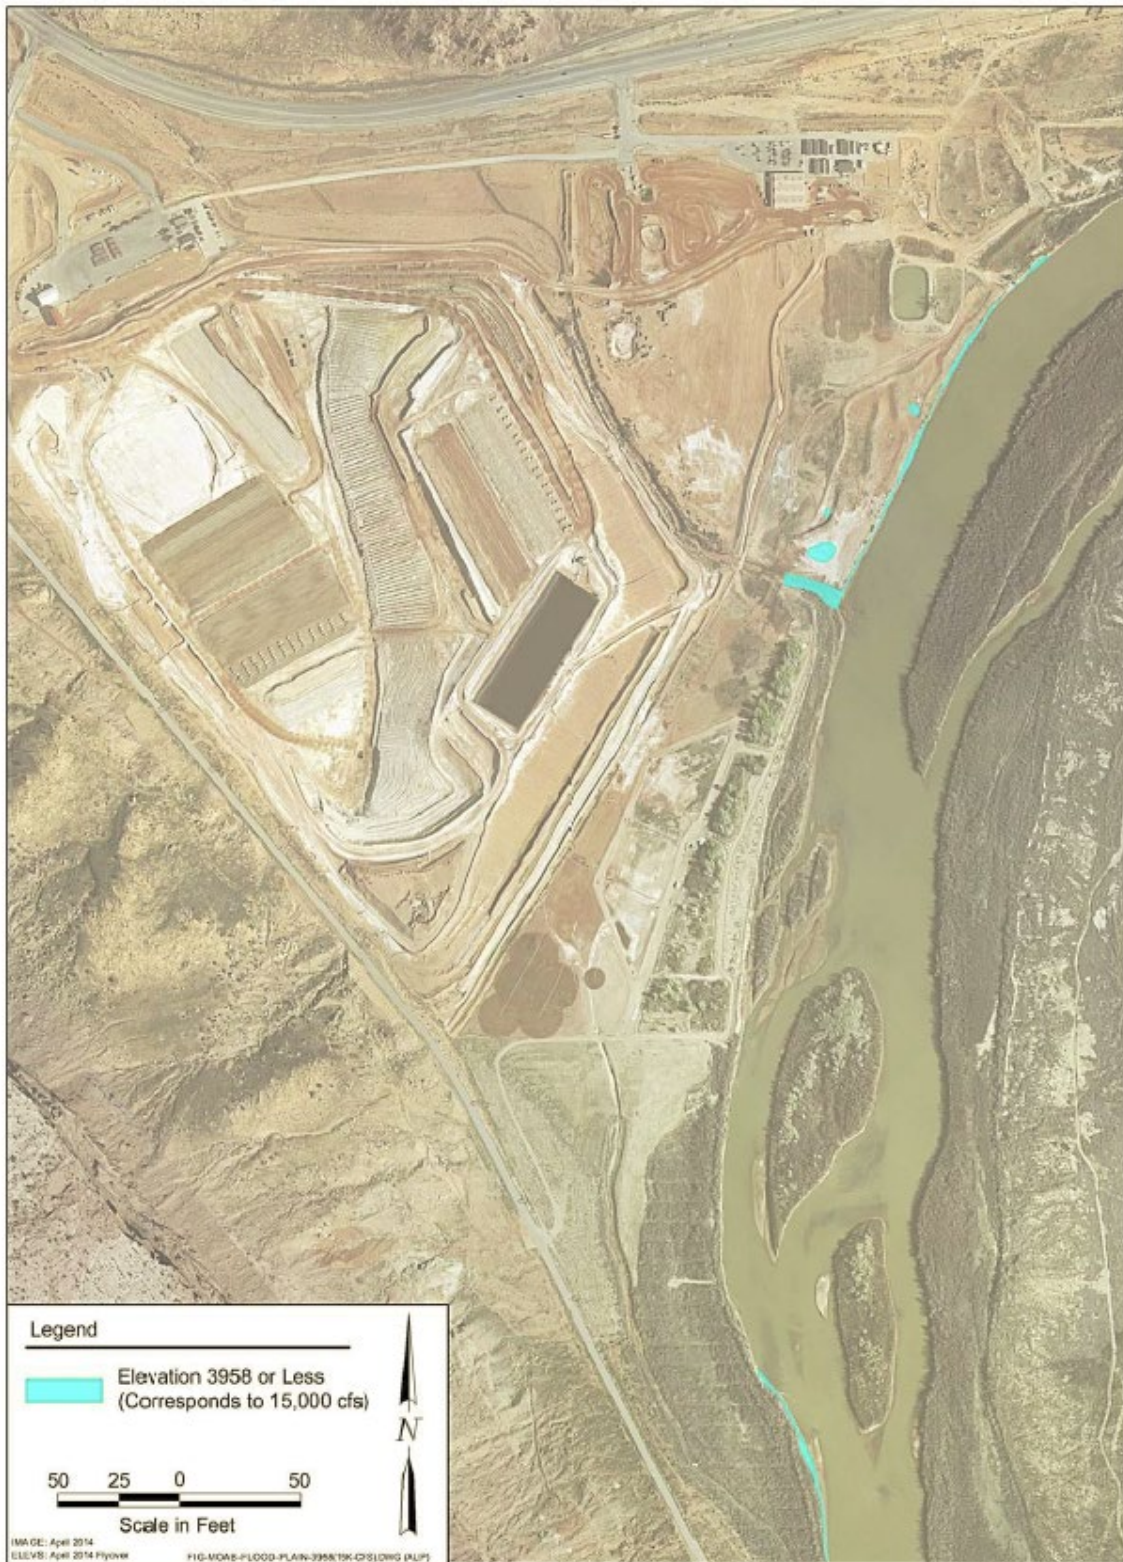
Figure A-1. Potential Impact of 15,000 cfs

These trigger points account for increases in flow rate that may occur over the weekend, when site support is reduced. Figures A-1 through A-4 in Appendix A show the ground elevation, the elevation of specific river flows, and how the site may be impacted.
