Moab UMTRA Project
Flood and Drought Mitigation Plan

Revision 9

January 2021

U.S. Department
of Energy

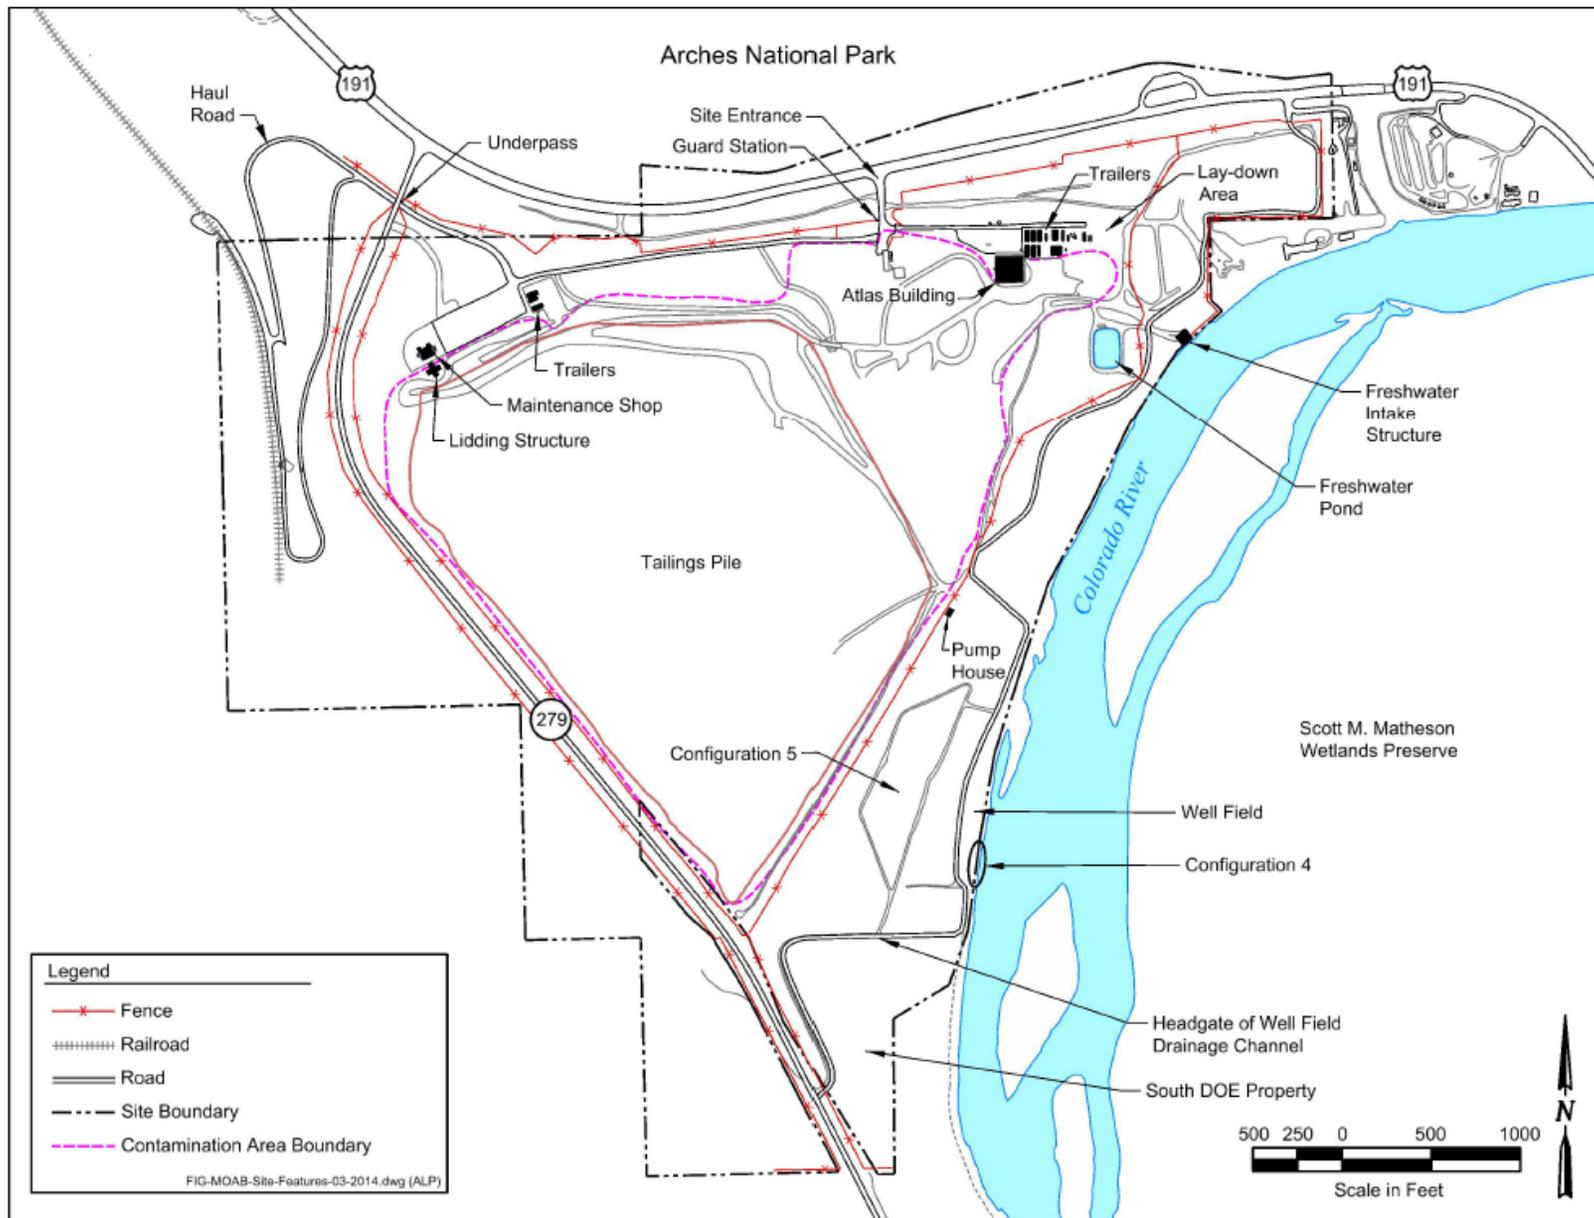
Figure 1. Moab Site Features

Several features of the Moab site are shown in Figure 1. The site is transected by the Moab Wash, which flows during significant storm events. North of the Wash is a freshwater intake structure that supplies a pond used for irrigation, dust control, decontamination, rinsing containers, and injection water as part of groundwater interim action (IA) remediation. Low stage of the Colorado River associated with drought conditions can result in insufficient water flowing into the Project's freshwater intake structure. The IA well field is located between the toe of the tailings pile and the river south of the Moab Wash. The site is susceptible to flooding because about 160 acres of the nearly 480 acres of the property are within the 100-year floodplain of either the Colorado River or the Moab Wash.

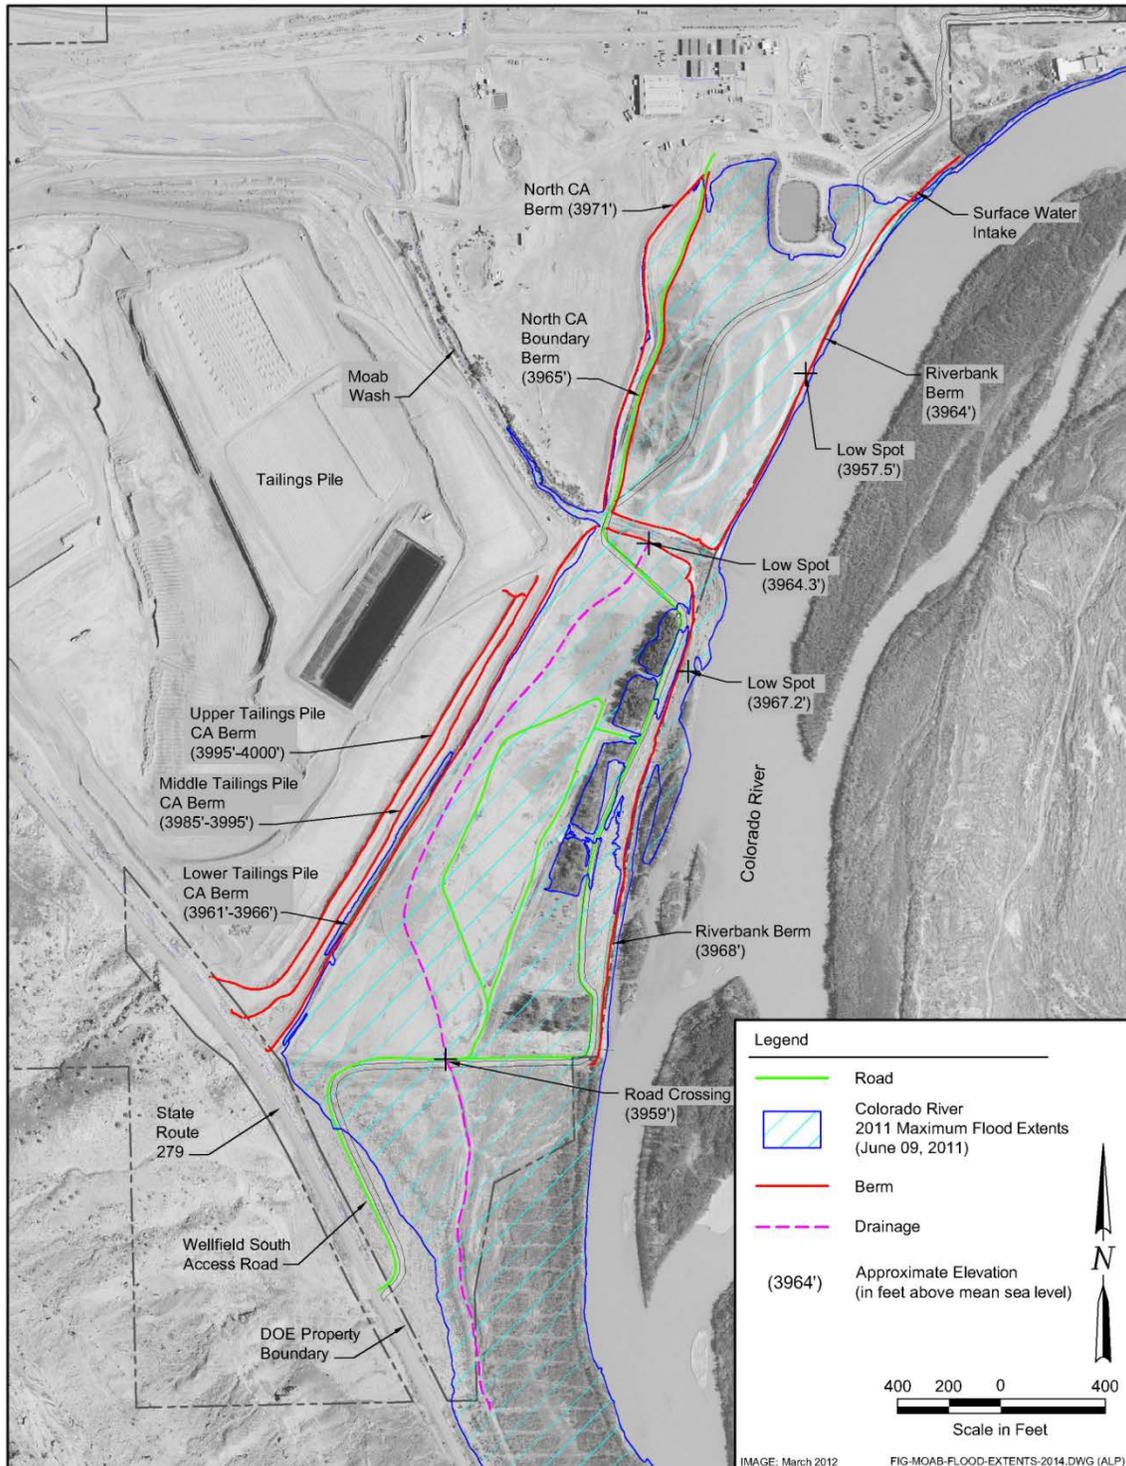
Figure 2. Moab Site Features, Colorado River Elevations, 2011 Flood Extent, and CA Berms and Elevations

During spring of 1983 and 1984, the Moab site was reportedly flooded up to the toe of the tailings pile. The most significant recent site flooding event occurred in 2019 (Figure 2), when the peak runoff reached 40,000 cfs, which is equivalent to a river surface elevation of 3,967.2 ft mean sea level (msl) on June 10, and the river flow was above the average annual peak flow from early June through late August. The impacts of this flooding event are well documented in the *Moab UMTRA Project 2019 Flood Response Summary* (DOE-EM/GJTAC3035).

Once flows exceed approximately 33,000 cfs, the low point on the berm along the Moab Wash will be topped, and river water is expected to flow to the south within the constructed channel that runs through Configuration (CF) 5 from the Moab Wash. At a flow near 35,000 cfs, Colorado River water will enter the well field from the south in the drainage channel noted on Figure 2.

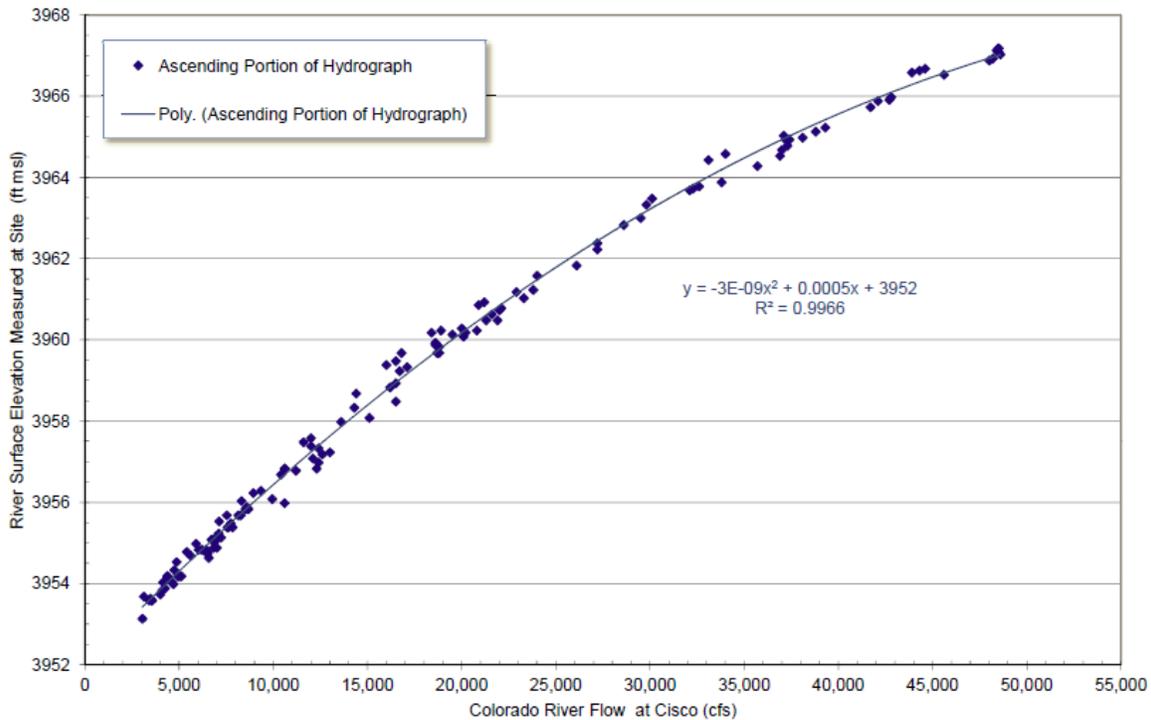
Figure 3. Cisco River Gage vs. Site Elevation Gage

Figure 3 represents a rating curve generated using the 2011 flows for the site based on the river flows measured at the Cisco gaging station and the corresponding river surface elevation measured at the site river intake structure. Ground surface elevation shows a low point on the riverbank south of the freshwater pond with an elevation of 3,957 ft msl (Figure 2). Using the rating curve, the associated river surface elevation for flows above 10,750 cfs will exceed the land surface elevation at this location, allowing river water to begin to migrate into the area.

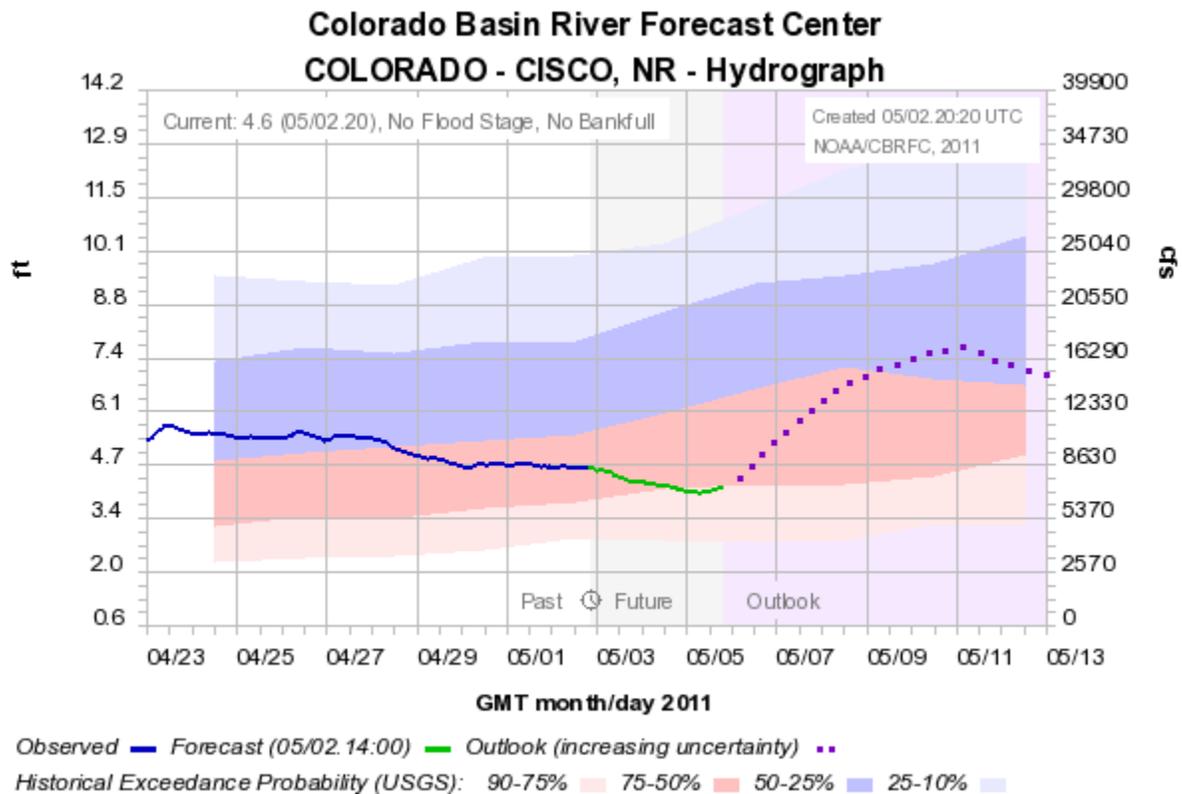
Figure 4. Example Hydrograph From Cisco, Utah, Gaging Station

Estimated Colorado River flow rates for the Cisco, Utah, gaging station (based on upstream flow rates and weather systems impacting the Colorado River basin) can be monitored on the National Oceanic and Atmospheric Administration (NOAA) website at <http://www.cbrfc.noaa.gov/river/station/flowplot/flowplot.cgi?CLRUI>. Figure 4 shows an example hydrograph from the Cisco gage.

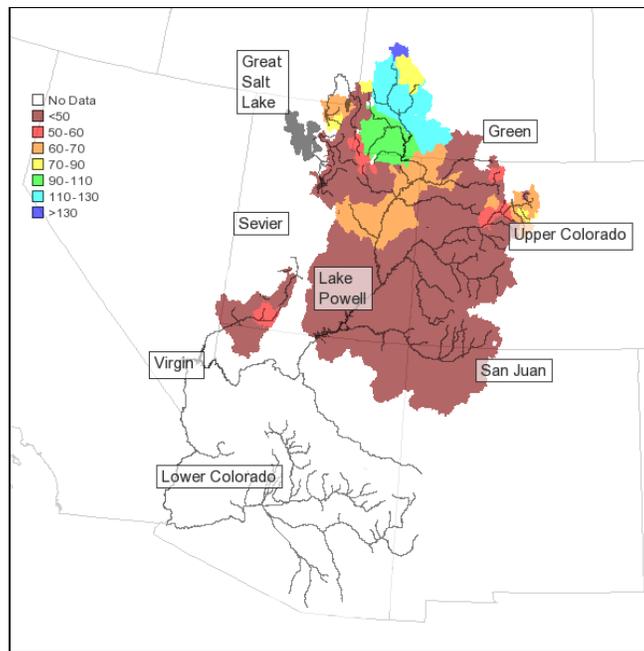
Figure 5. CBRFC Percent Average Water Supply Conditions for June 1, 2018

Figure 5 shows the water supply forecast for June 1, 2018, during drought conditions. During 2018 the peak river flow was only 8,470 cfs, approximately one-third of the average, and flows decreased below 2,000 cfs by late-September. In addition, NOAA has a separate program called the National Integrated Drought Information System (NIDIS) (drought.gov), which includes a national drought early warning system.

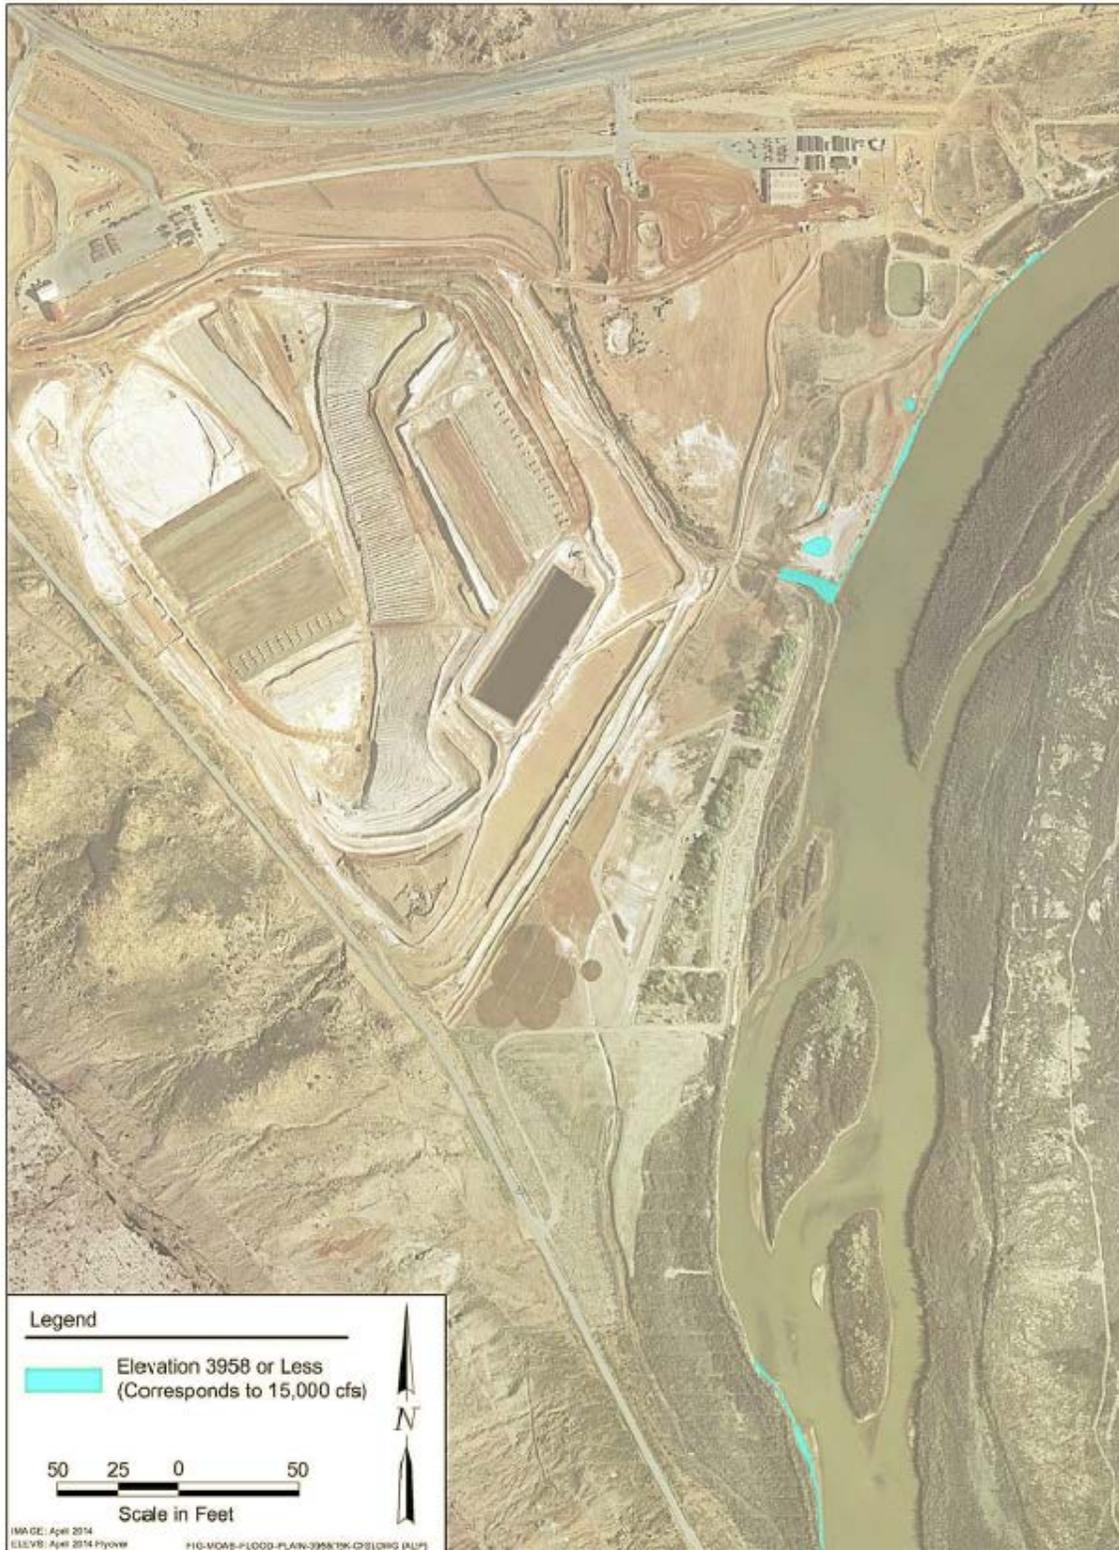
Figure A-1. Potential Impact of 15,000 cfs

These trigger points account for increases in flow rate that may occur over the weekend, when site support is reduced. Figures A-1 through A-4 in Appendix A show the ground elevation, the elevation of specific river flows, and how the site may be impacted.
